ADA Transition Plan and Self-Evaluation

City of
Manchester
Manchester, TN

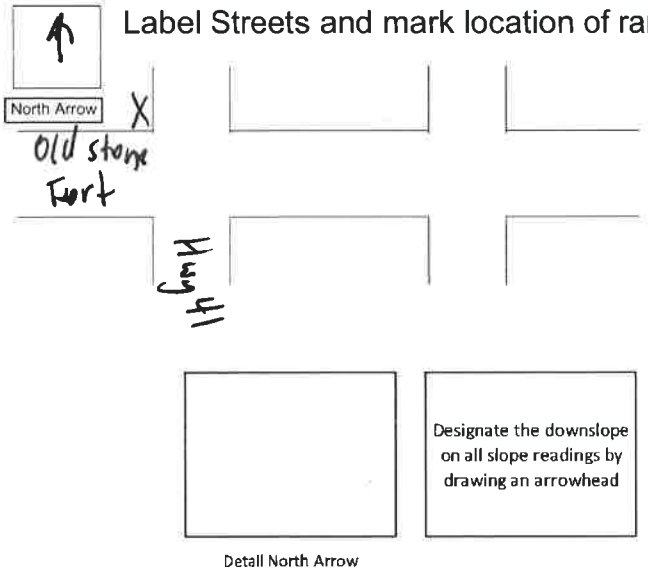
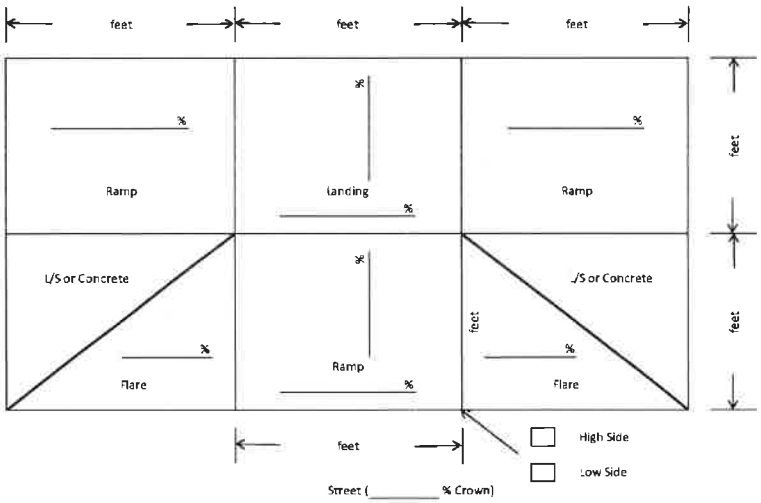
No curb ramp

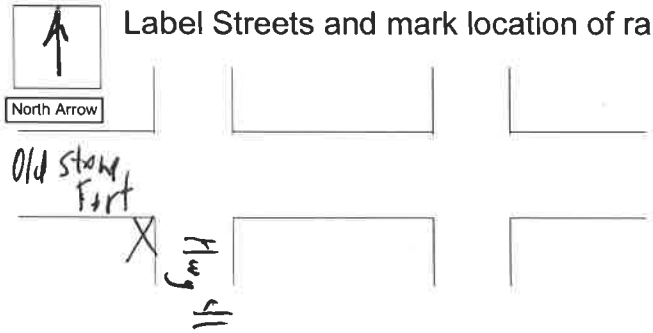
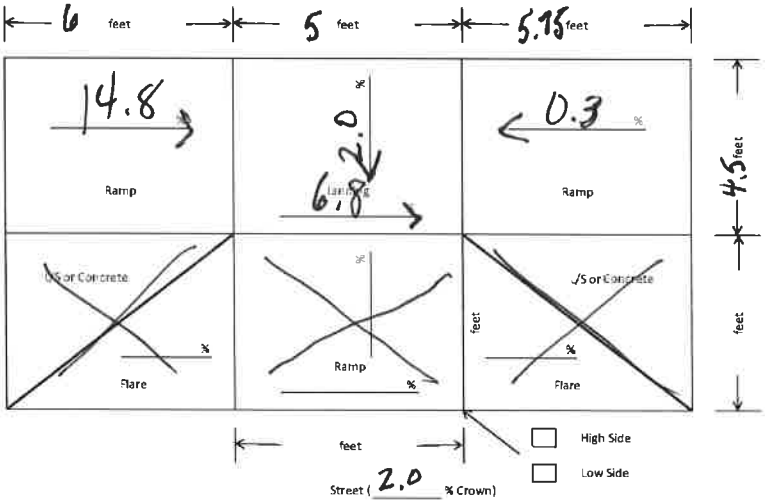
Detectable warning is red

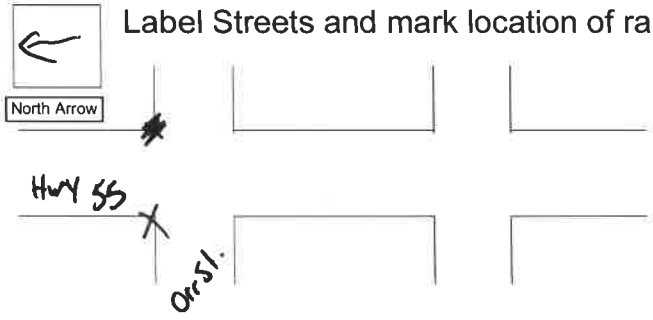
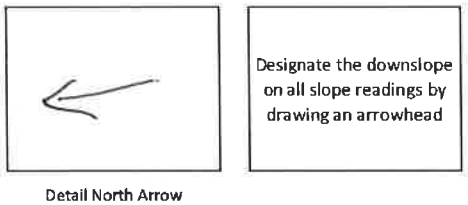
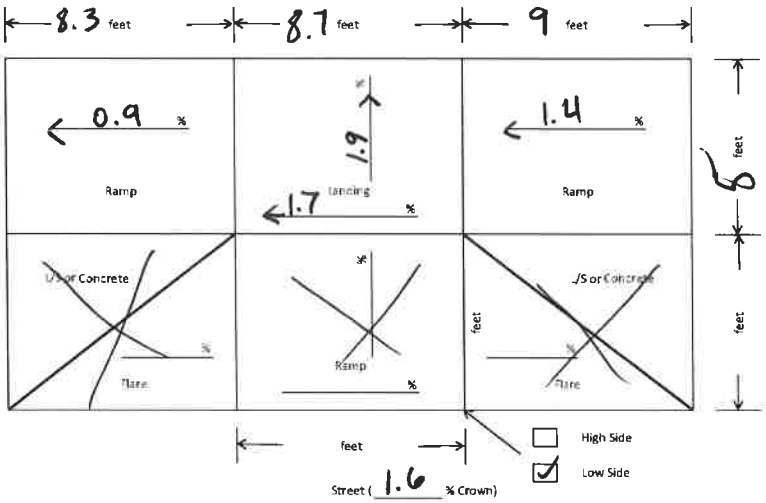
Curb ramp has no domes & isn't aligned with direction of travel

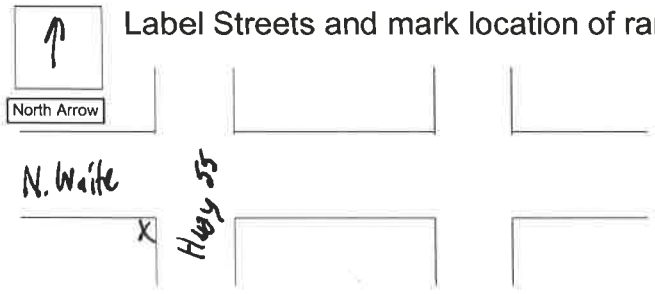
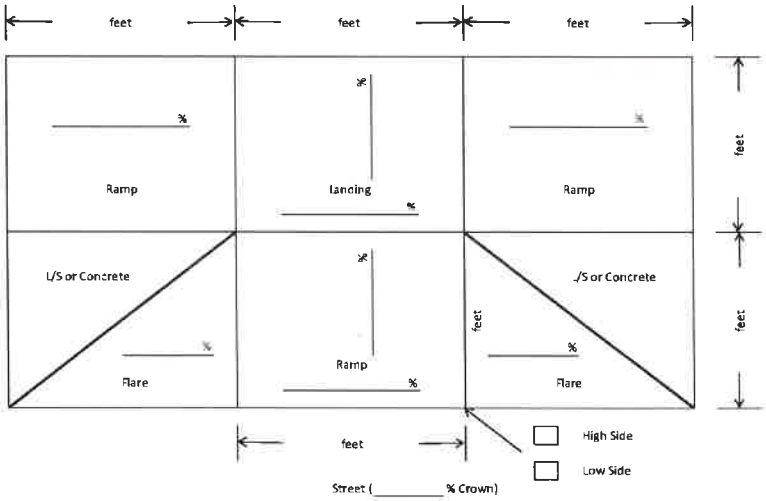
No curb ramp

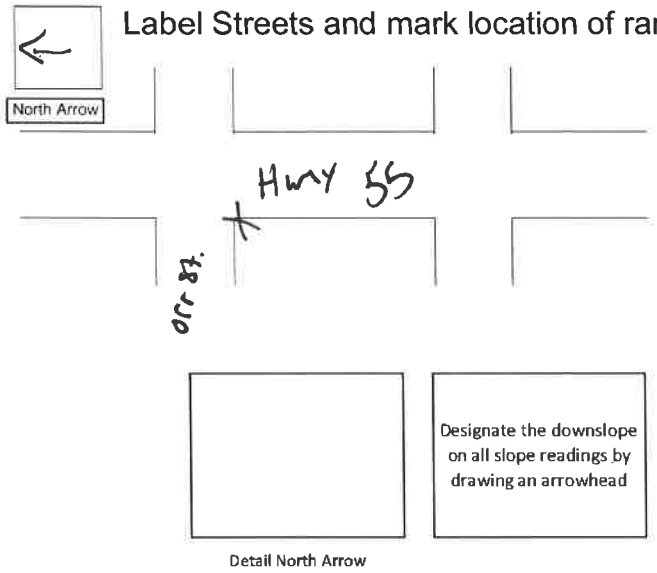
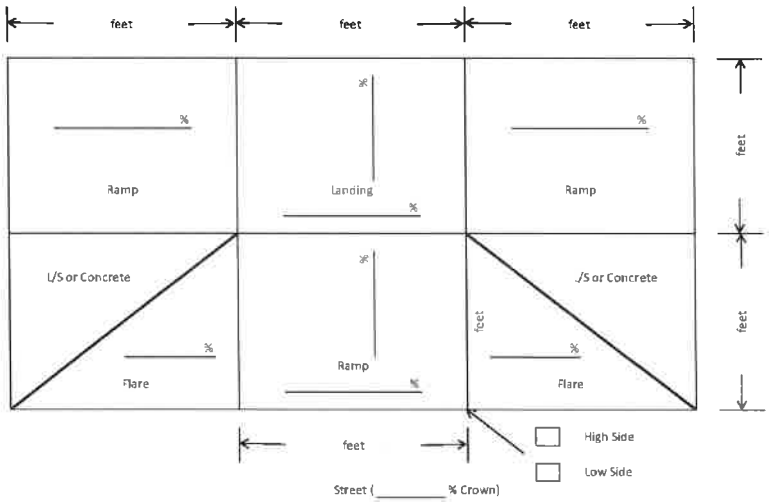
No. Curb ramp

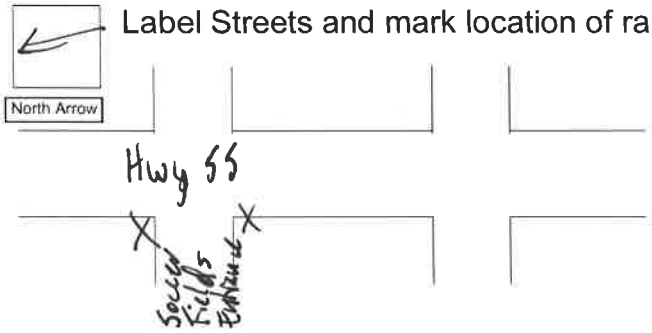
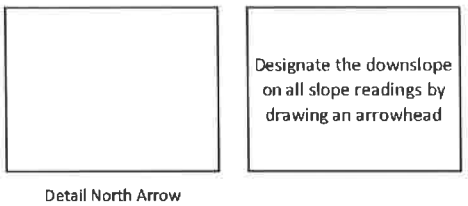
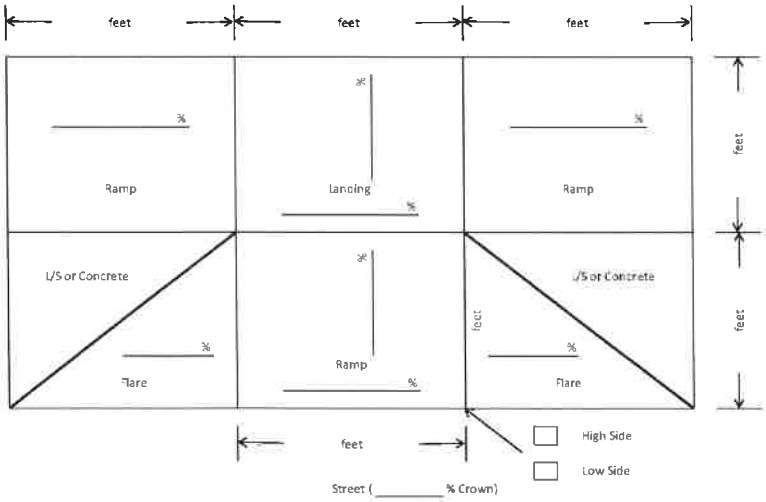
Needs detectable domes; Entrance does not need curb ramps (part of sidewalk)

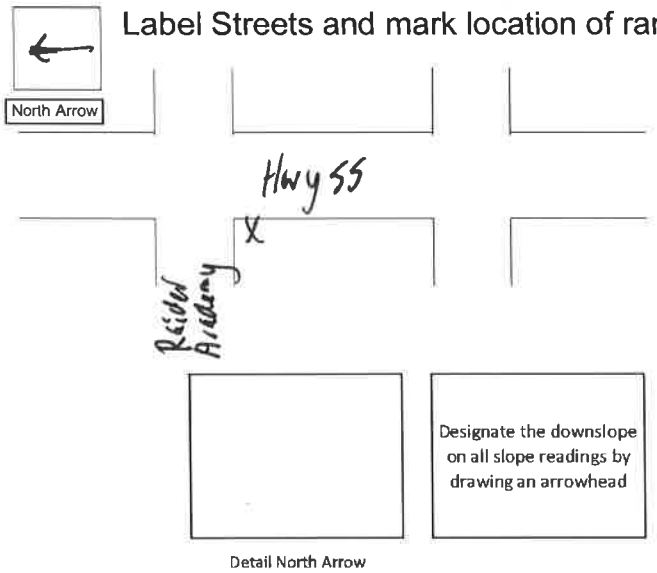
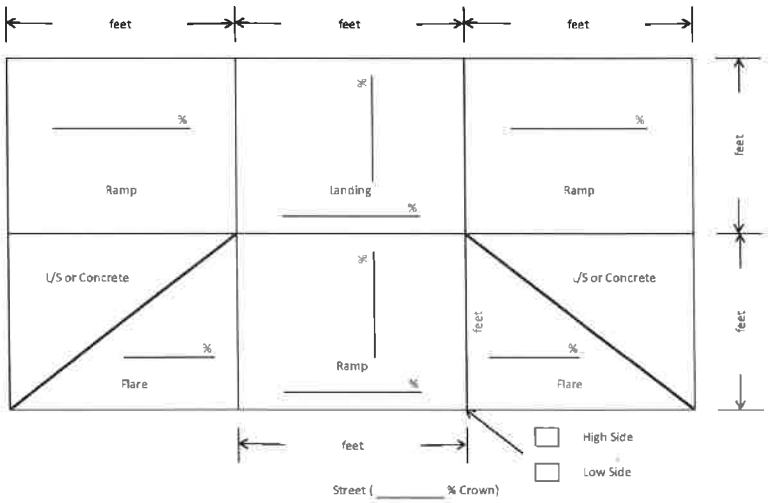
No curb ramp

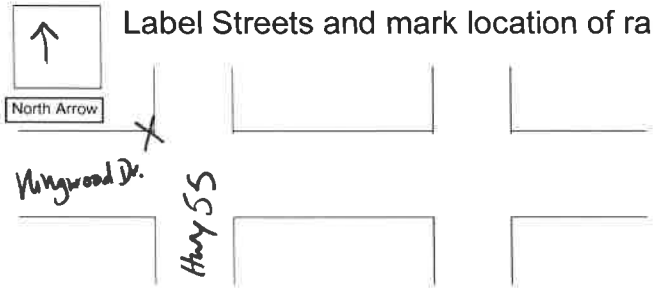
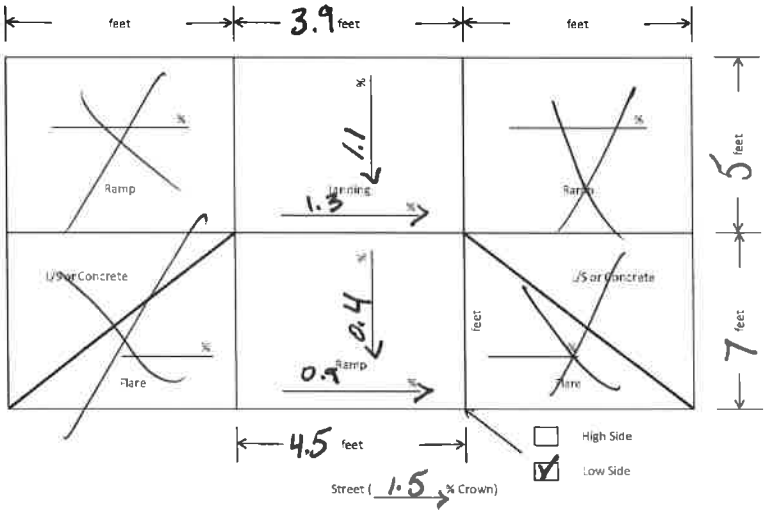
No Domes

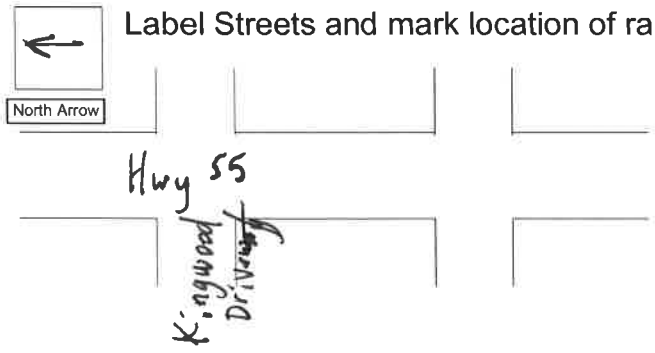
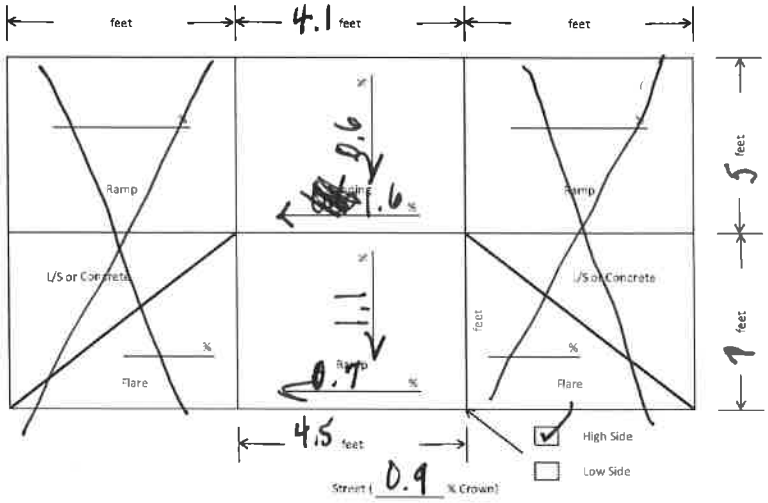
No domes

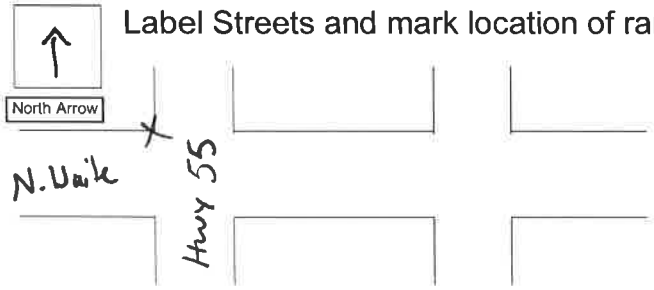
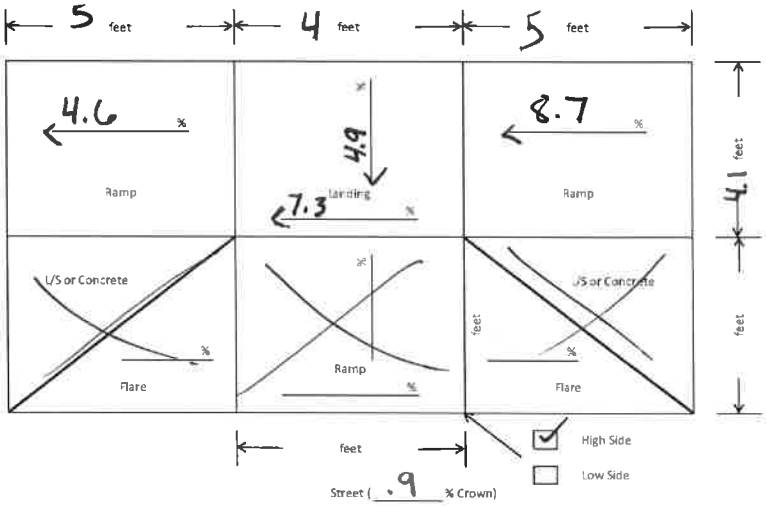
No domes Feasible to fix cross slope; Infeasible to fix running slope

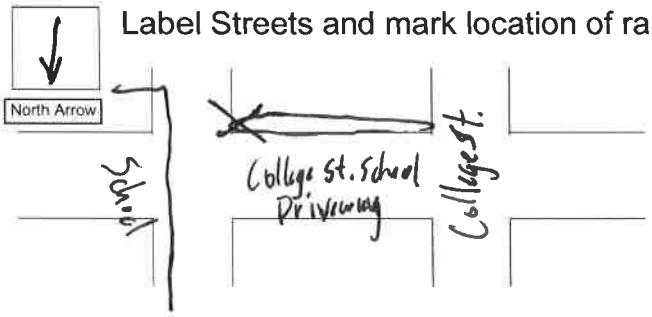
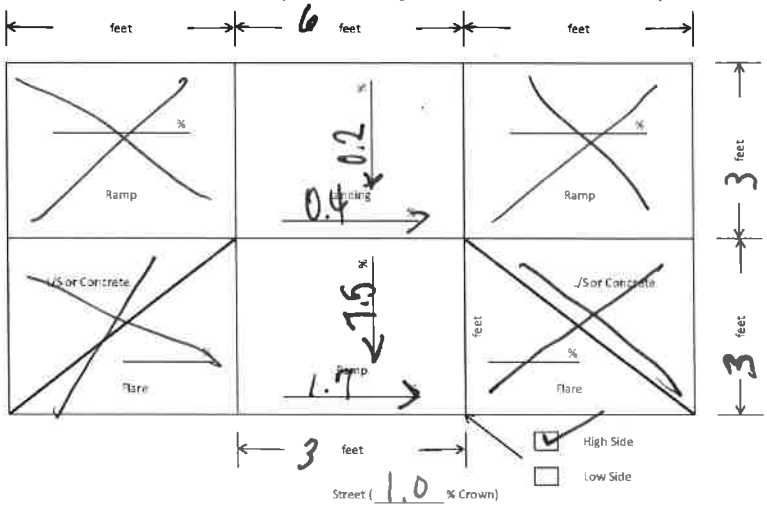
Landing and ramp too small
Could be fixed easily
No domes

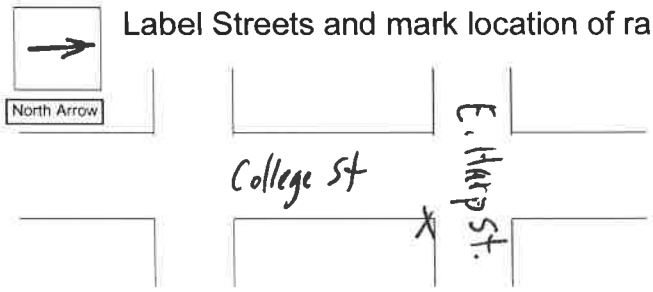
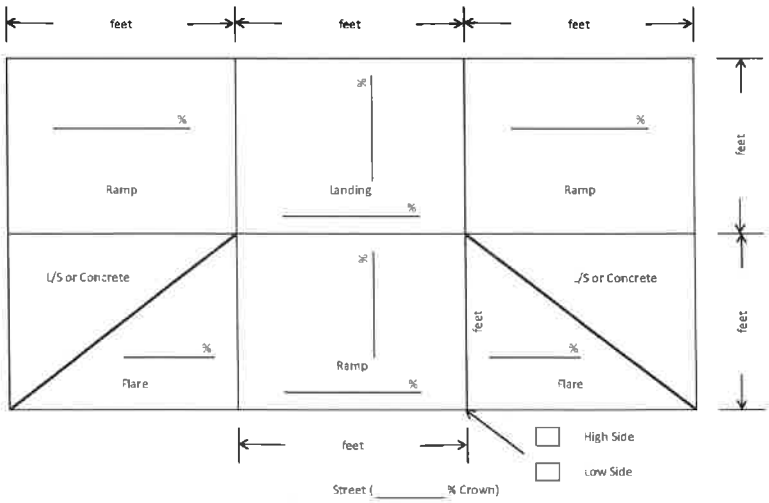
Sidewalk dead ends into pavement of College St. without a proper landing and no domes

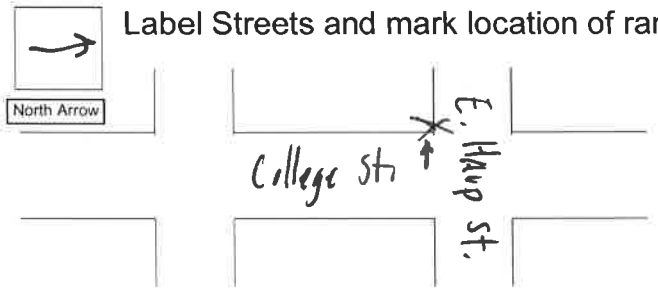
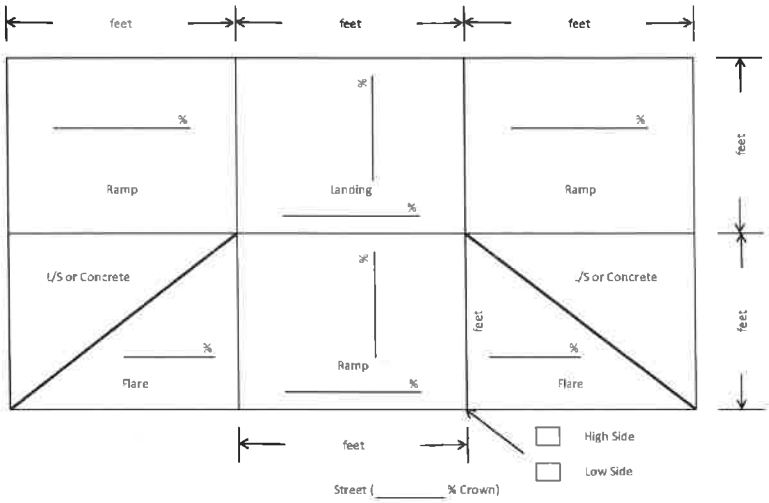
Needs a curb ramp coming from other side of College St.

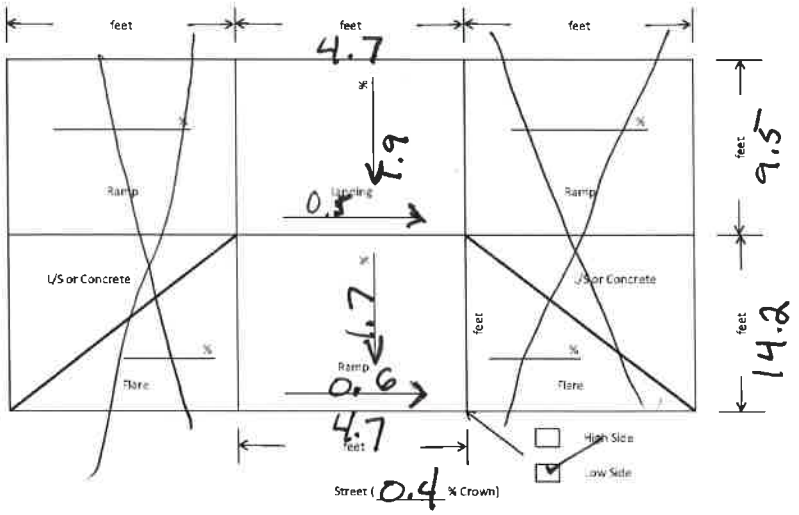
No detectable warnings

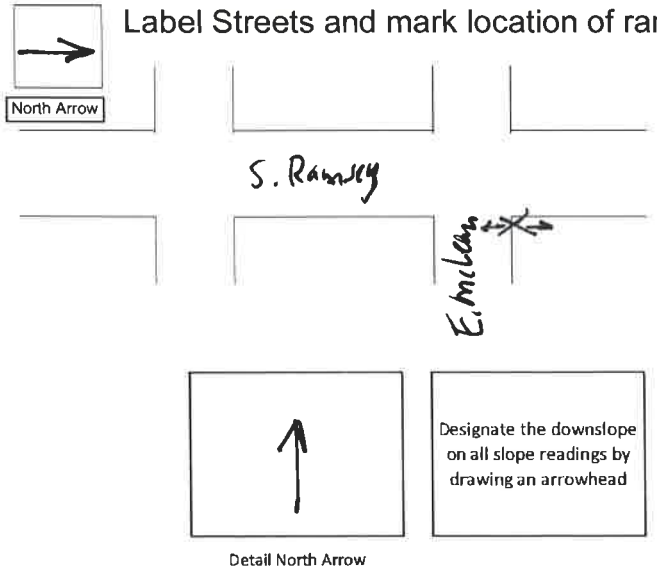
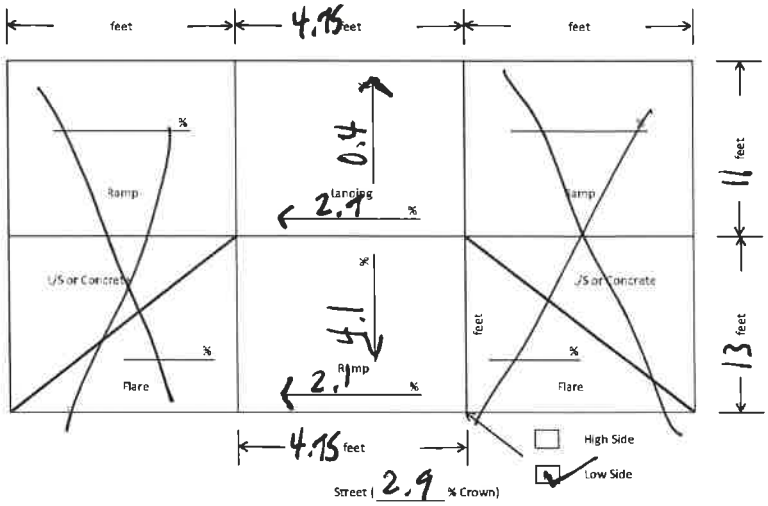
No domes; Easily fixable

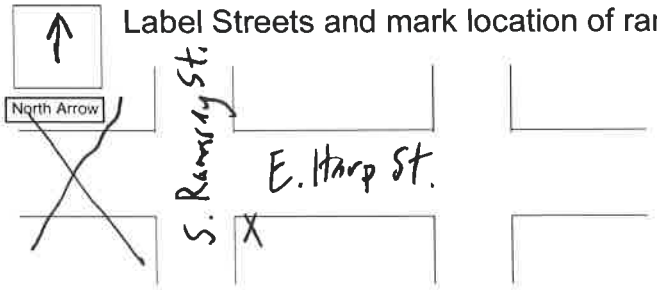
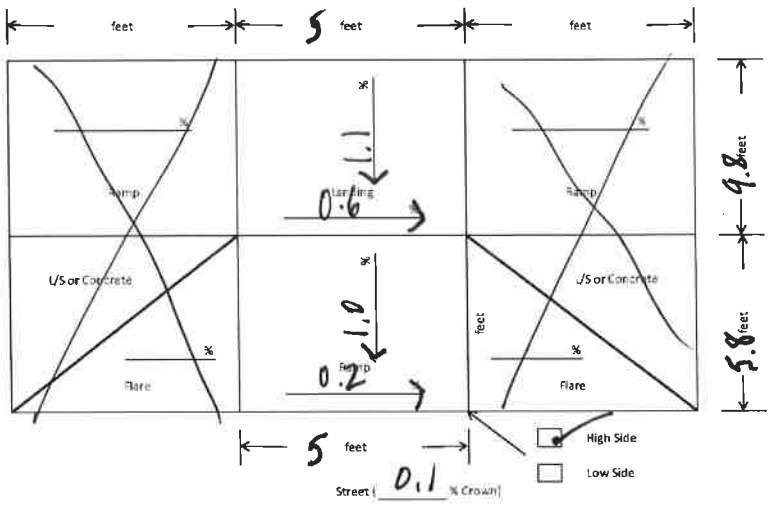
Chunk out of ramp for water valve box
only 3" into ramp
No domes

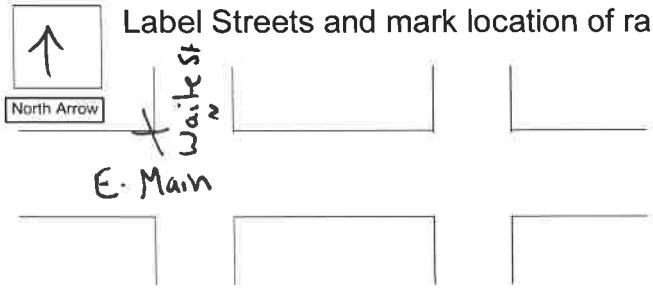
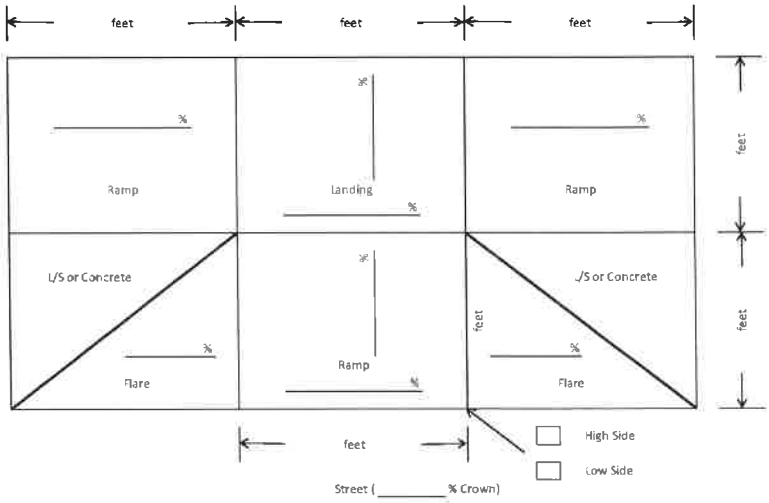
No curb. ramp. Side walk ends in grass

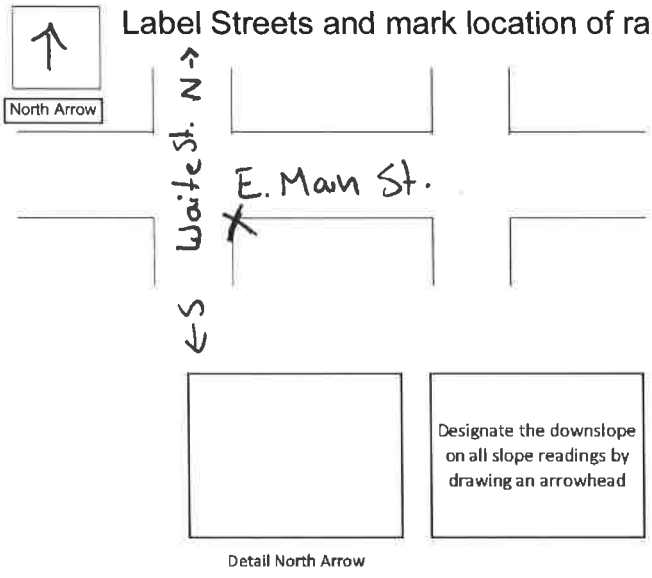
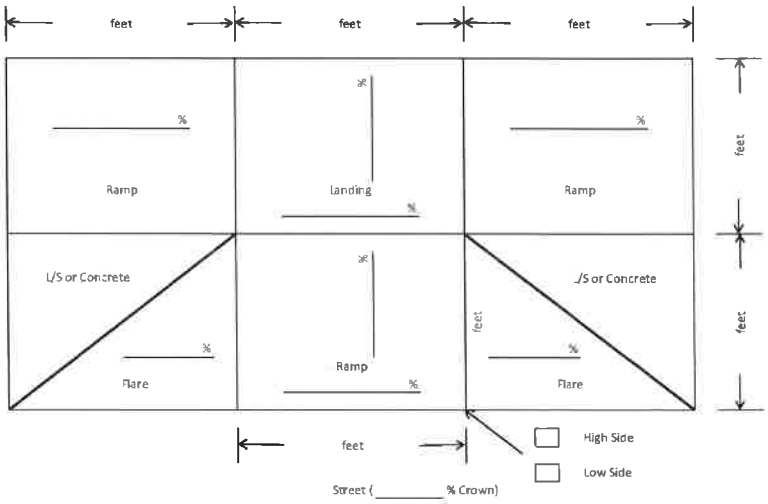
No Curb. ramp. Sidewalk ends in grass

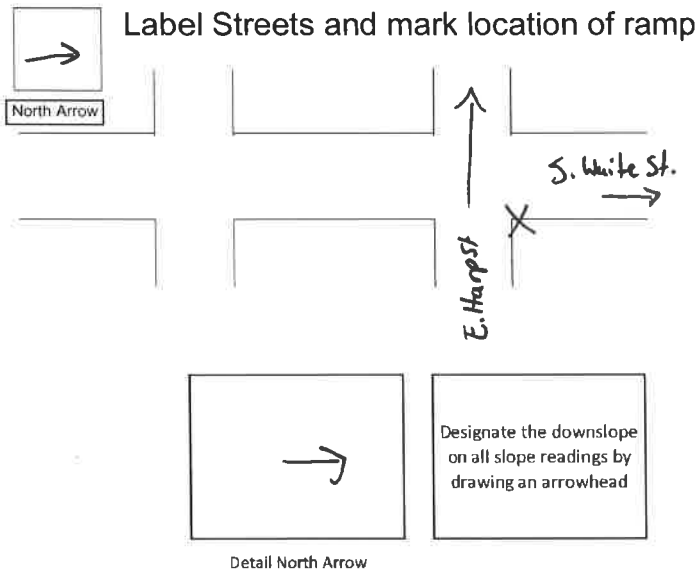
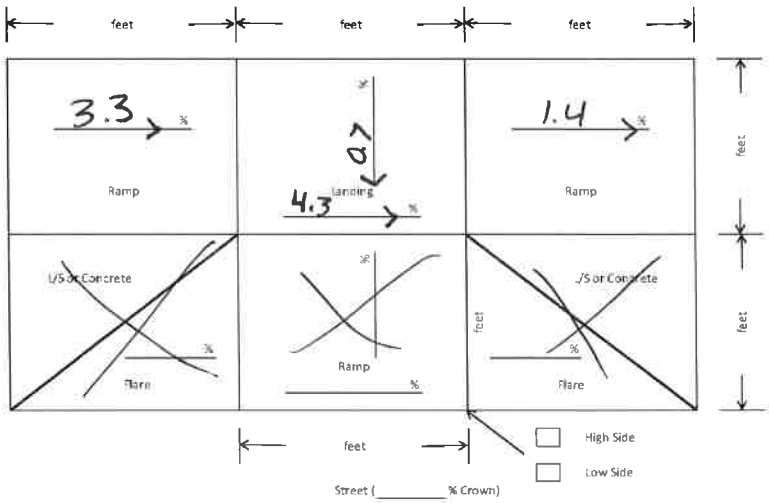
No curb ramp.

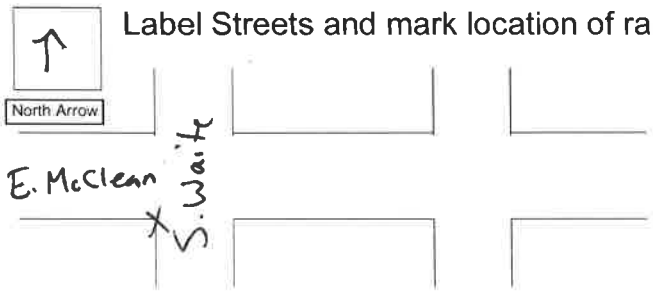
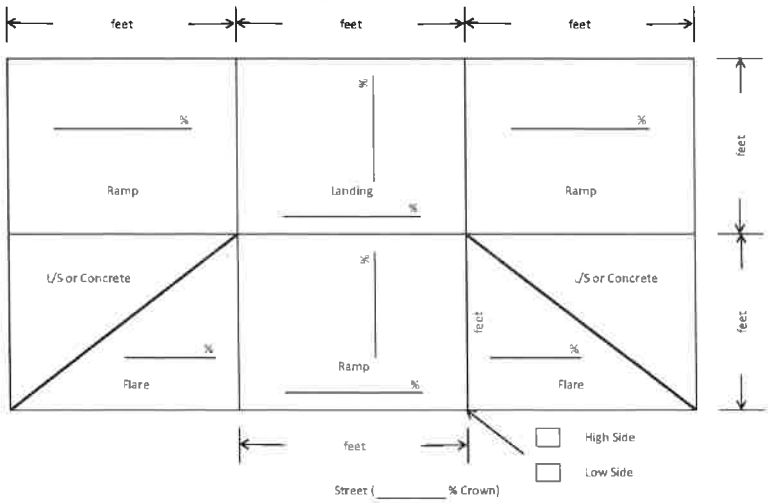
No curb. ramp. ~~Edges~~ Sidewalk ends in grass

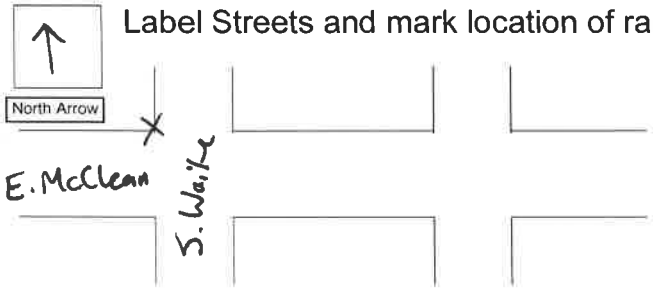
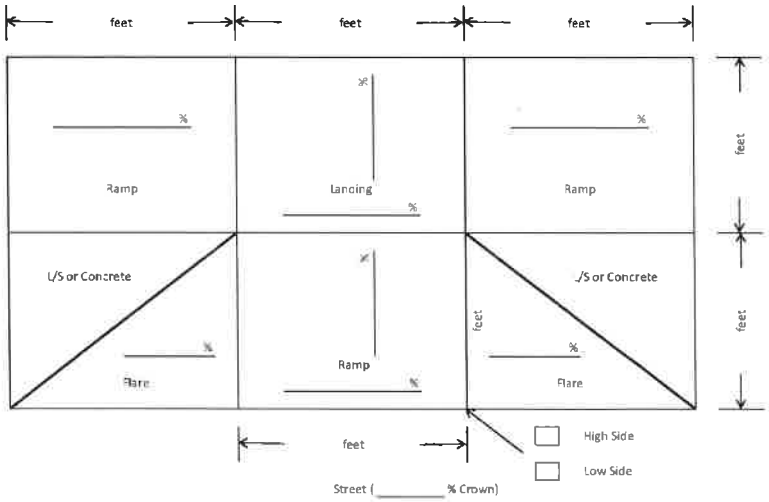
No Curb ramp. Side walk ends in grass

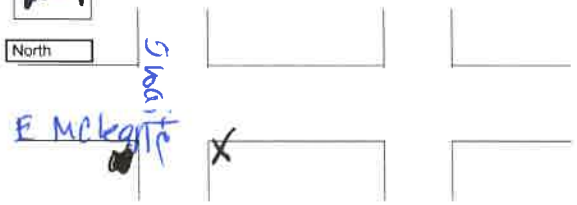
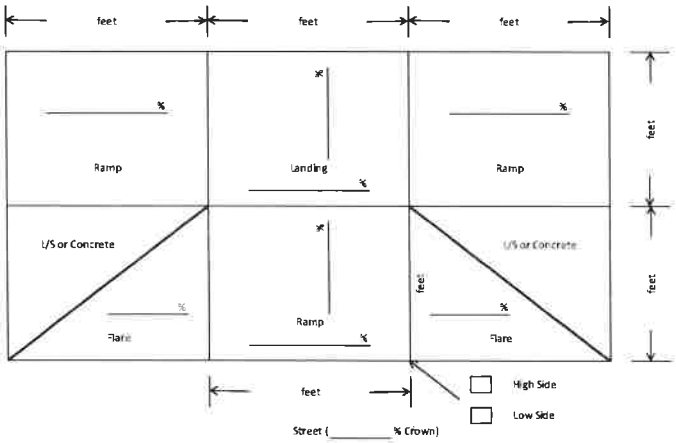
No Curb Ramp

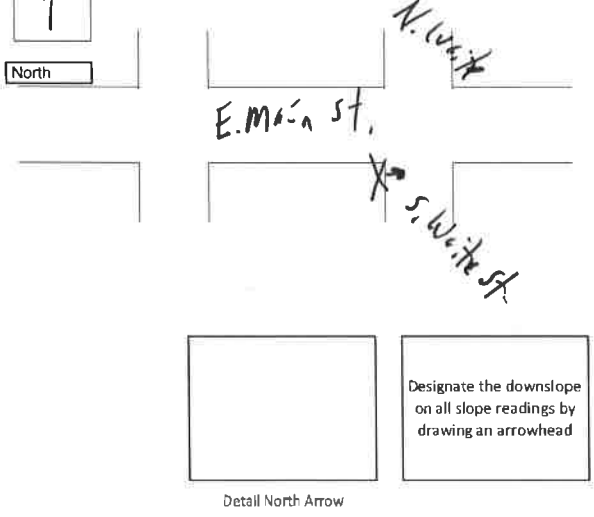
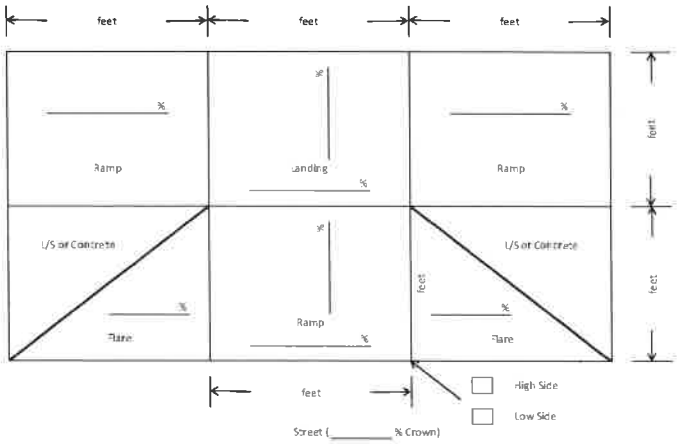
No curb ramp. Electric pole and drainage tile will be in way of new curb ramp.

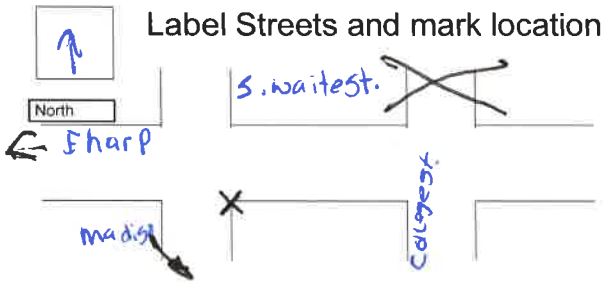
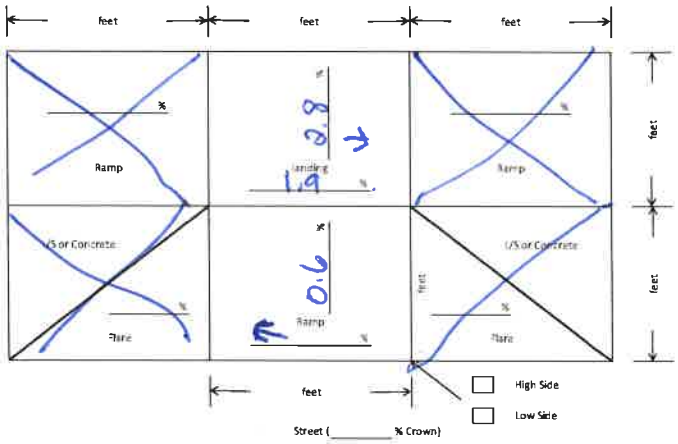
No Curb Ramp

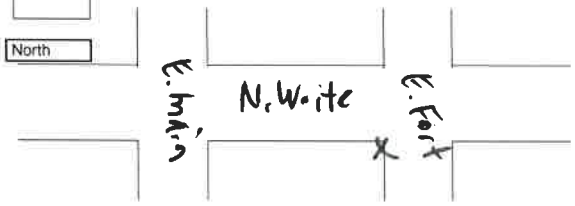
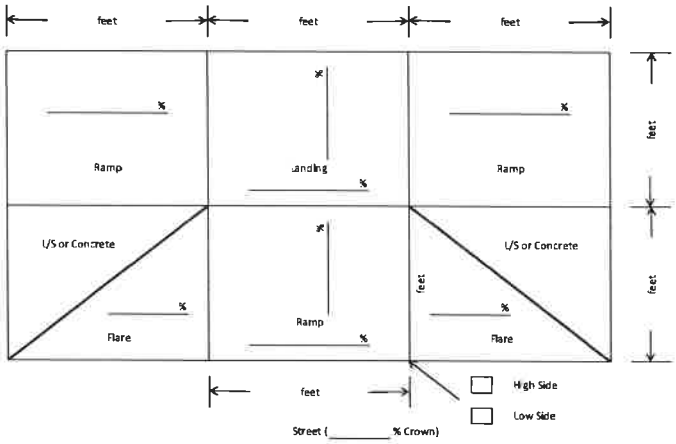
Sidewalk ends at E. Fort St. with no curb ramp

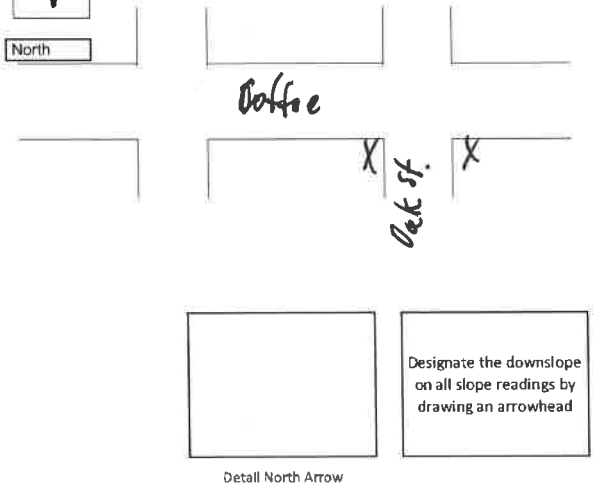
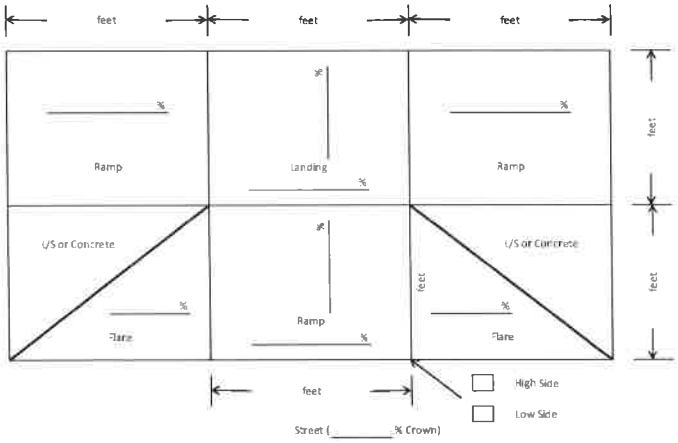
No curb ramp on both sides of Oak St.

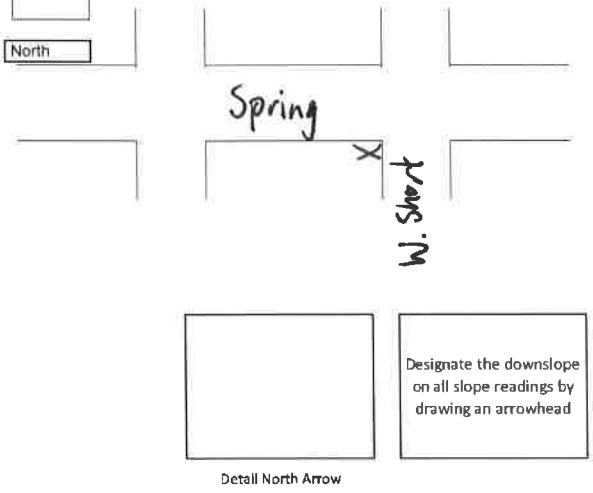
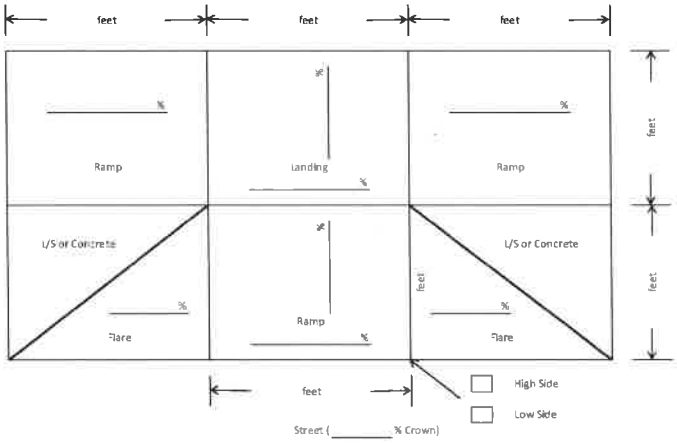
No curb ramp

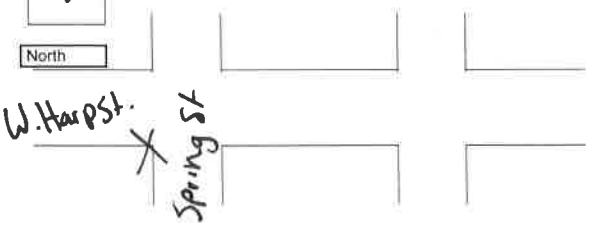
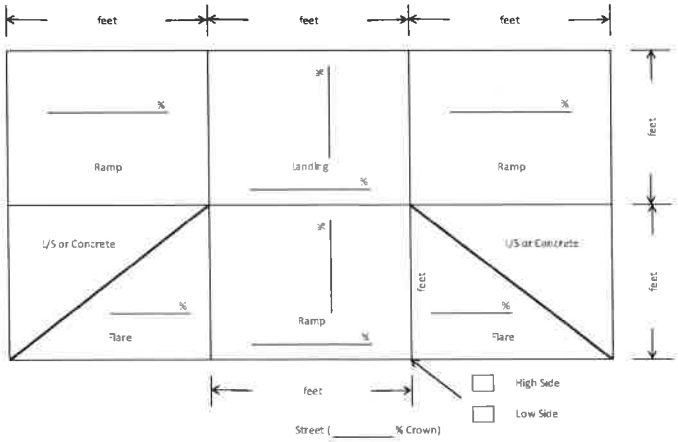
No curb ramp.

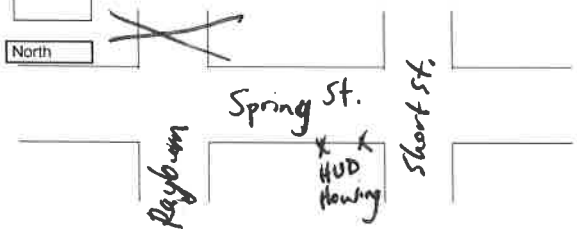
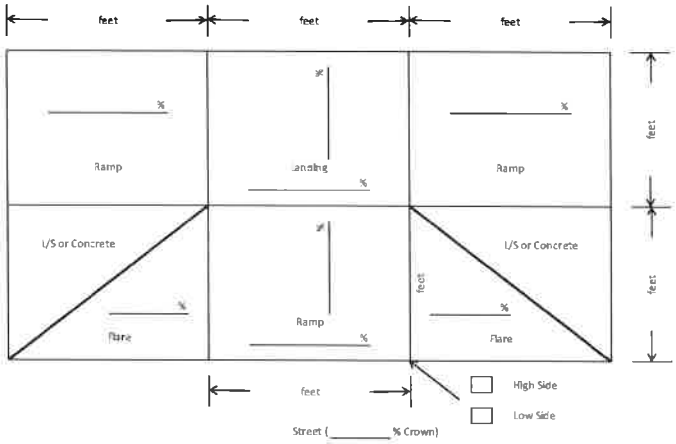
No curb ramps at HUD Housing Drive
Needs two curb ramps

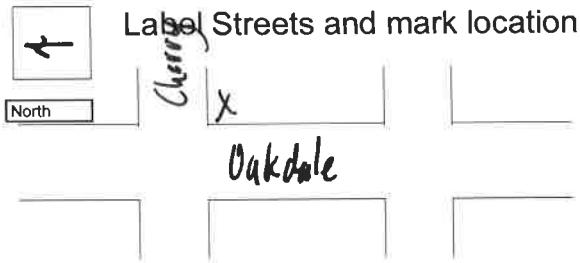
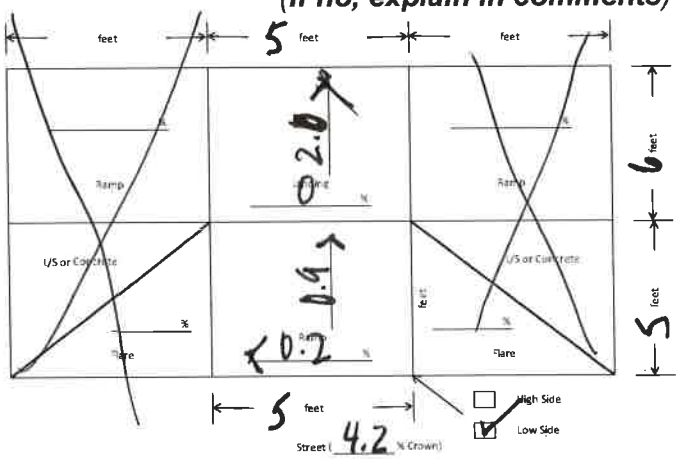
Detectable domes are red

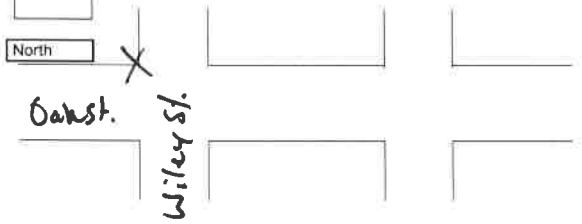
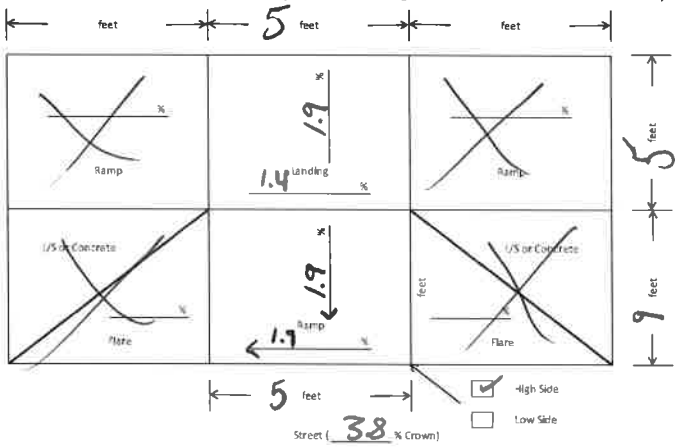
COMMENTS: detectable warnings
No.

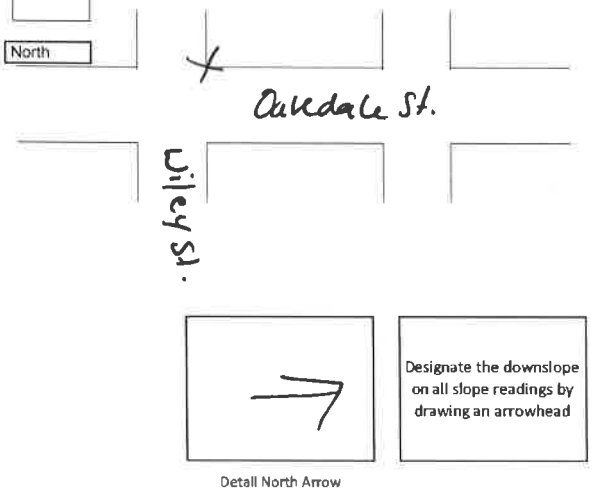
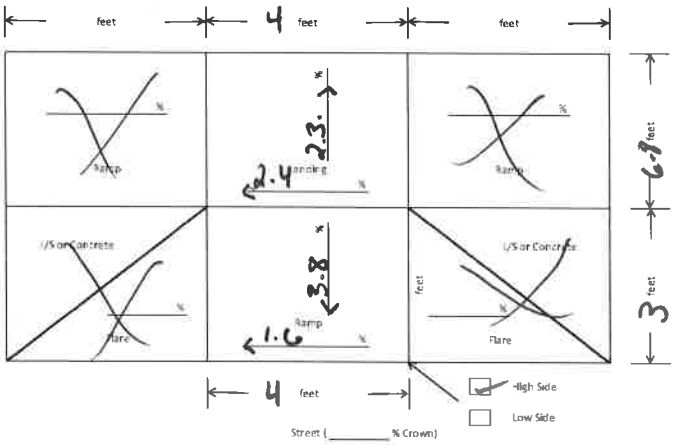
Curb ramp has small section of sidewalk that ends at playground

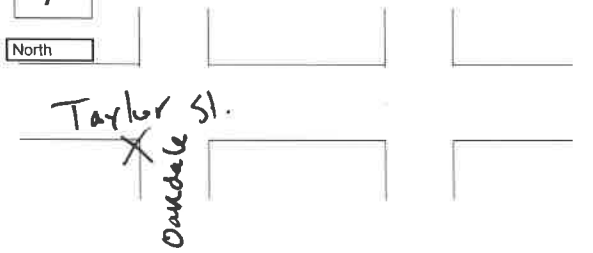
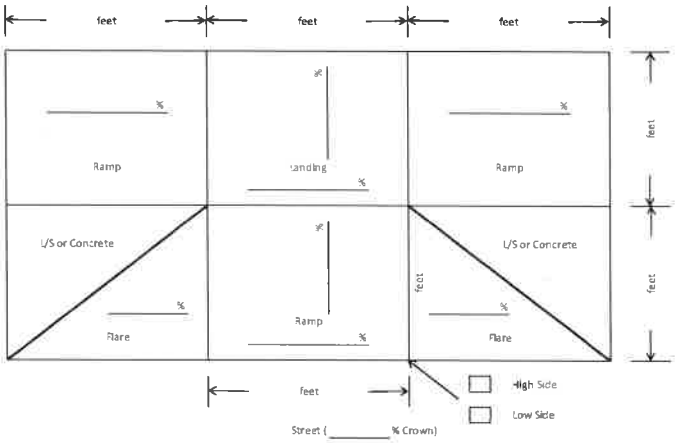
No. Curb ramp.

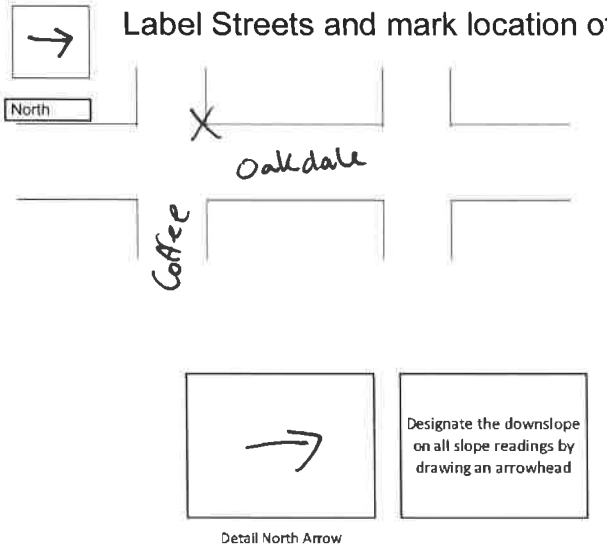
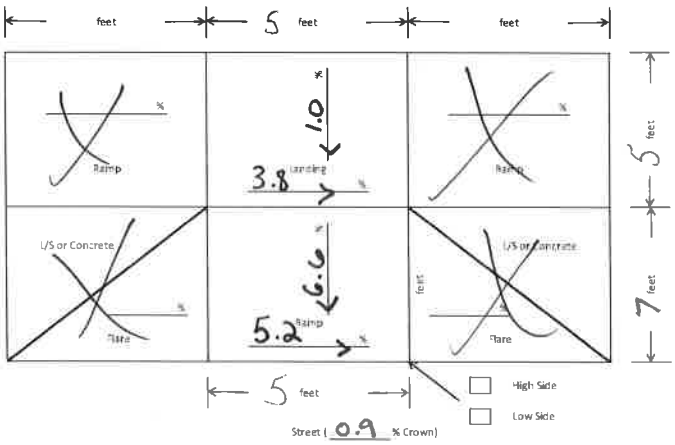
Domes are red.

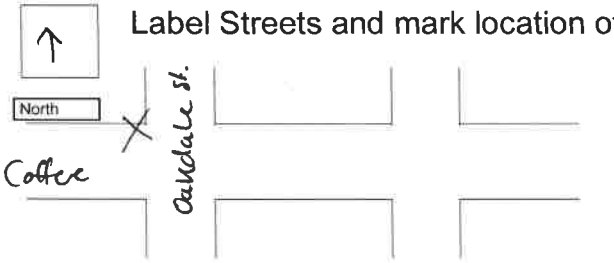
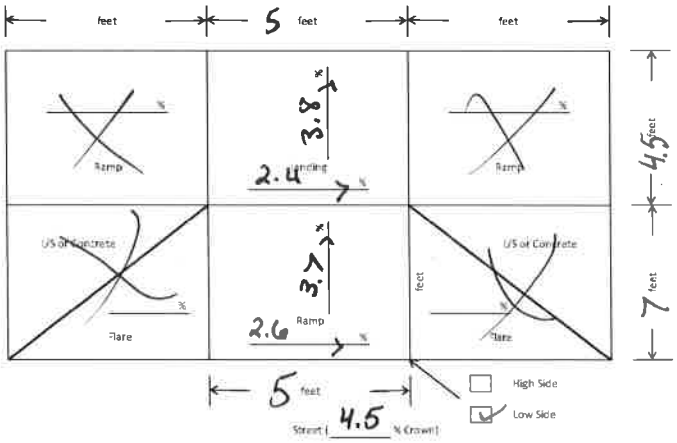
domes are red.

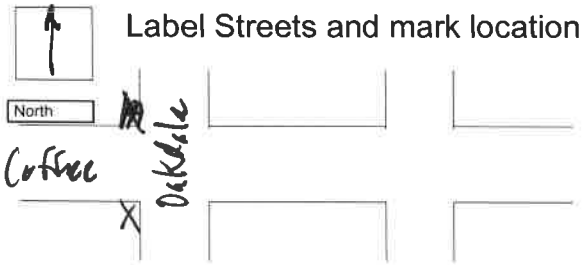
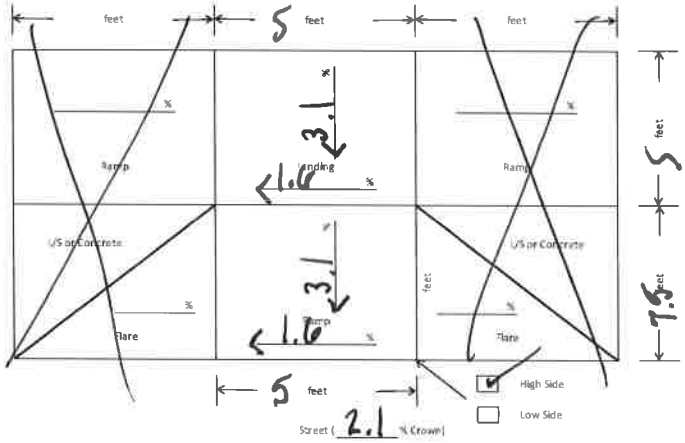
Detectable domes are red

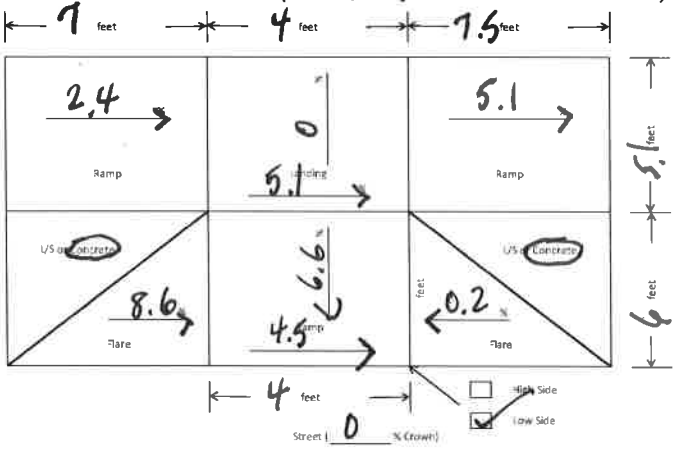
Detectable domes are red

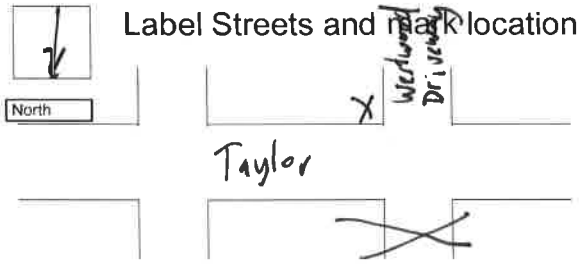
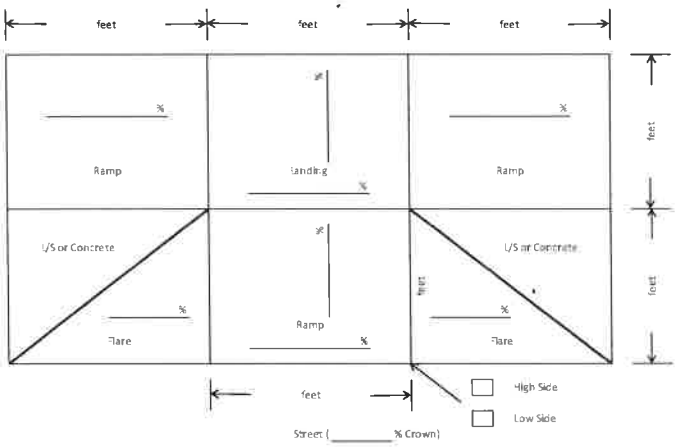
They have tied asphalt into existing sidewalk to make a ramp.

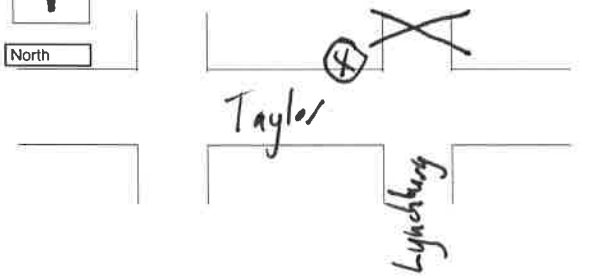
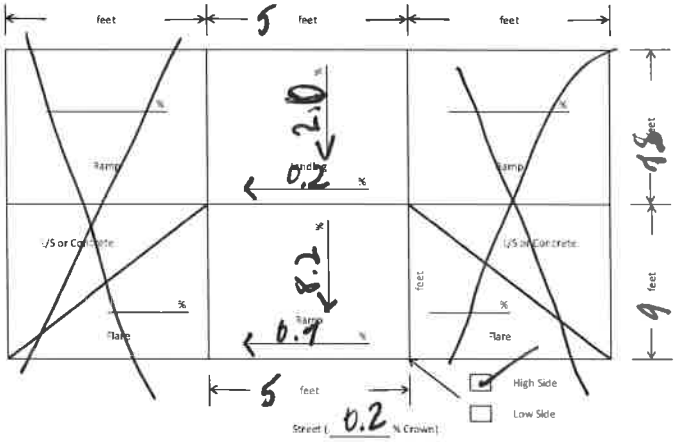
Ramp and landing slope exceeded
Could be fixed easily

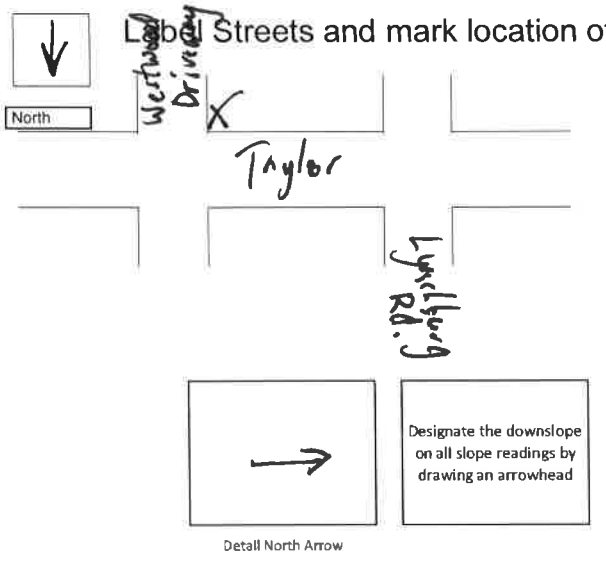
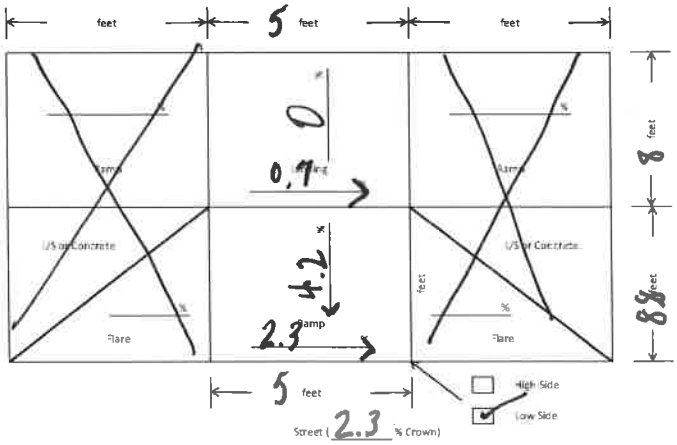
Cross slope of ramp exceeds max
