ADA Transition Plan and Self-Evaluation

City of
Manchester
Manchester, TN

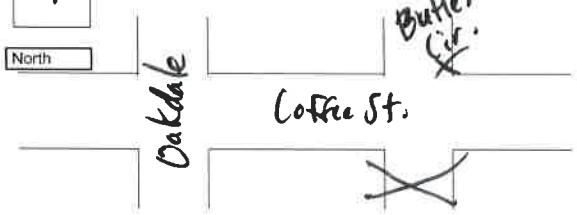
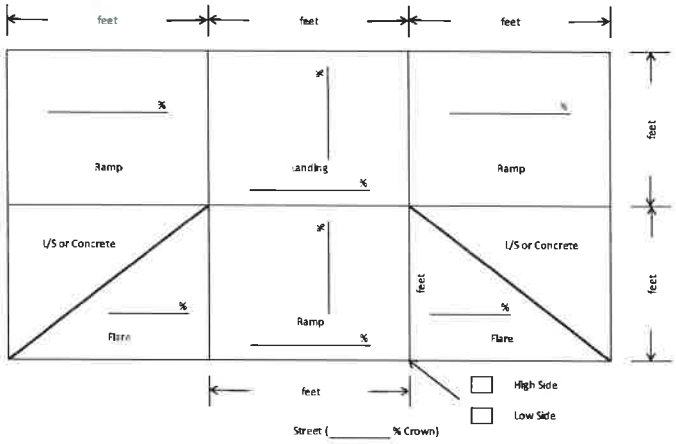
No curb ramp

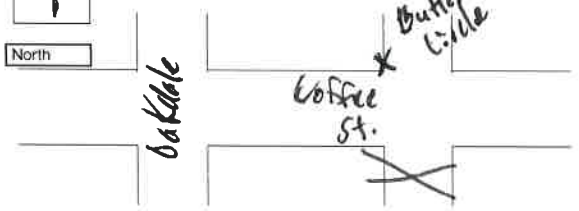
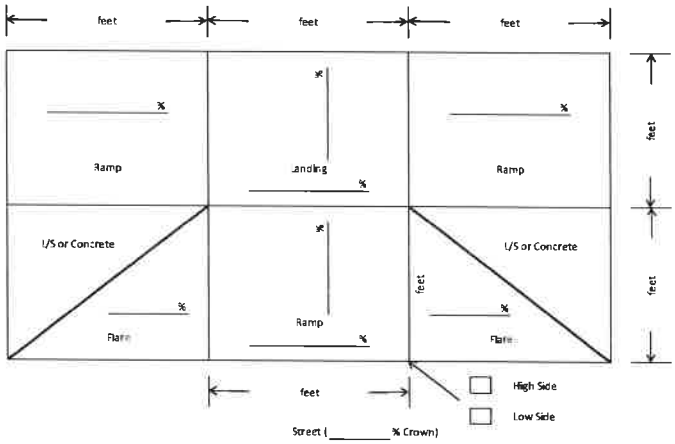
No curb ramp

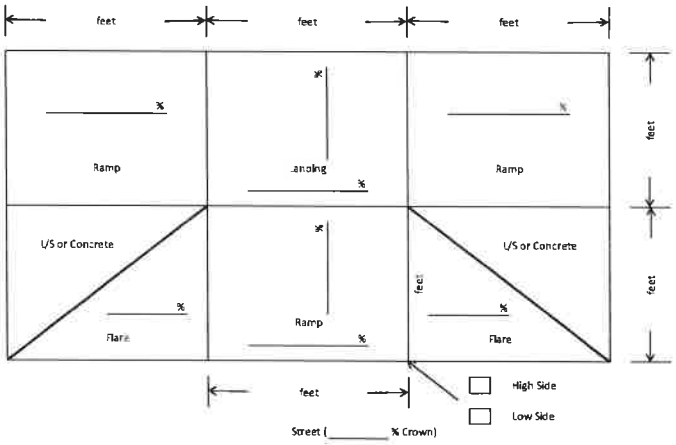
No curb ramp

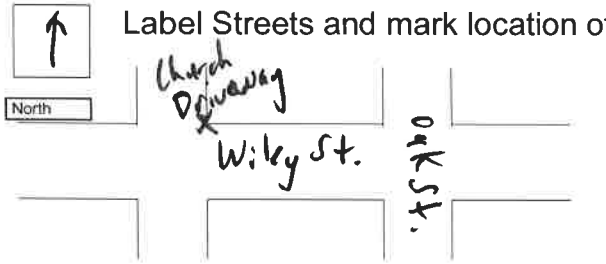
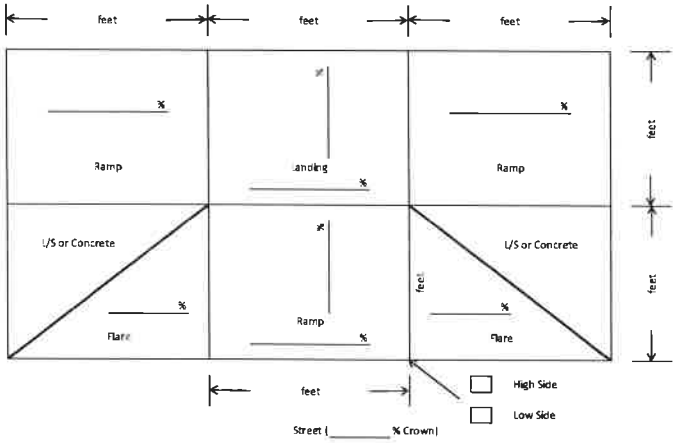
No curb ramp

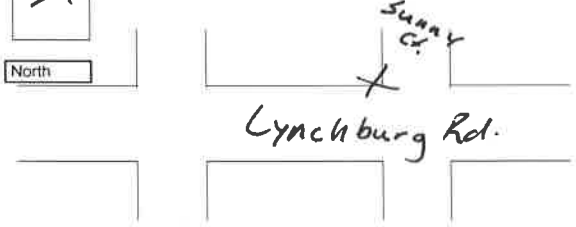
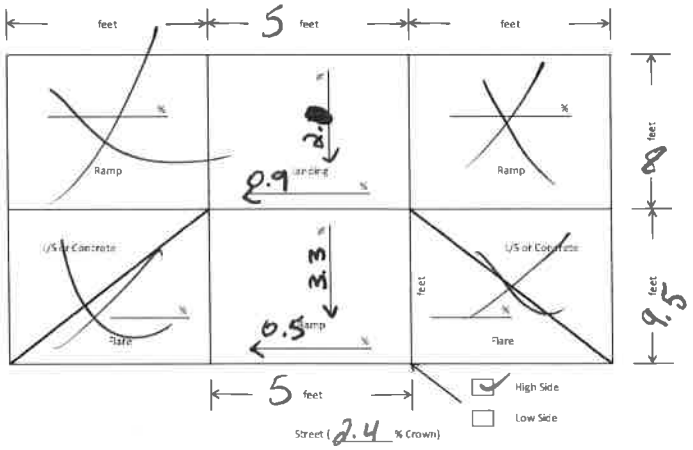
Domes are not perfectly in line of travel.

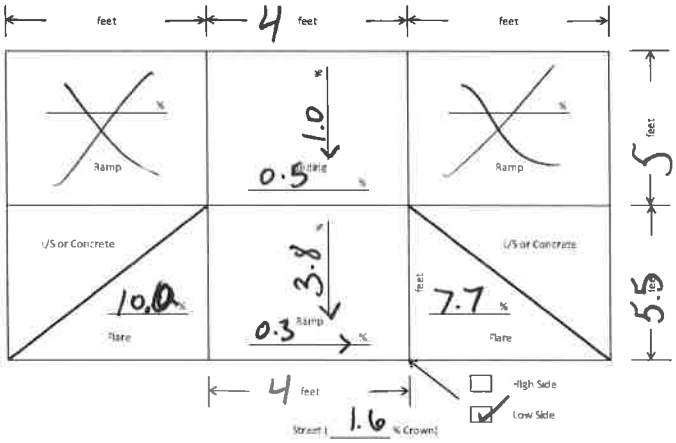
domes are red

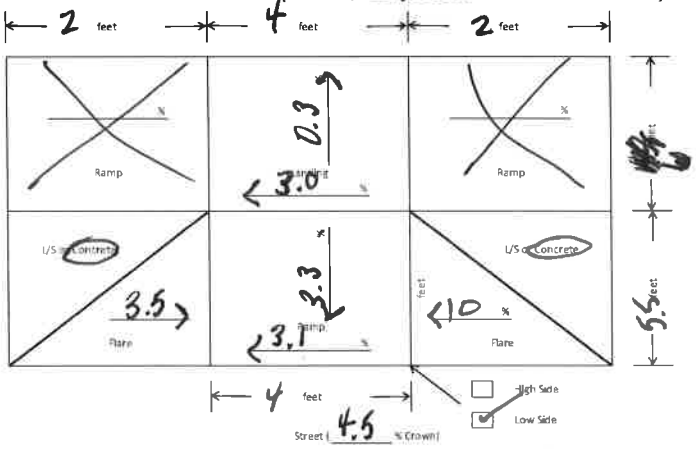
Detectable domes are red

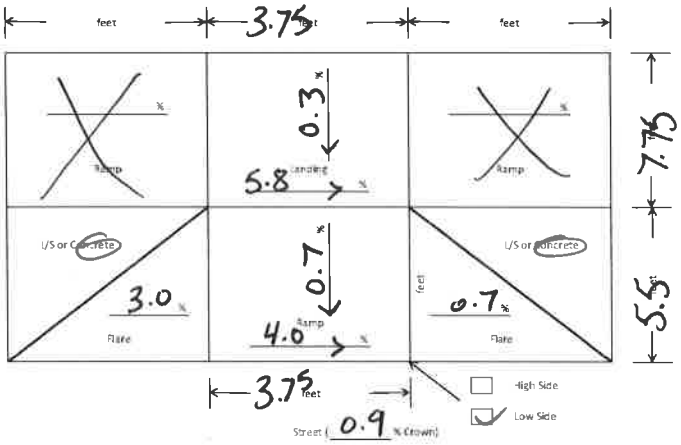
domes are red

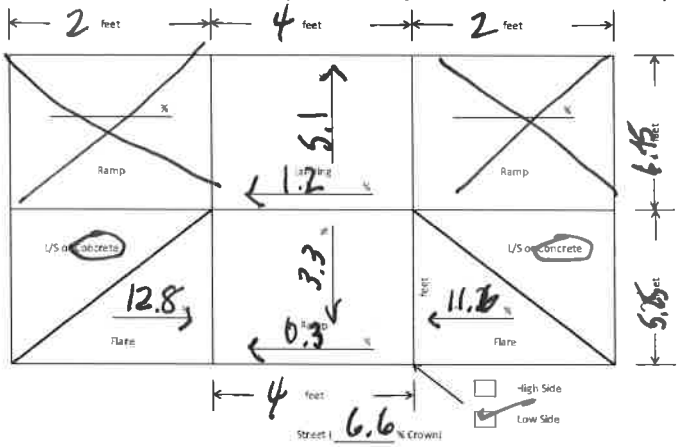
Detectable domes are red; Not enough room between flare and edge of sidewalk coming in front of City Hall for accessibility

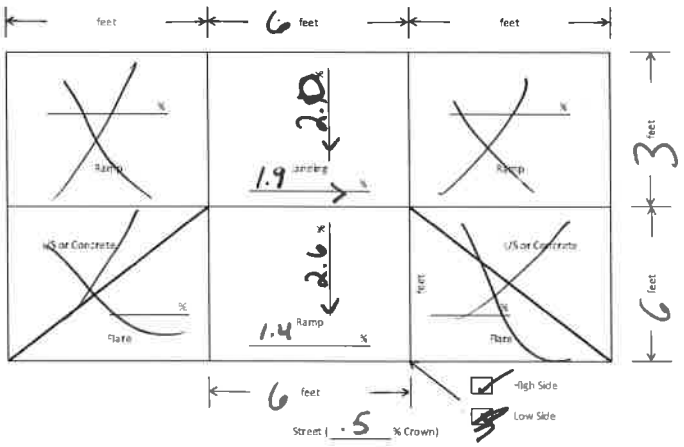
domes are red

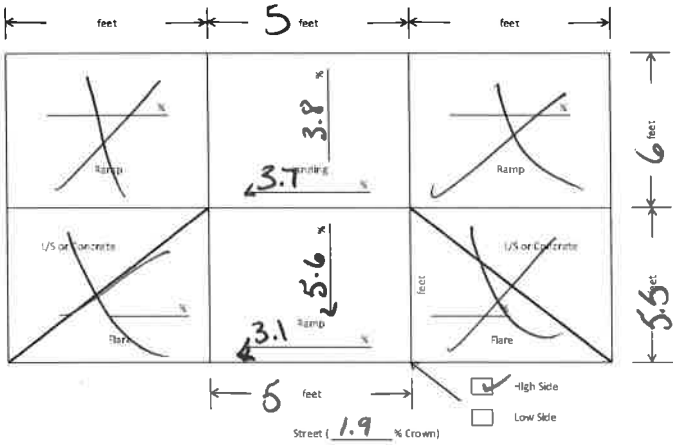
Drainage problem

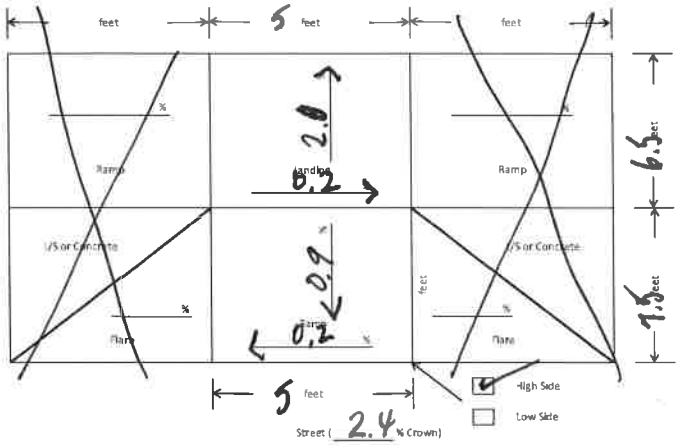
No detectable domes

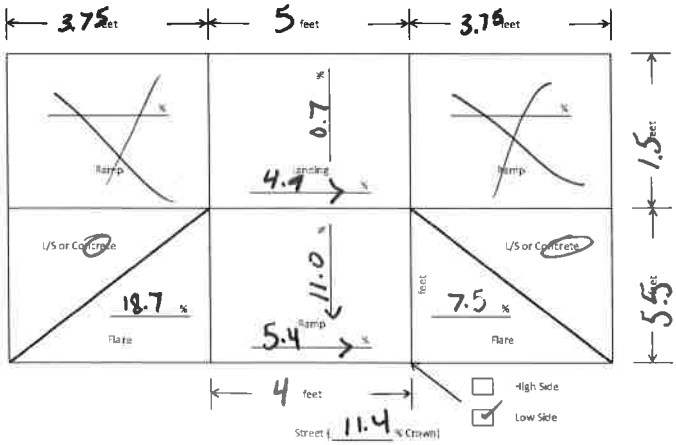
domes are red.

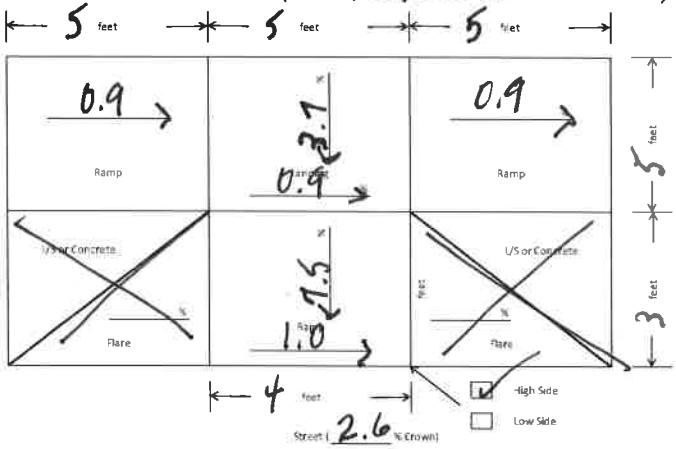
No detectable domes

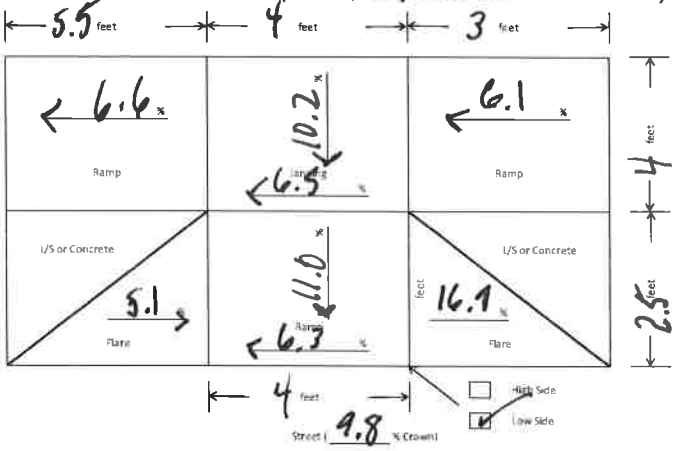
Detectable domes are red

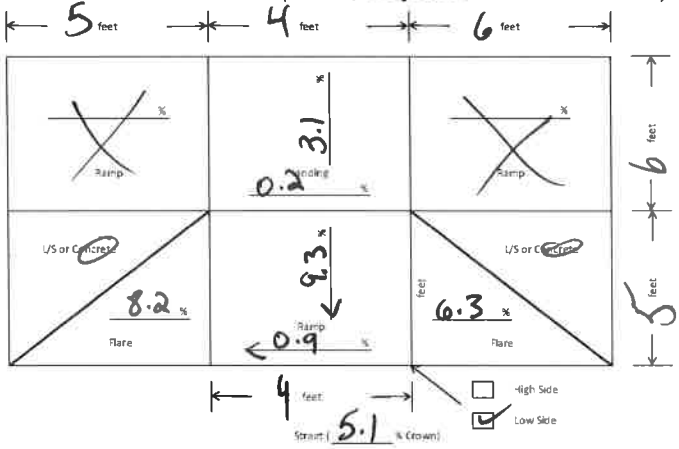
domes are red

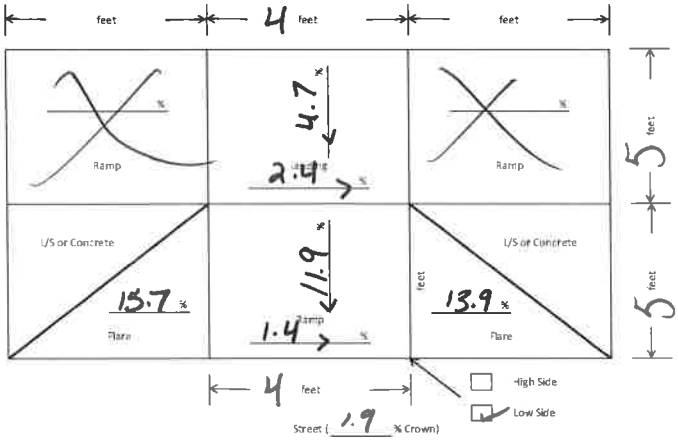
domes are red

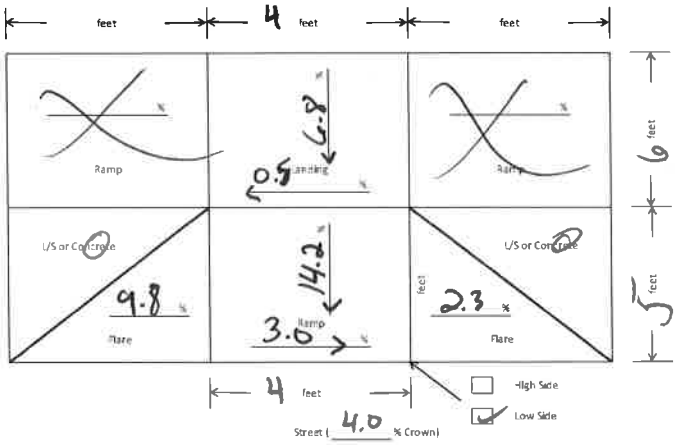
Domes are red

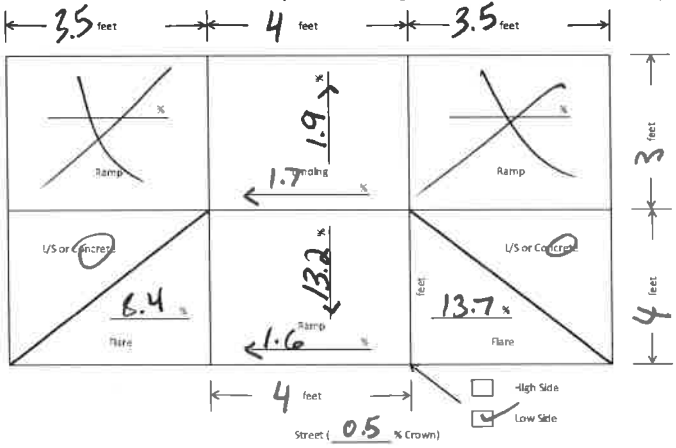
domes are red

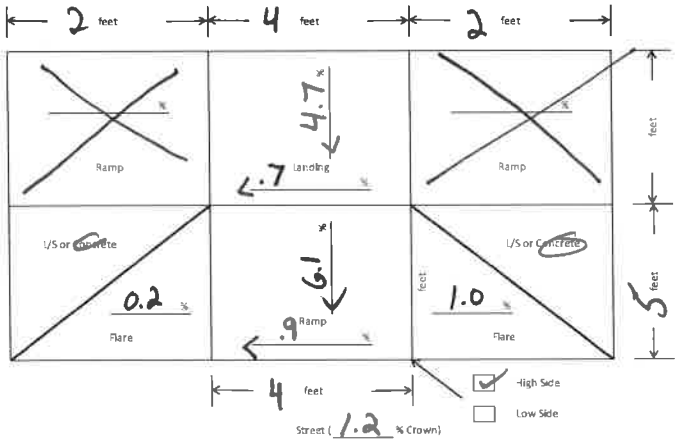
Detectable domes are red

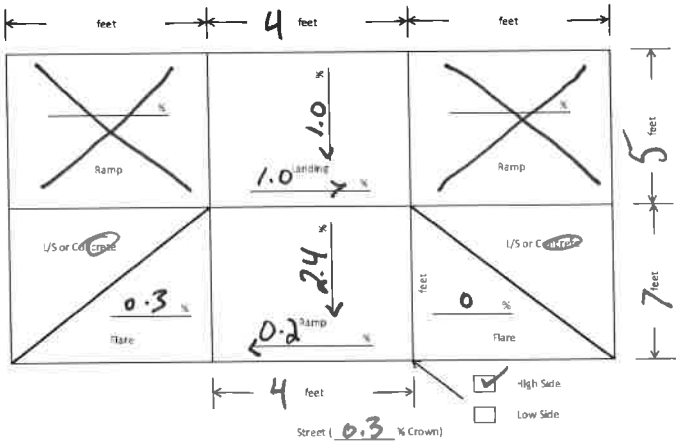
Detectable domes are red

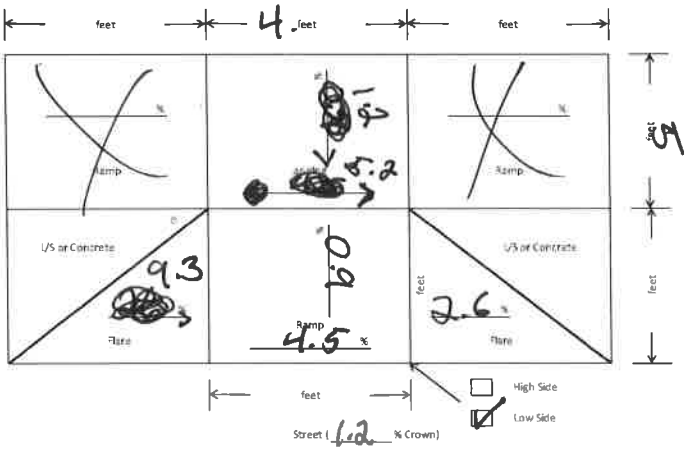
Red Dones

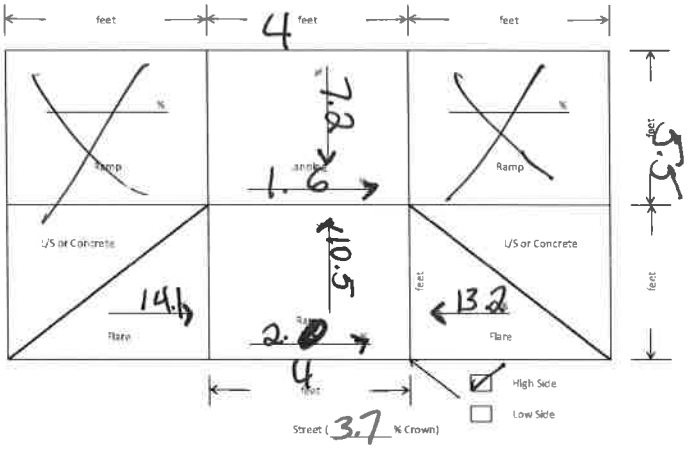
Red Domes

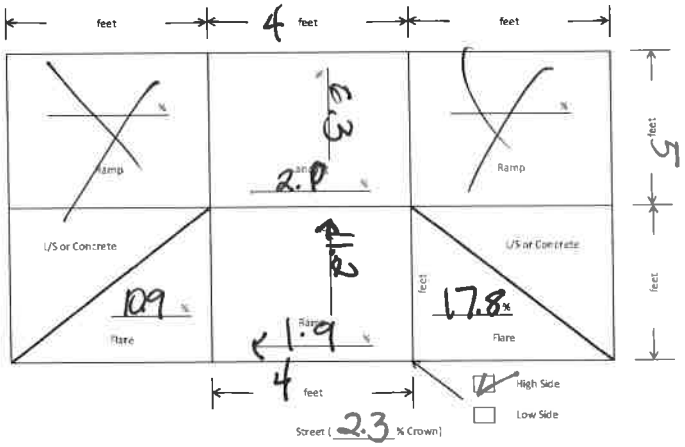
domes are Red

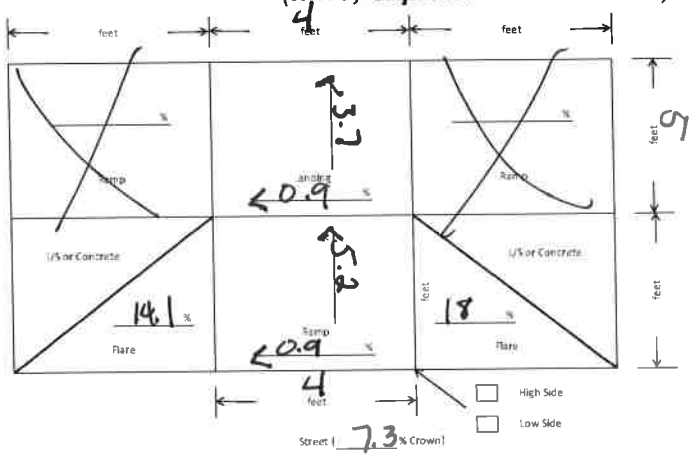
done are Red

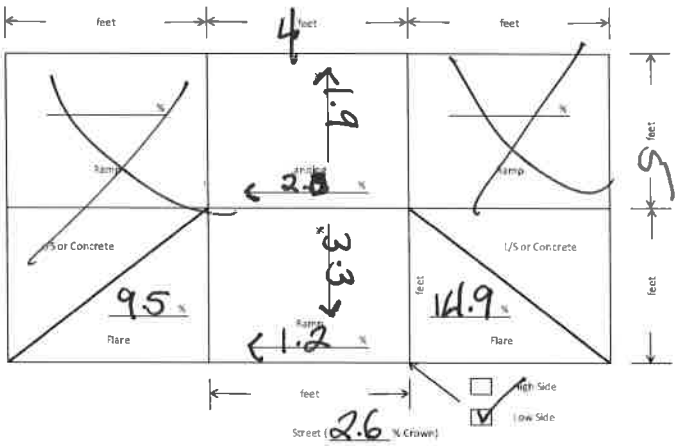
Red Domeo

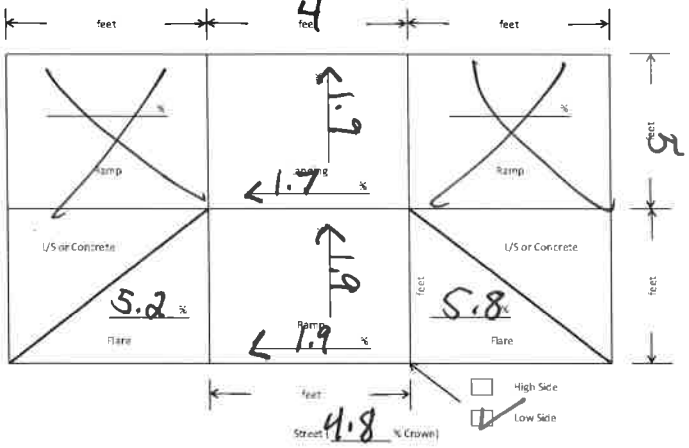
Red Domes

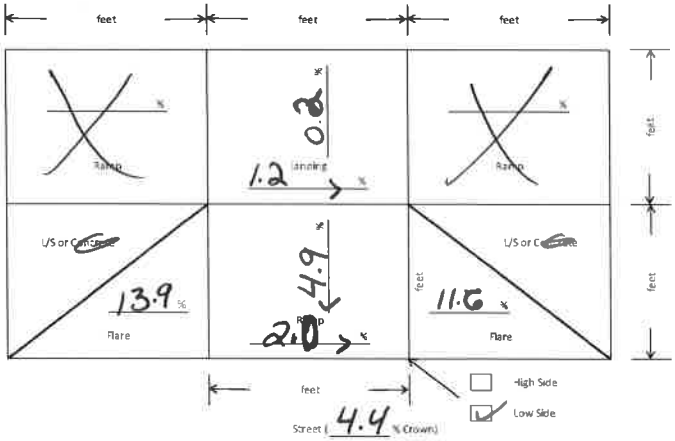
domes are red

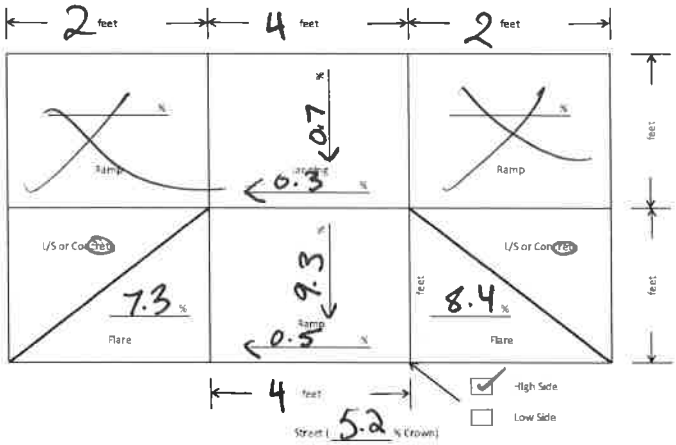
domes are red

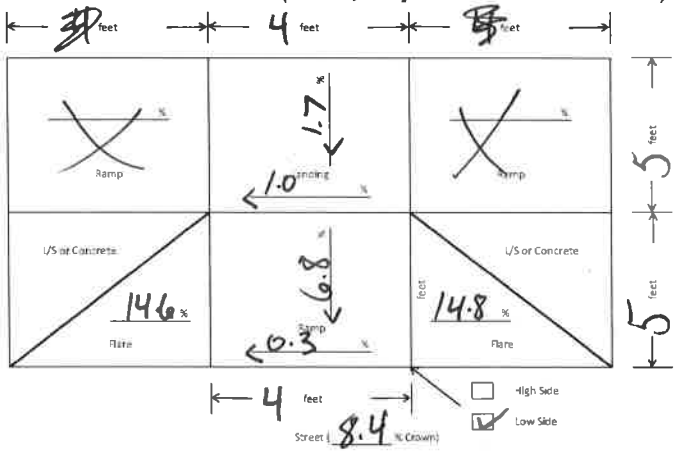
domes are red

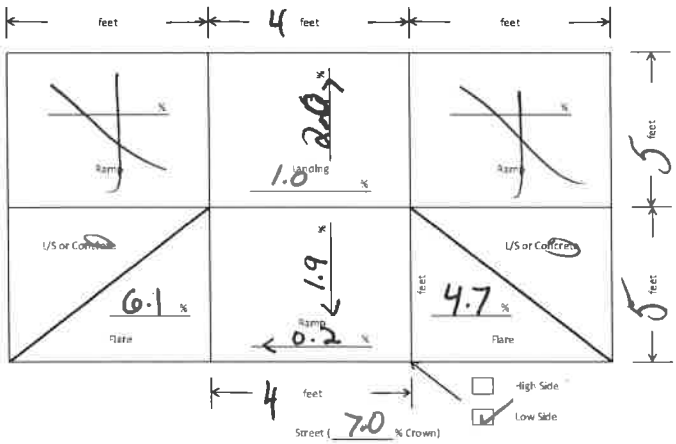
doors are red

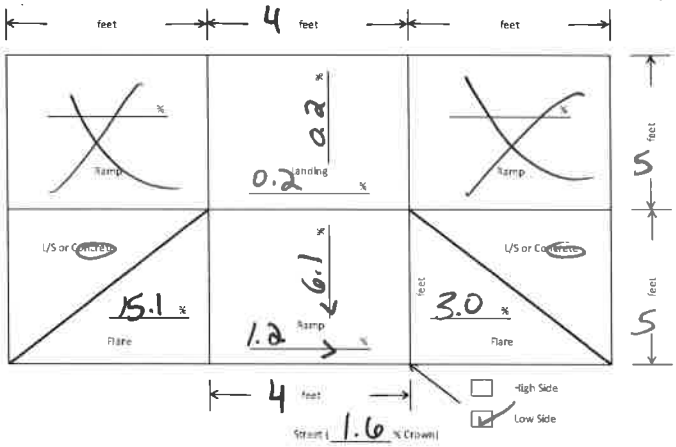
domes are red

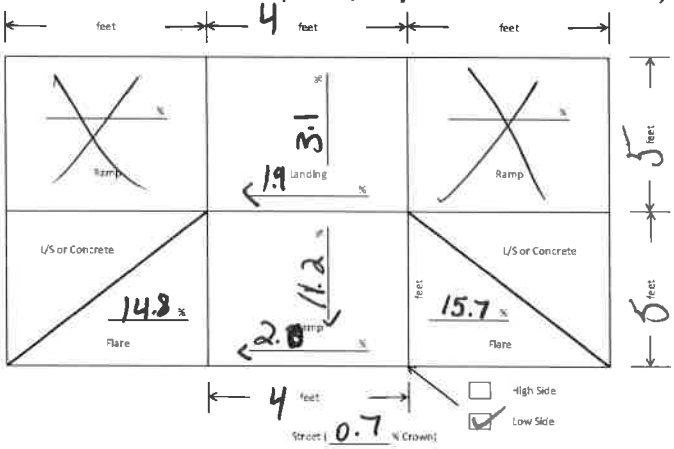
domes are red

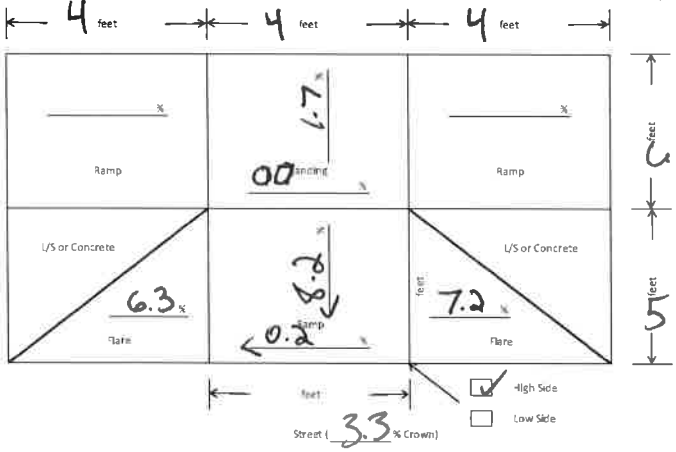
domes are red

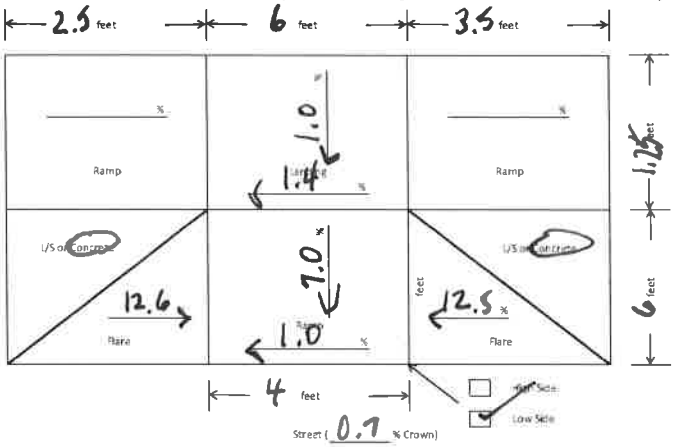
Detectable domes are red — Landing not deep enough

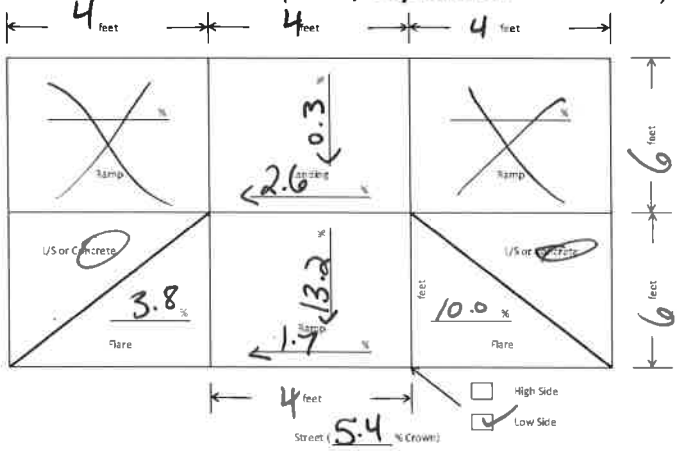
Domes are red

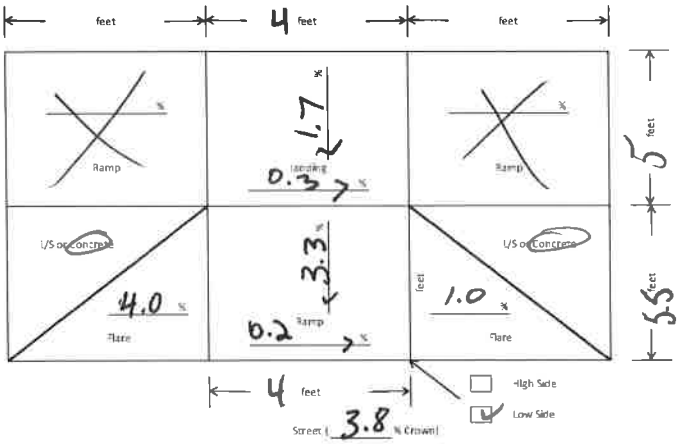
Detectable domes are red

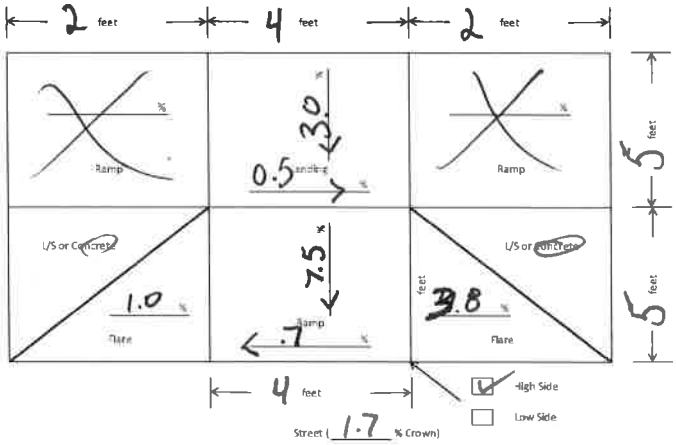
domes are red

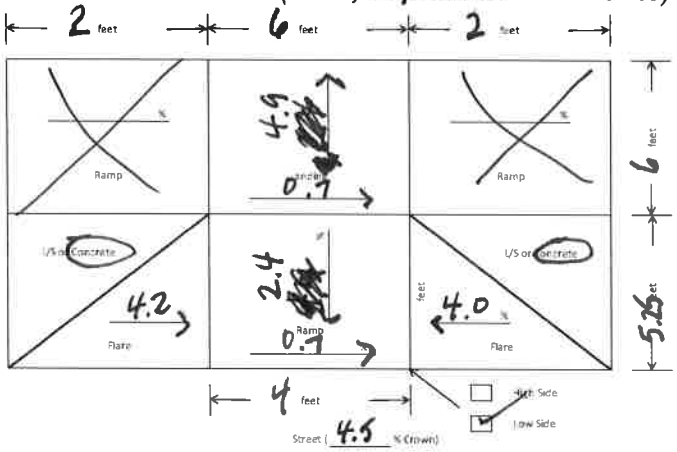
Detectable domes are red

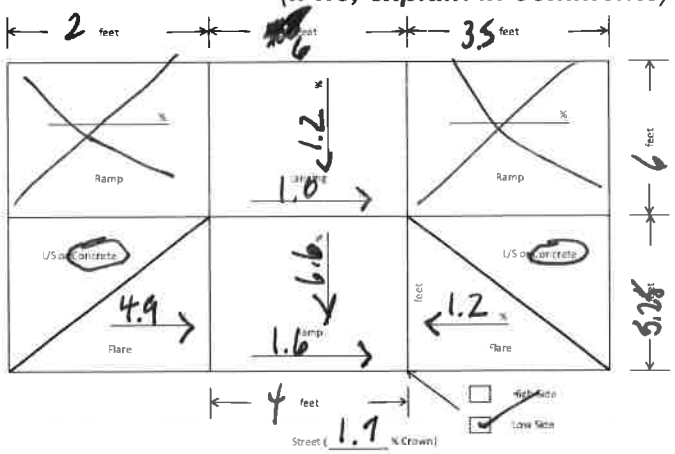
Detectable domes are red

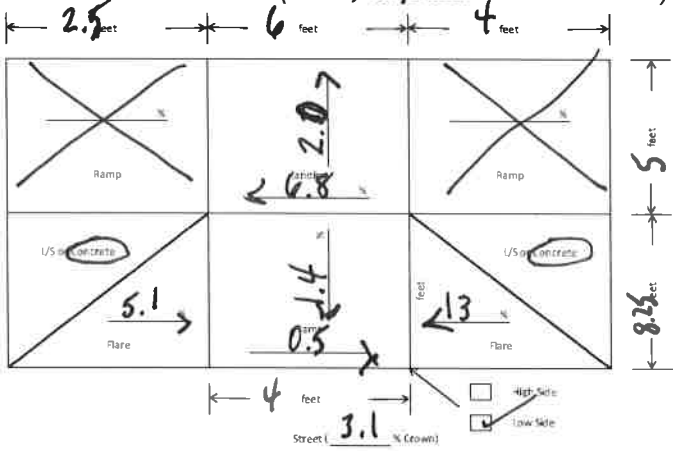
Detectable domes are red
Cross slope and flare slope exceeded
can be fixed

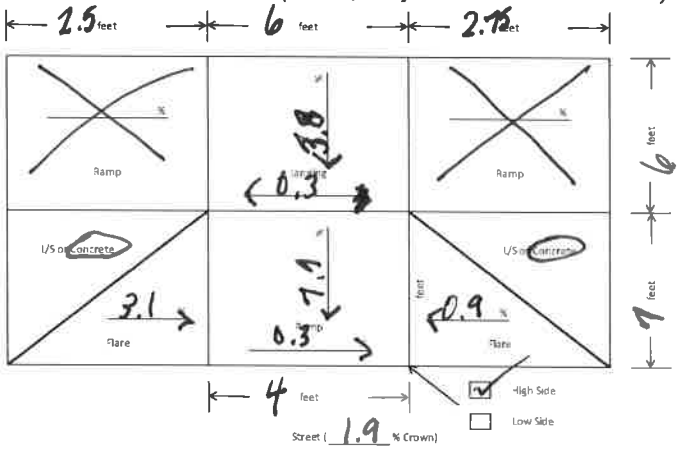
Detectible domes are red

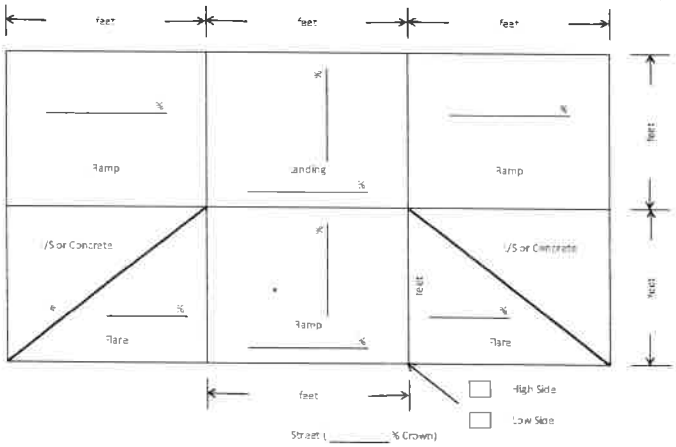
No curb ramp

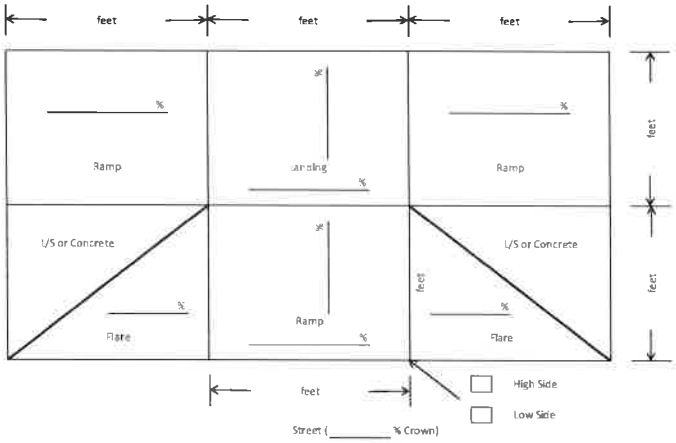
Steps instead of curb ramp with no railing

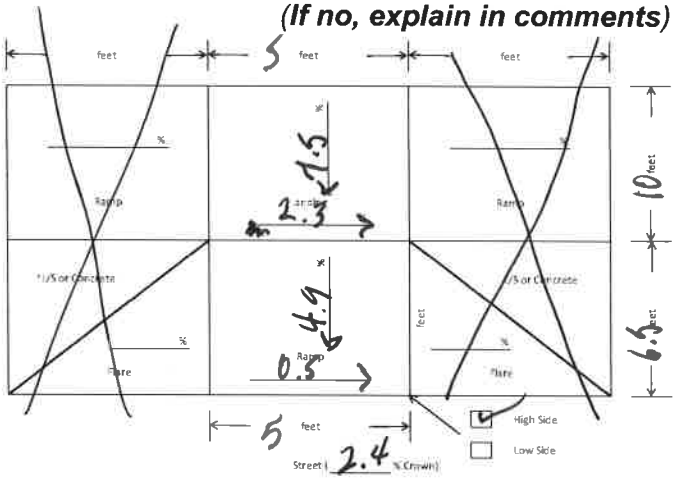
Excessive cracking in both landing and ramp

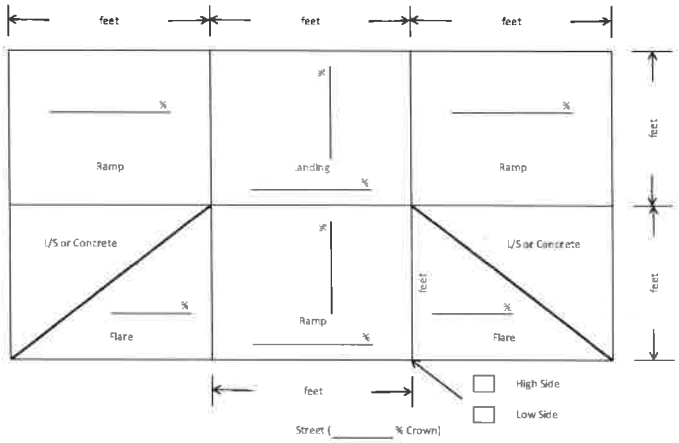
No curb ramp

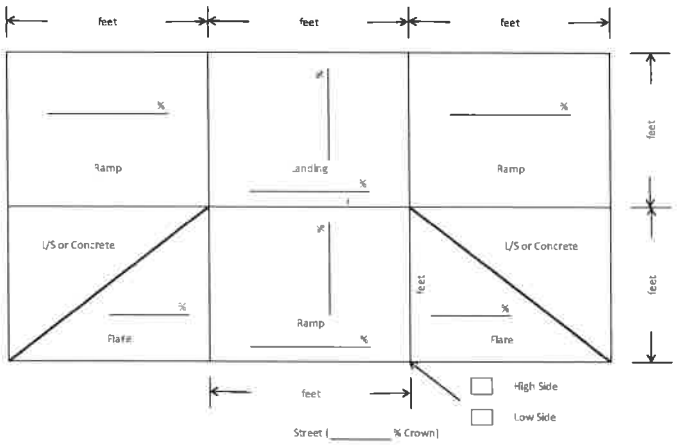
No curb ramp at either corner of intersection
missing 2 curb ramps
Sidewalk dead ends on south side of Fort St.

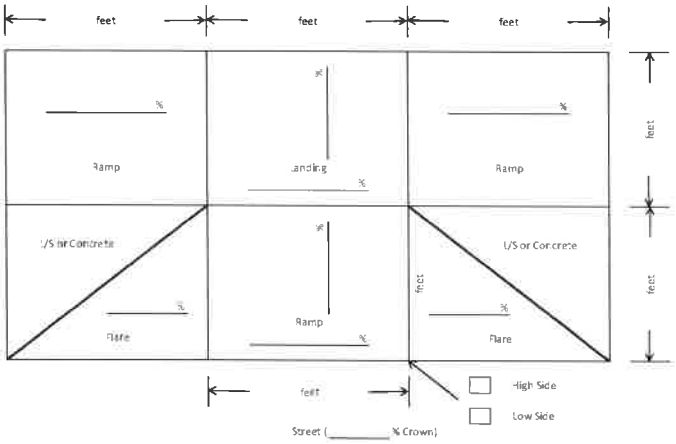
No curb ramps

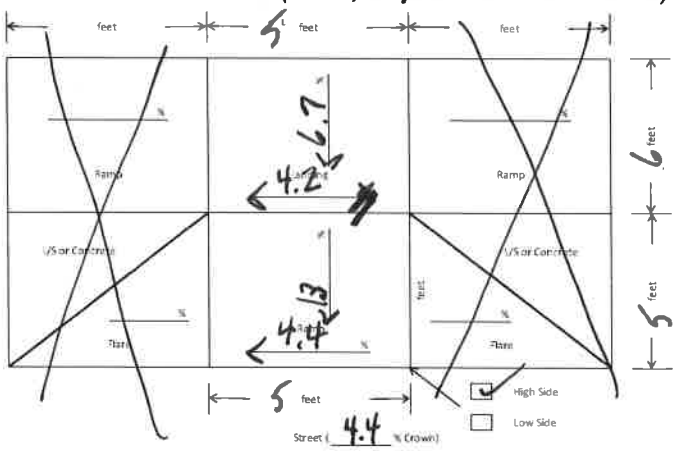
Excessive cracking in landing and ramp

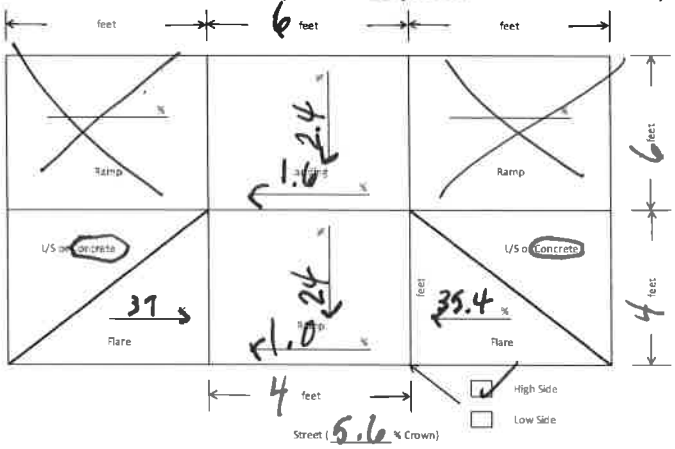
Can be fixed

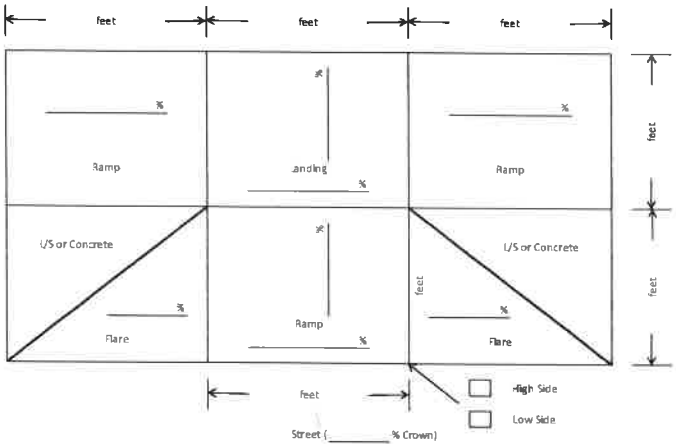
No curb ramps at Main St. Church of Christ Drive
2 ramps - 6 in. steps

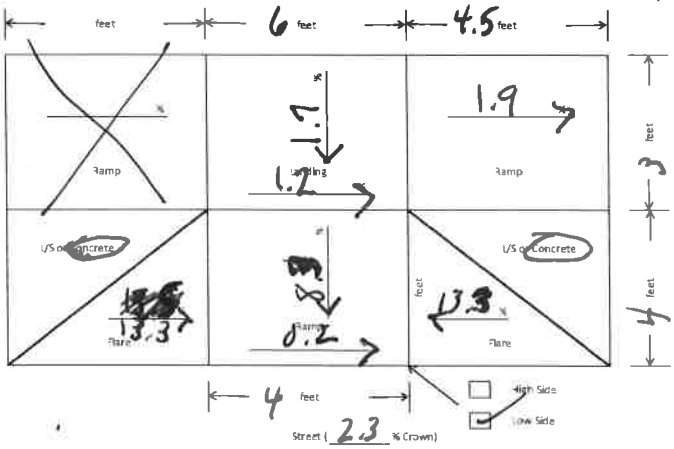
Needs a crosswalk

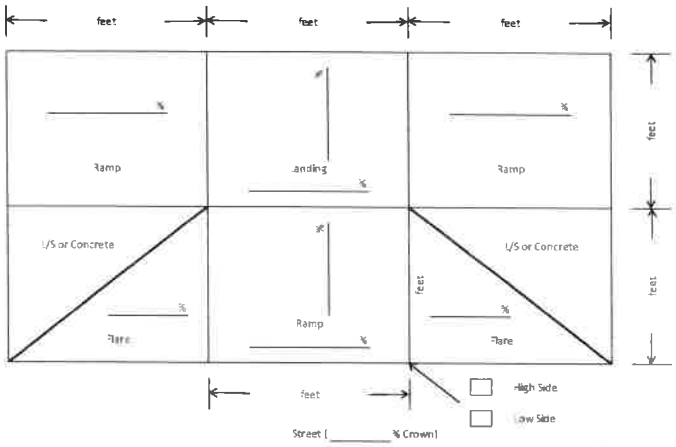
No curb ramp @ end of sidewalk @ City Park

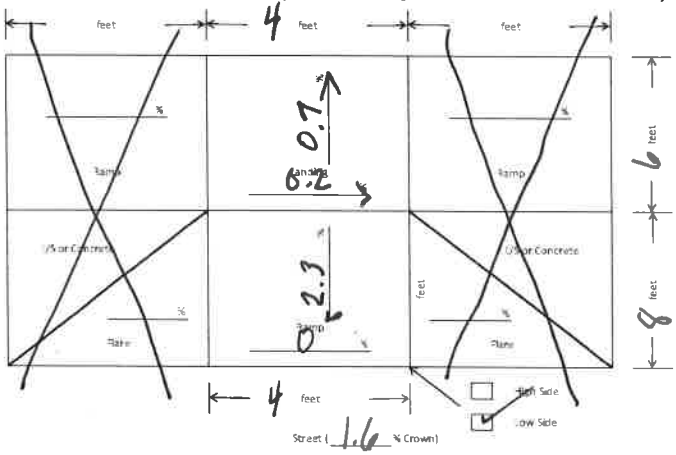
Large lip (3 in.) from ramp down to road

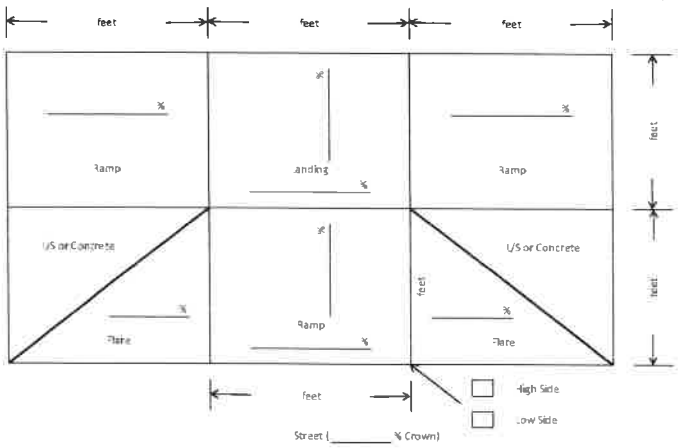
No curb ramp or crosswalk

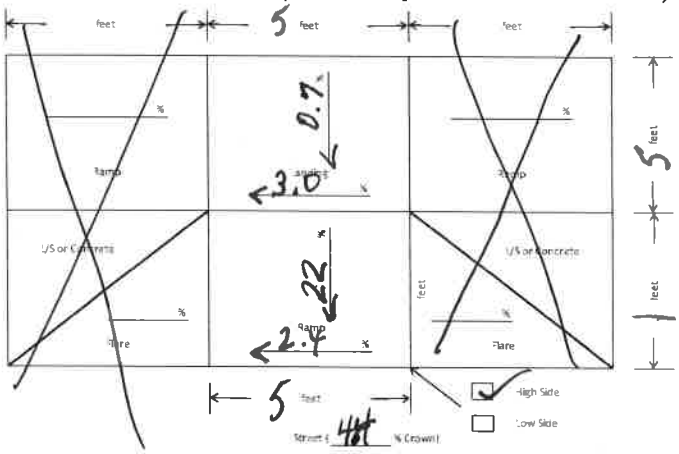
@ Shirley Auto Sales building

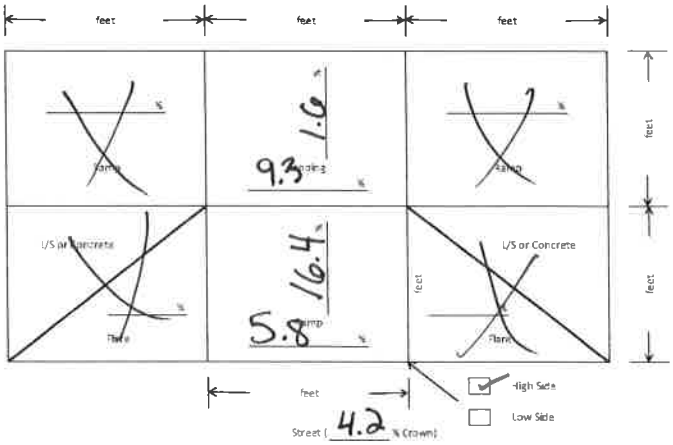
landing is ramp from McClean

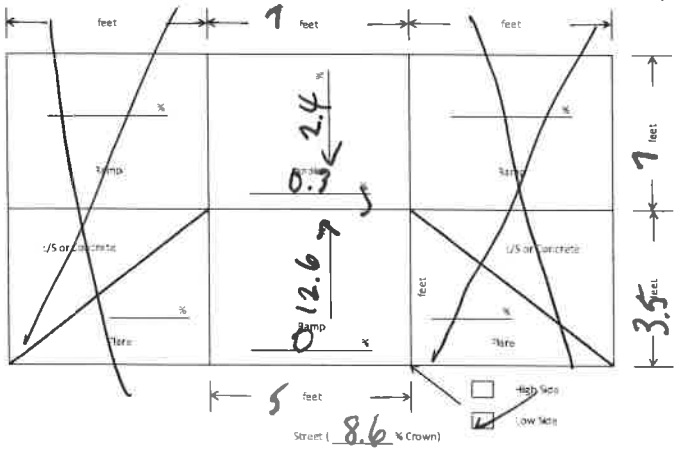
CPP exposed in ramp and leaves a 2" lip in ramp

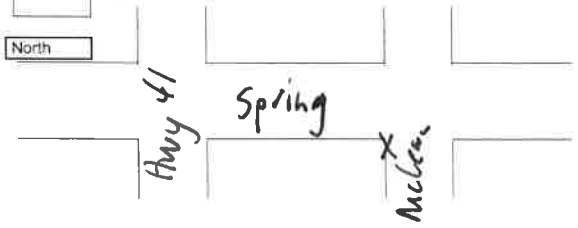
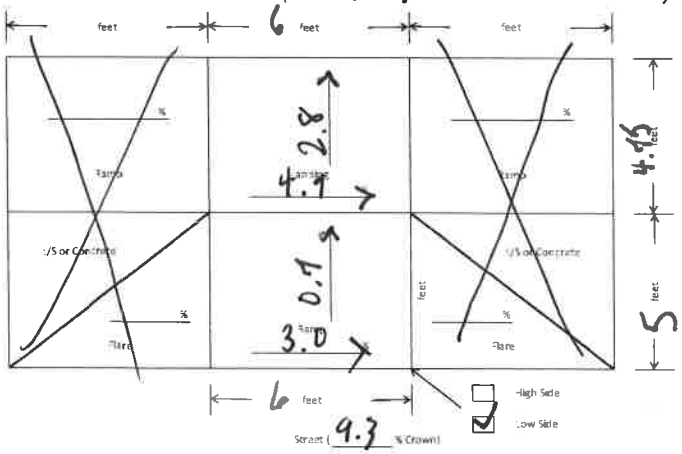
Ramp is busted up

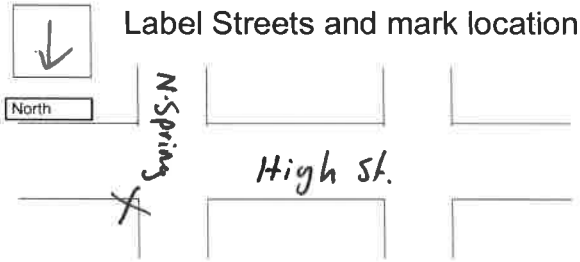
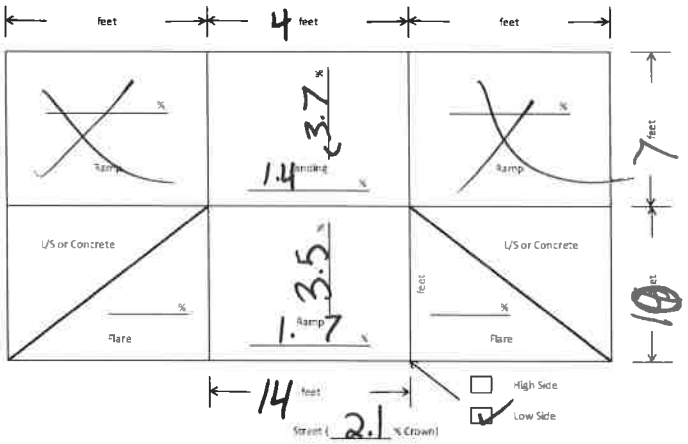
> ½ lip from sidewalk to landing. No detectable warnings

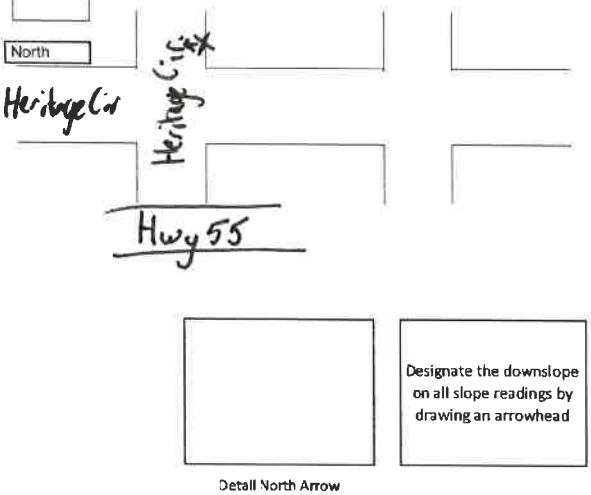
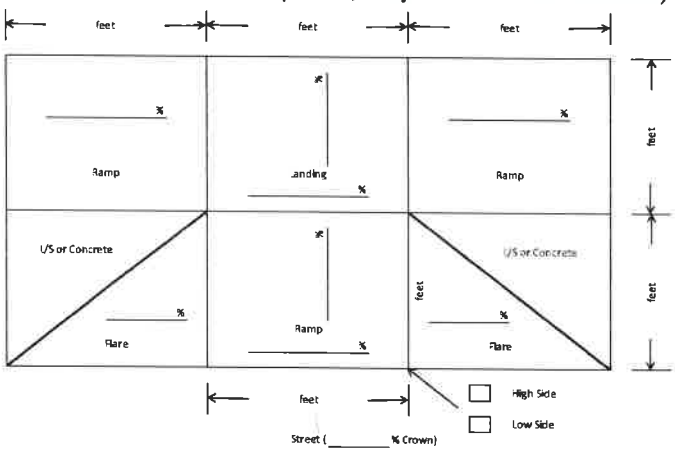
No curb ramp at end of sidewalk to cross to interior sidewalk of subdivision

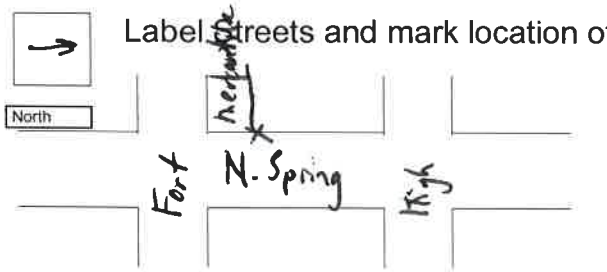
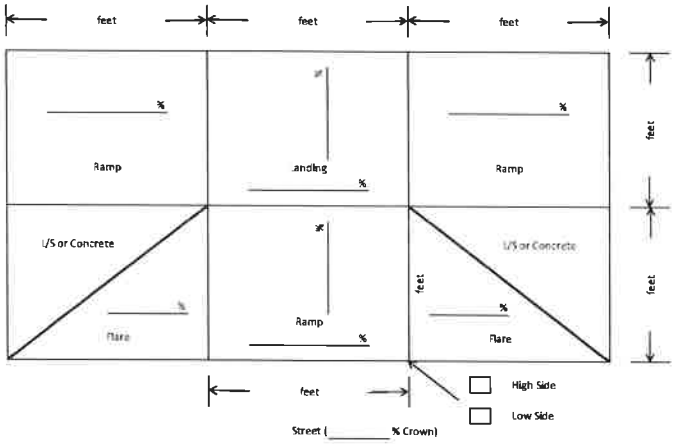
No curb ramp at alleyway behind the Mercantile
5 inch lip/step

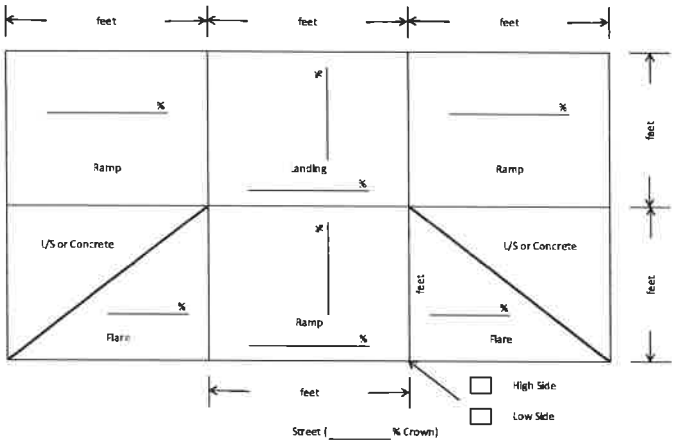
No curb ramp for crossing Irwin St.

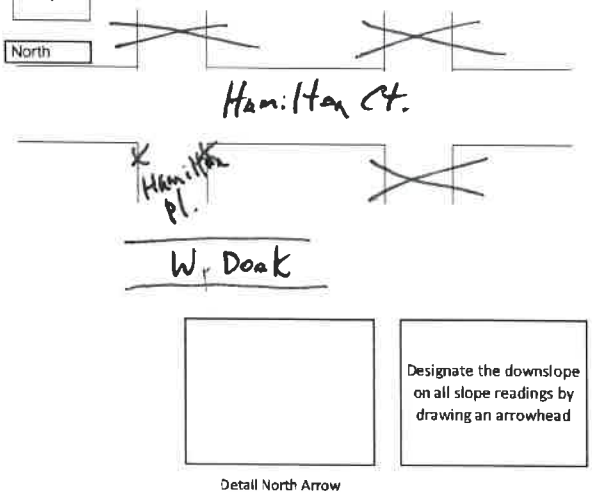
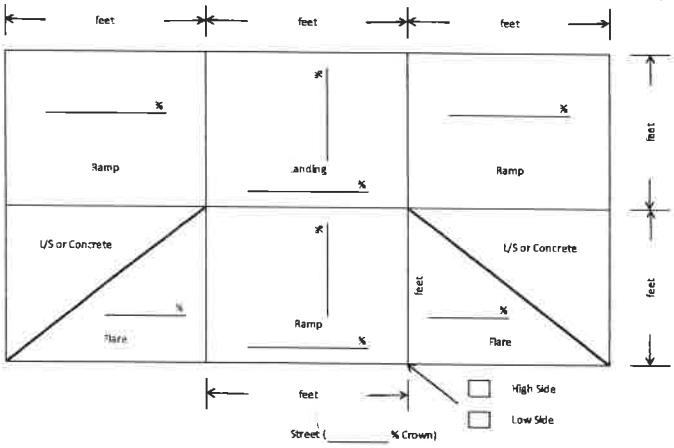
No curb ramps crossing Hamilton Place and no crosswalk – 4 in. step
2 ramps

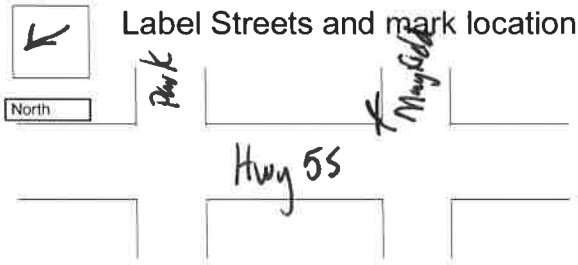
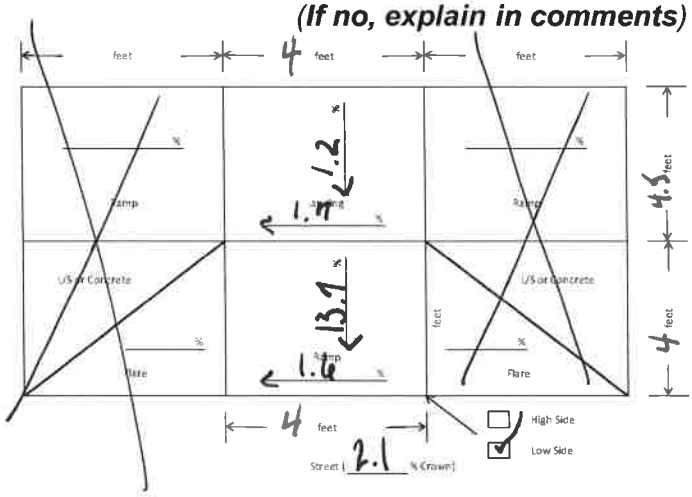
Ramp not aligned with direction of travel

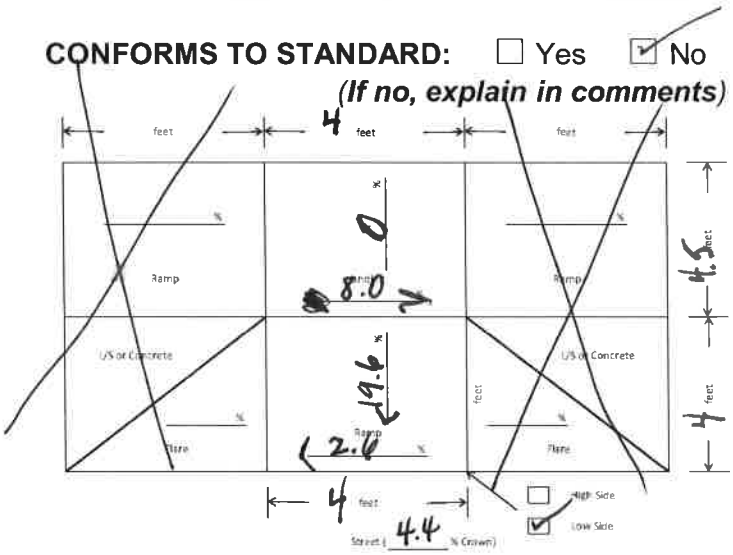
~~North~~ Reads curb ramp on ~~North~~ side of Mayfield

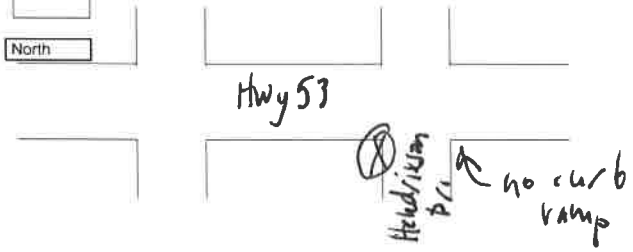
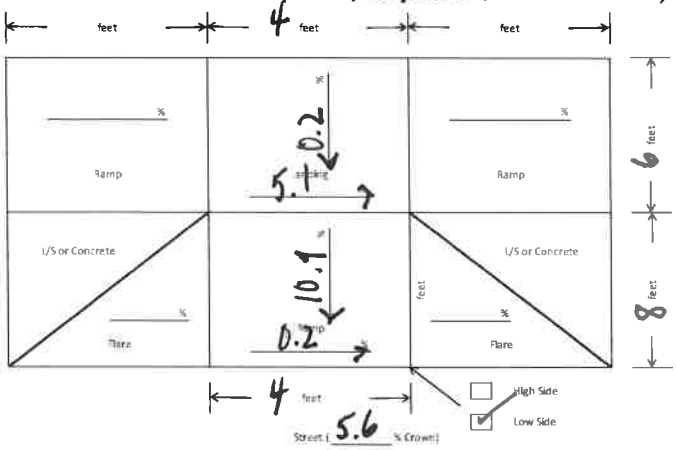
Ramp is not aligned with direction of travel
A ramp is needed on the south side of intersection
