ADA Transition Plan and Self-Evaluation

City of
Manchester
Manchester, TN

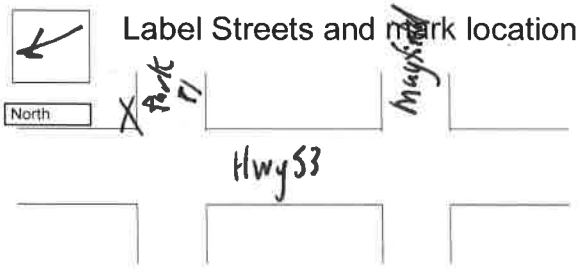
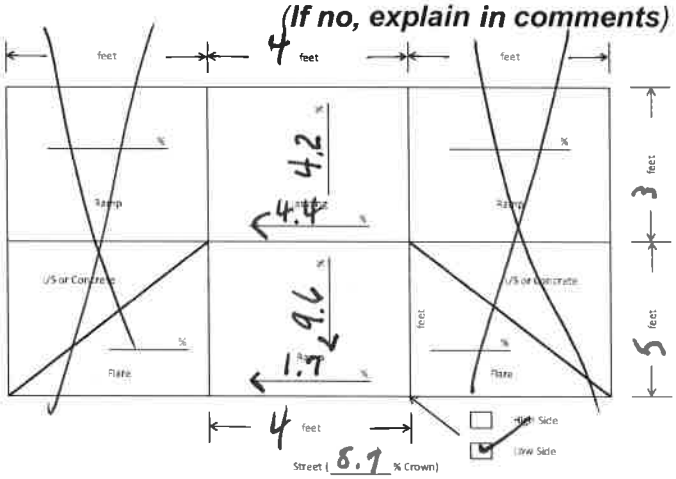
Landing has a hump in it where driveway cut is directly to its south
Ramp is not exactly in direction of travel

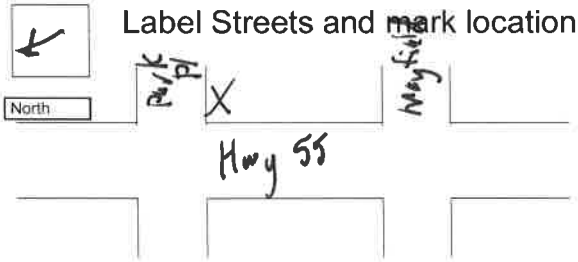
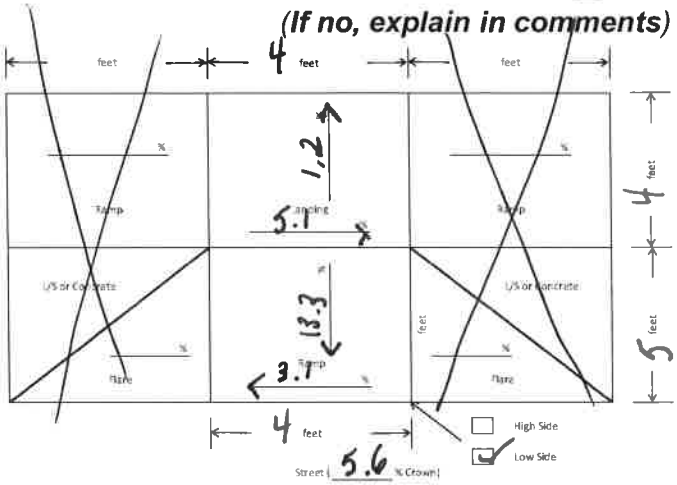
Ramp is not exactly in direction of travel

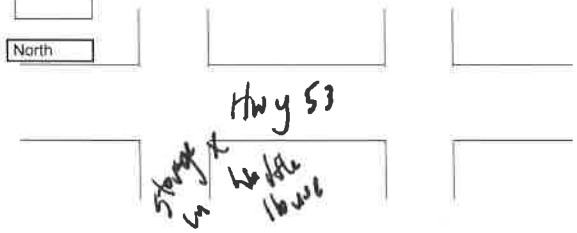
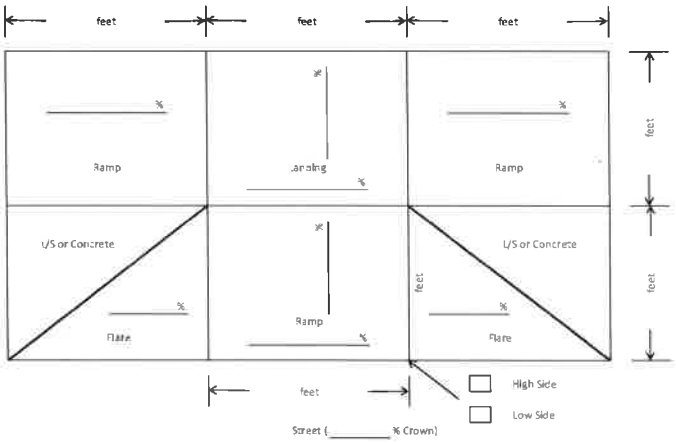
Needs a curb ramp

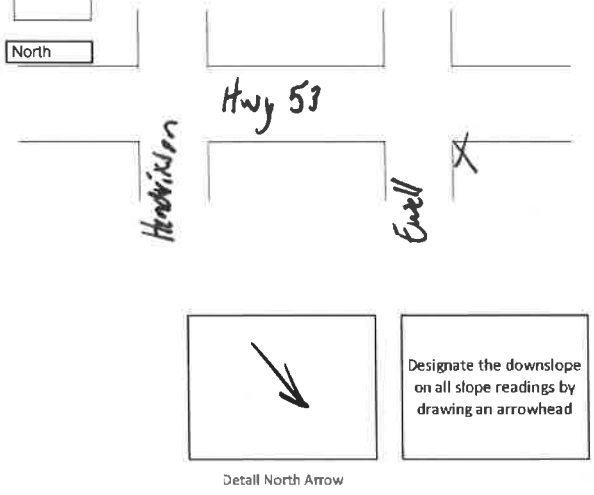
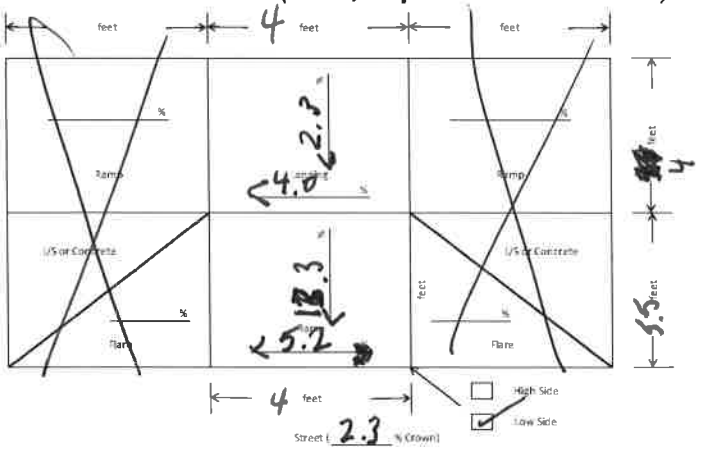
Hump in landing

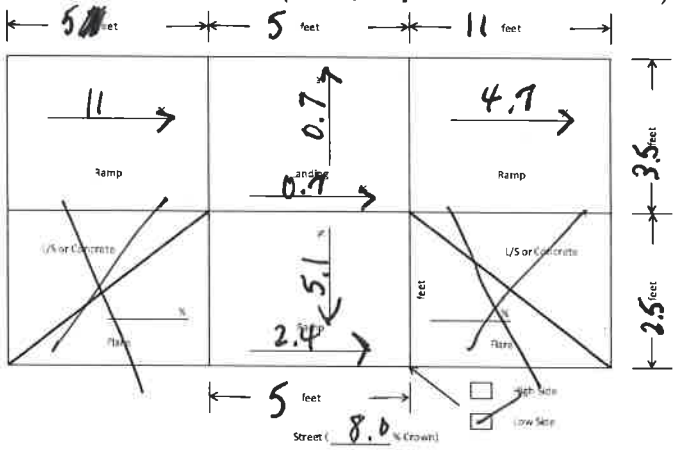
Curbing on back of landing

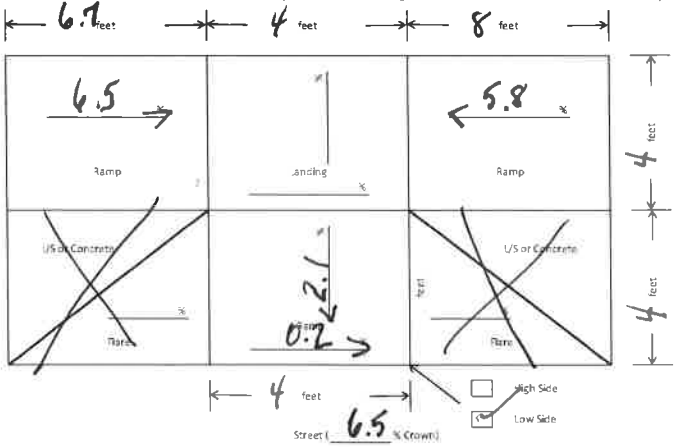
No landing
Do have curbing behind ramp/landing

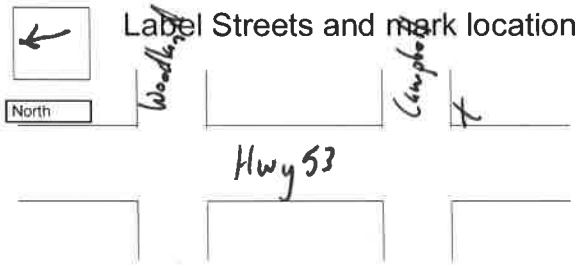
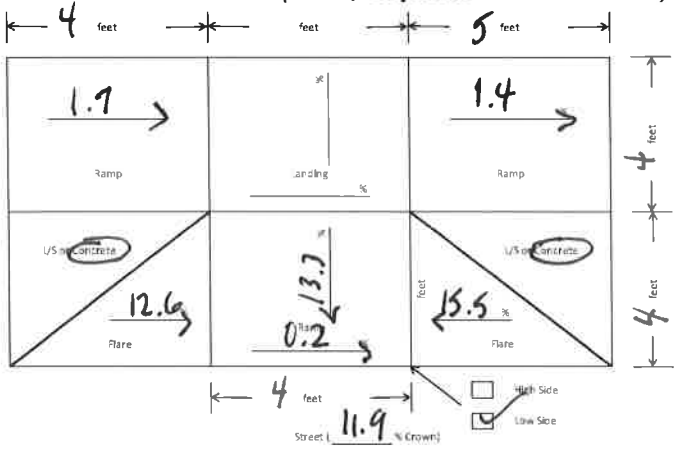
Needs a landing behind ramp
Ramp is not aligned with direction of travel

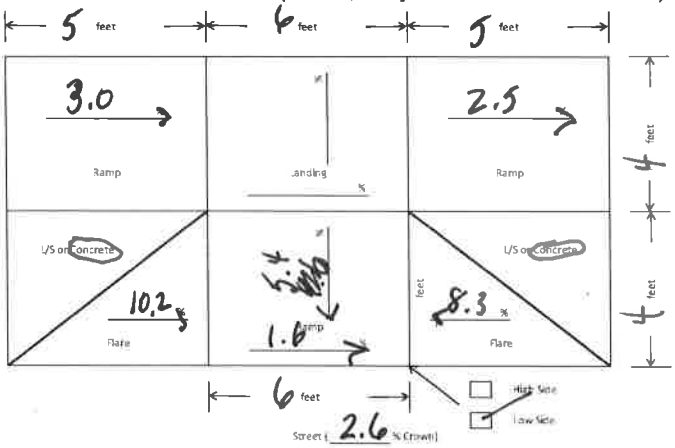
Needs a landing behind the ramp
Ramp is not aligned with direction of travel

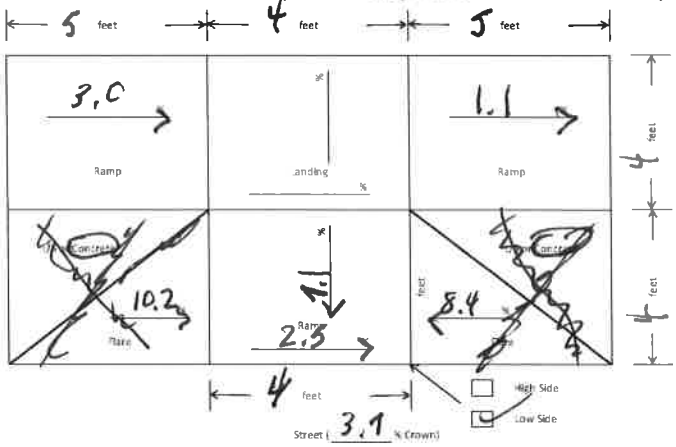
Needs a landing behind the ramp

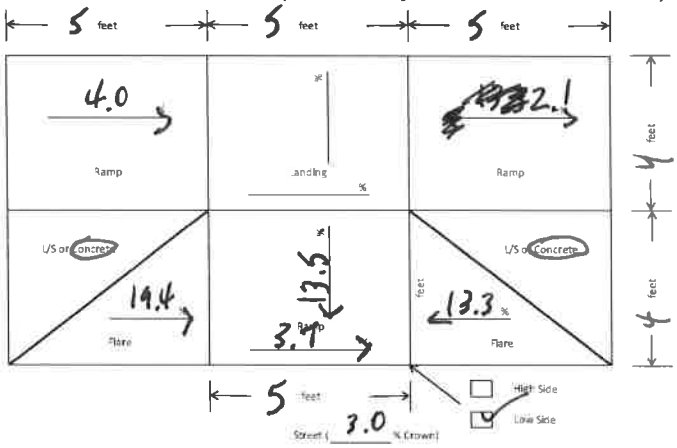
Needs a landing behind ramp
Ramp not aligned with direction of travel

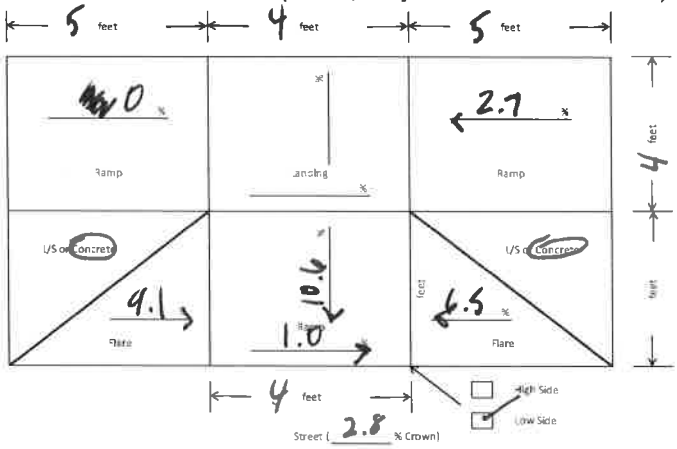
Needs a landing at back of ramp
Ramp not aligned with direction of travel

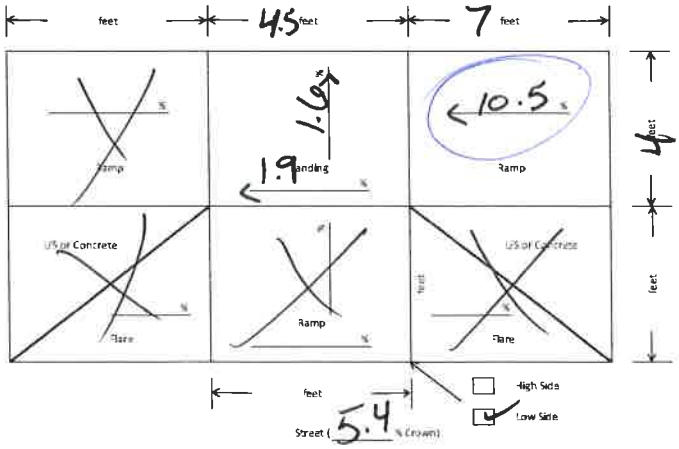
ramp slope exceed max

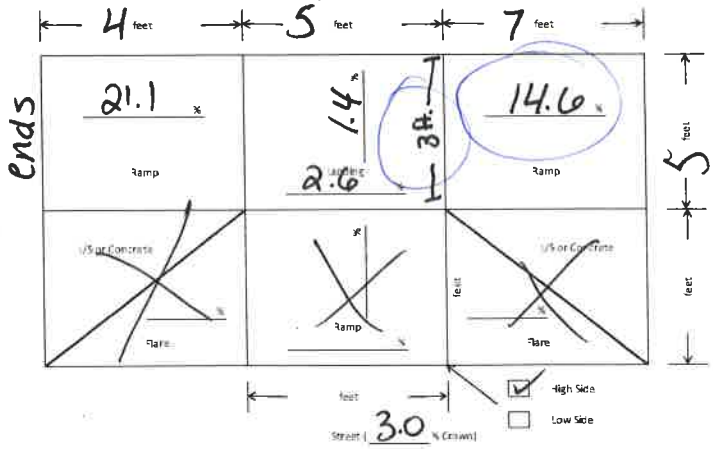
land is 3ft wide, 19.1% slope at dames

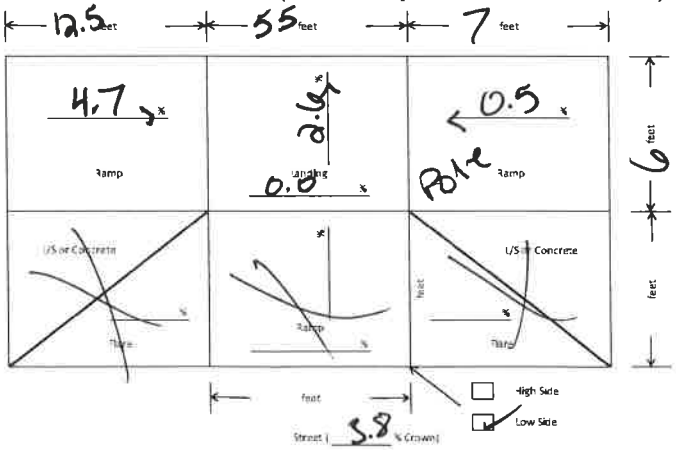
pole protruding at ramp

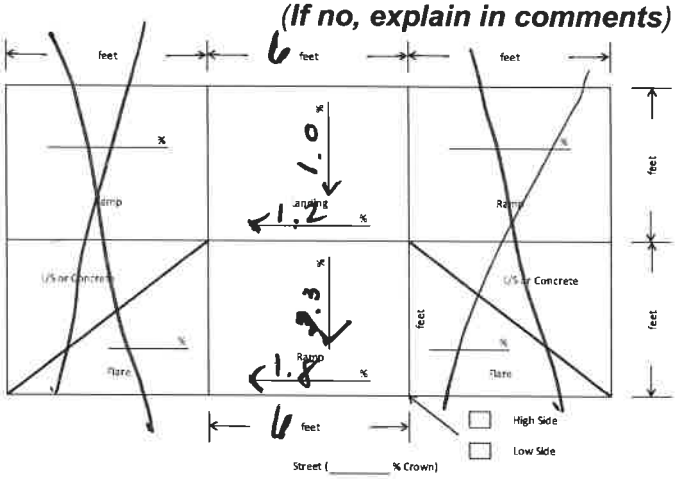
Needs detectable warnings

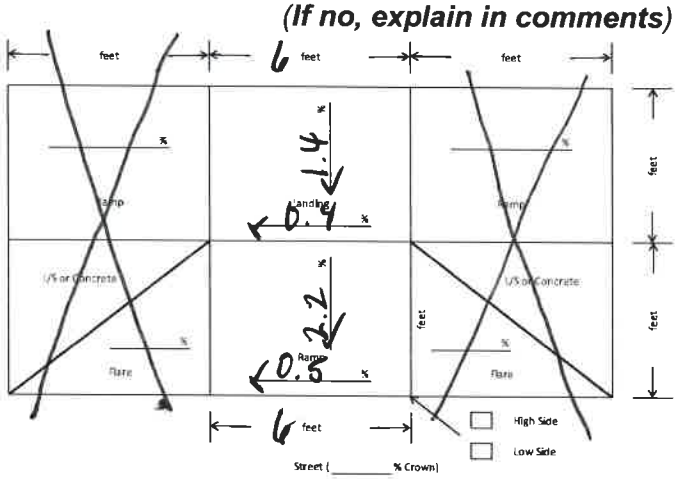
Needs detectable warnings

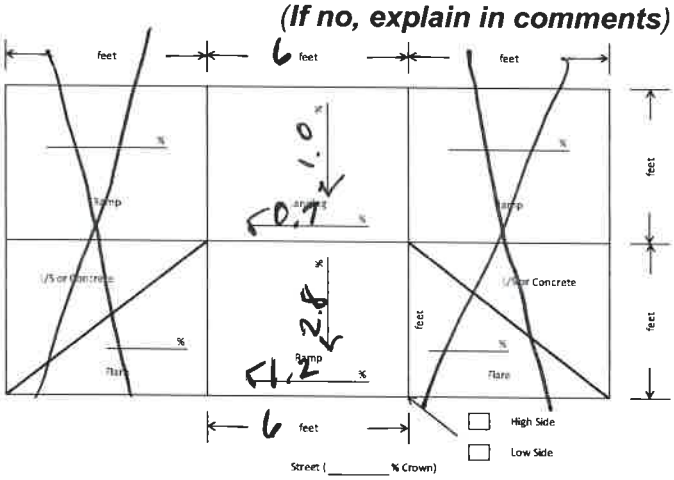
Needs detectable warnings

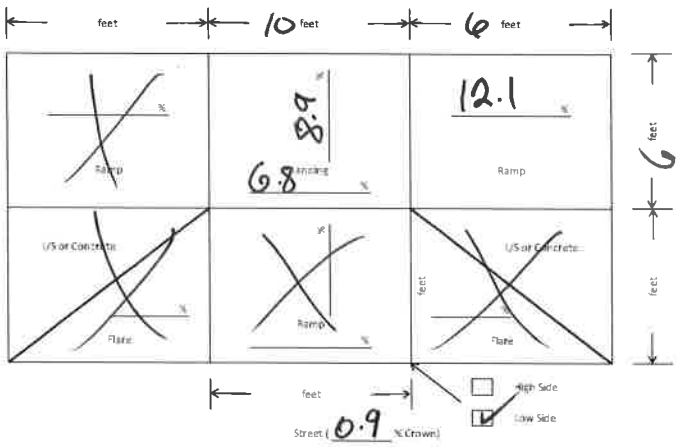
Could be ramp at W. Harp or could be driveway to business at corner

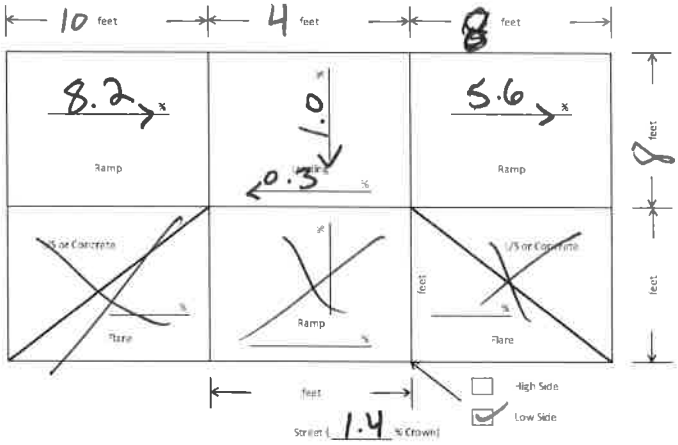
5 ft. clearance around signal box & pole

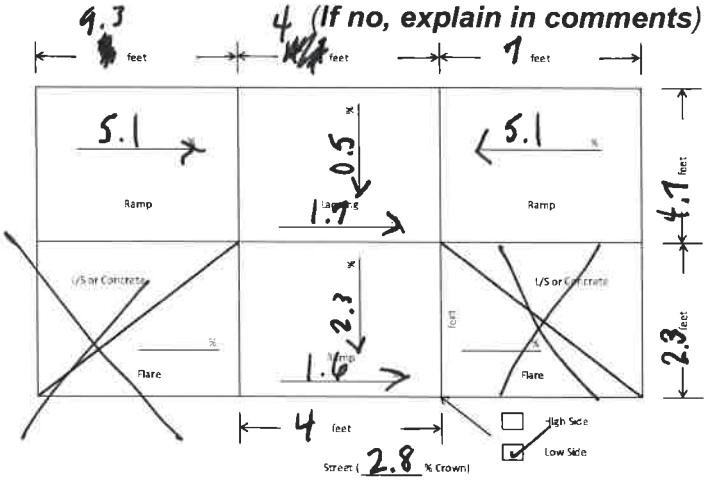
Signal pole in each ramp leaving 2 ft. clearance around

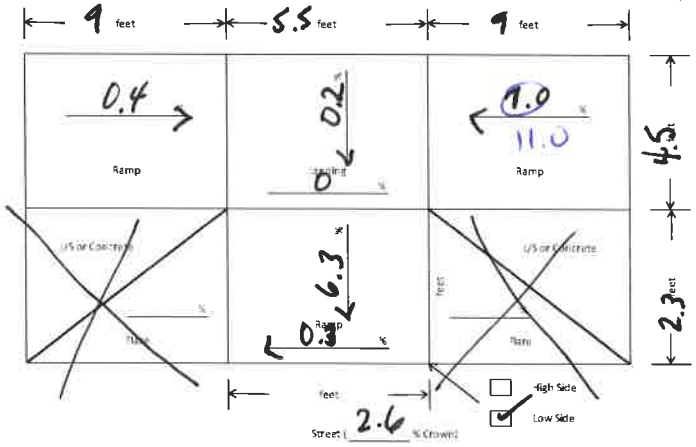
Signal Pole in south ramp leaving ~~[illegible]~~ 3 ft. clearance

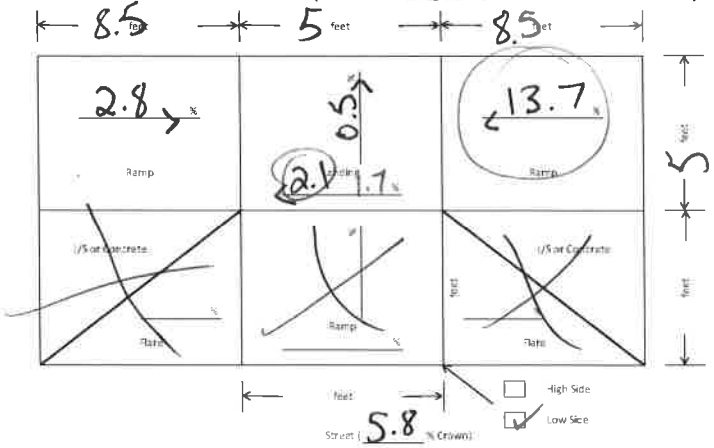
right ramp exceeds max slope

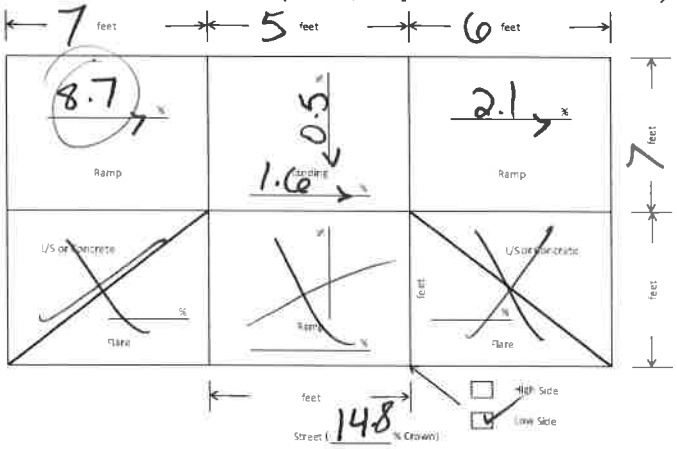
Slopes exceed max

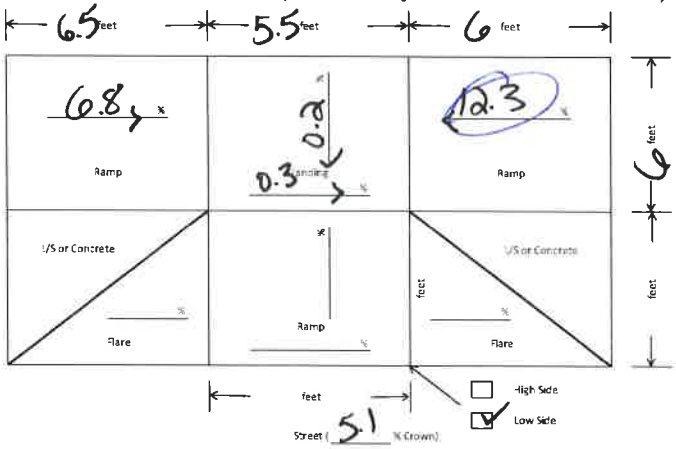
exceeds max slope

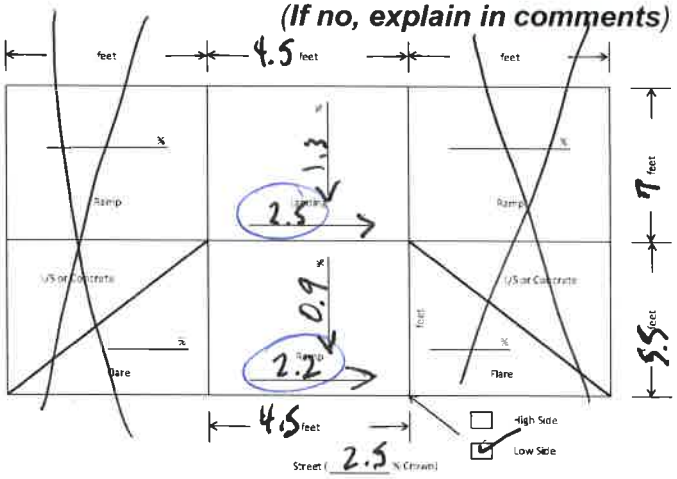
Cross slope max exceeded

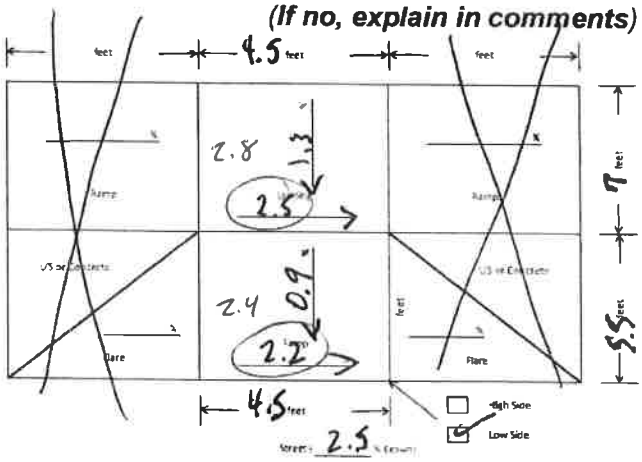
Cross slope max exceeded

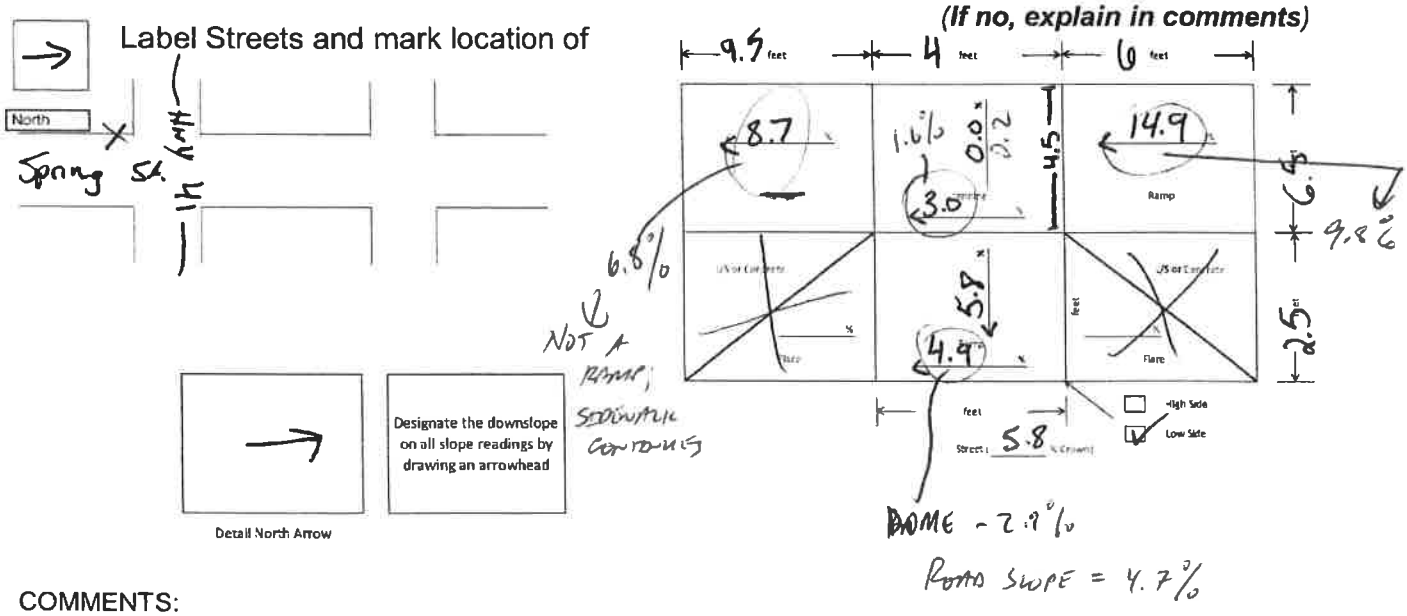
ramps exceed max slope and cross slope of landing and curb ramp exceed max

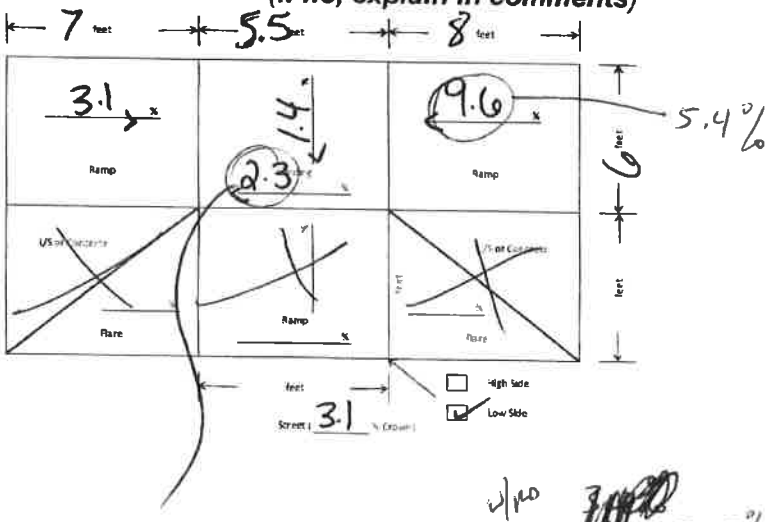
[redacted] SLOPE OF GUTTER w/pan = [redacted] 2.5%

CROSS-SLOPE OF 1.8% ON DOME MAT

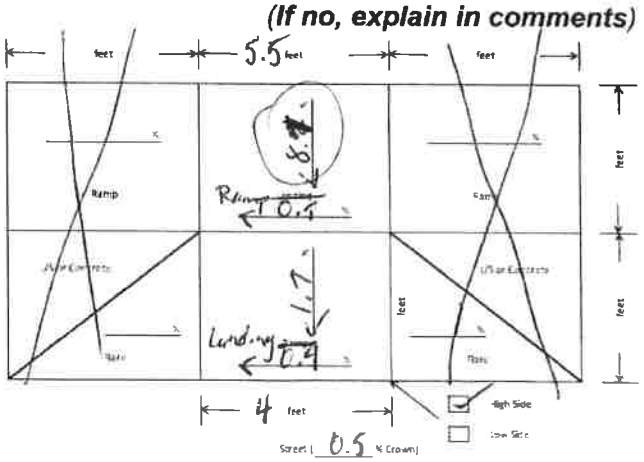
Landing 1.4% x 1.0 2

Ramp 5.2 x 0.3 2

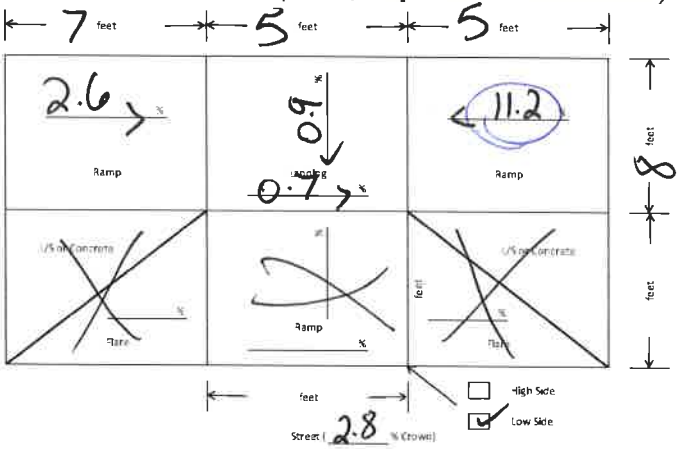
Ramp slope exceeds max.

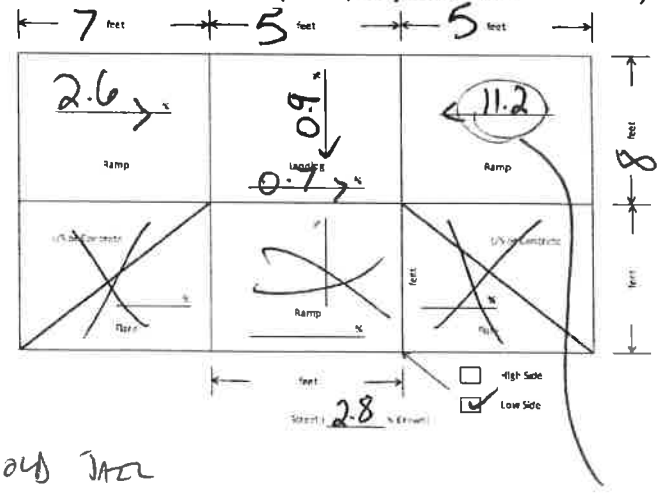
By old Jack

5.8%
7.1%

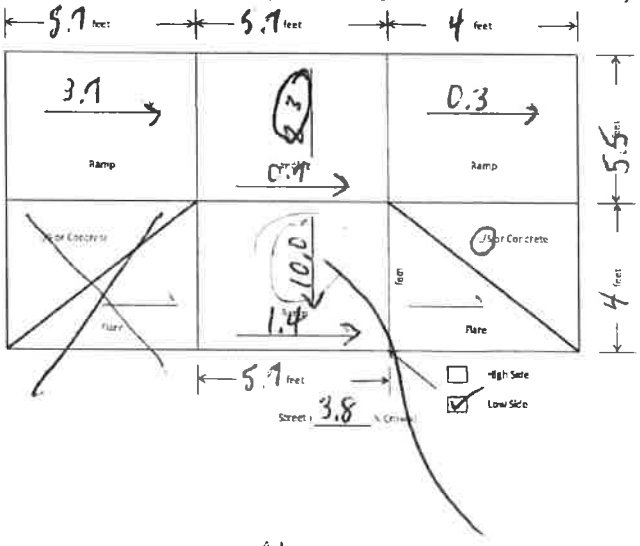
COMMENTS: Crosses 41 – Landing 0.4% 1.5% Ramp = 5.5%

Crosses Madison Landing 0.3% x 1.2%

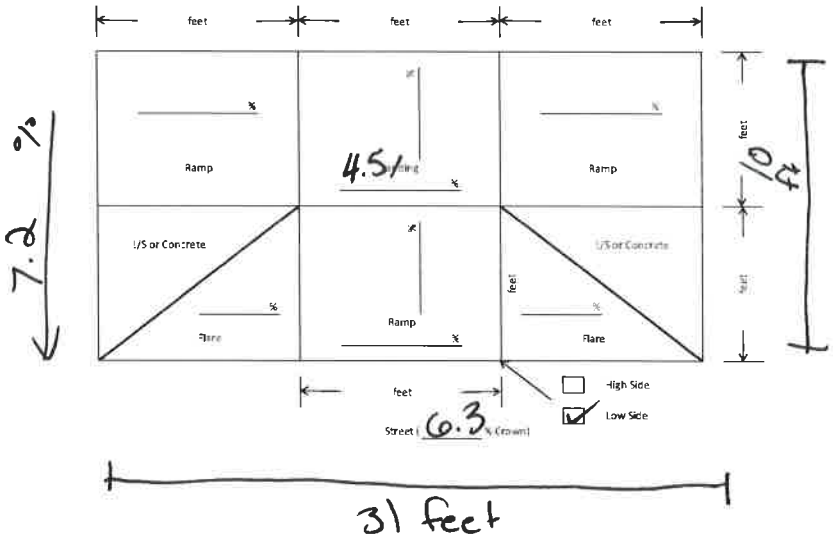
Blended transition, no domes, no landing

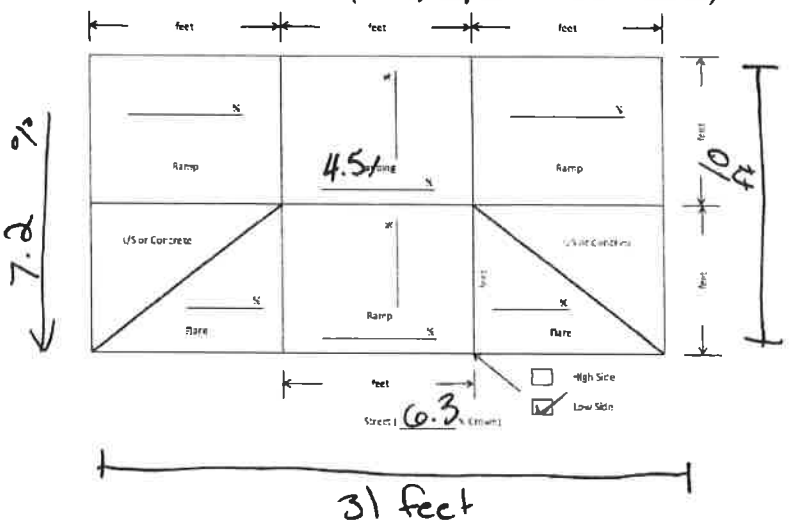
Blended transition, no domes, no landing

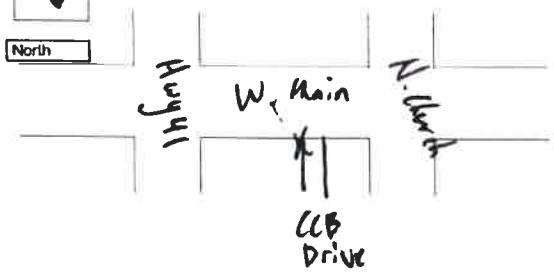
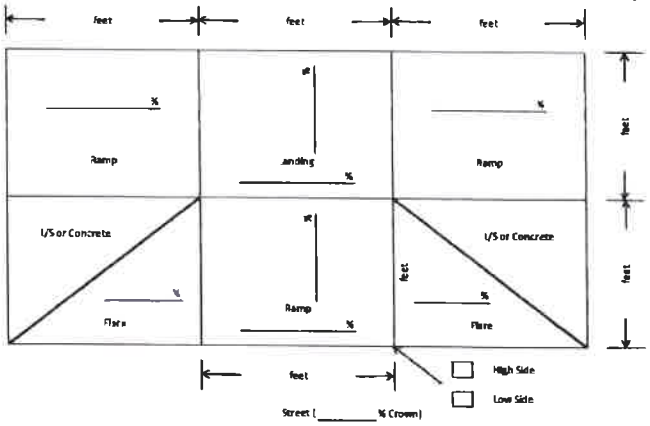
No curb ramp at end of sidewalk at CCB Drive Through

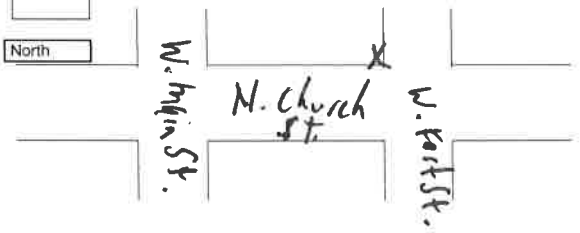
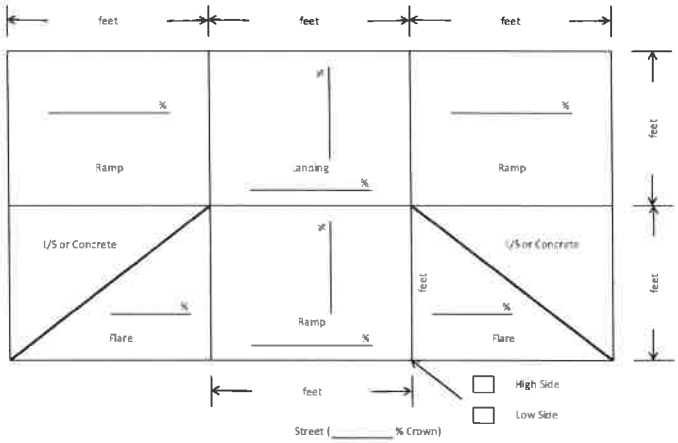
No curb ramp
Sidewalk ends with a large lip at W. Fort St.

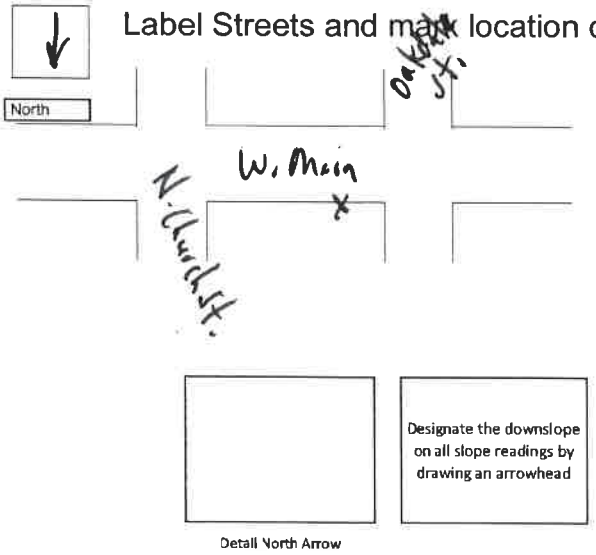
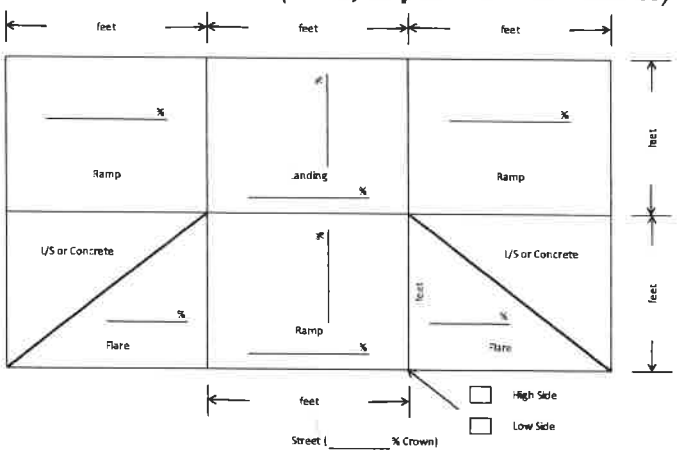
No curb ramp at end of sidewalk at rear church parking lot

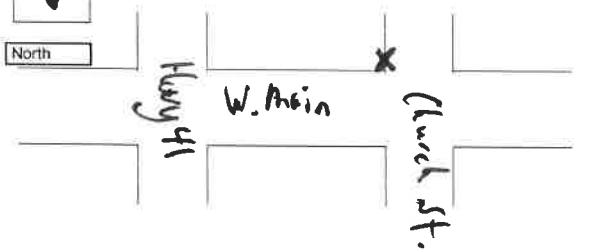
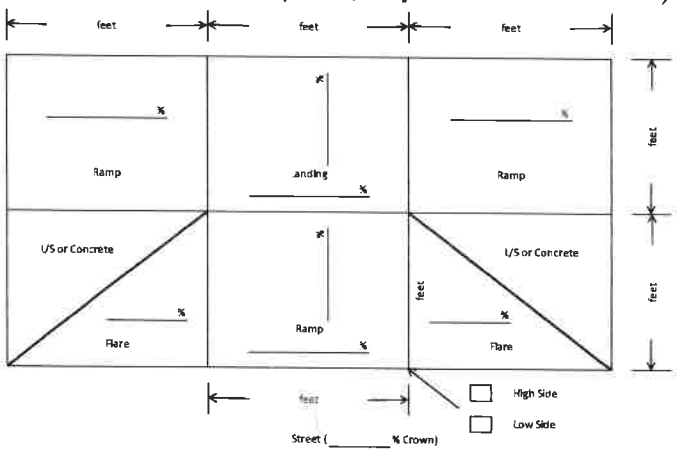
No curb ramp at end of sidewalk - ends in grass

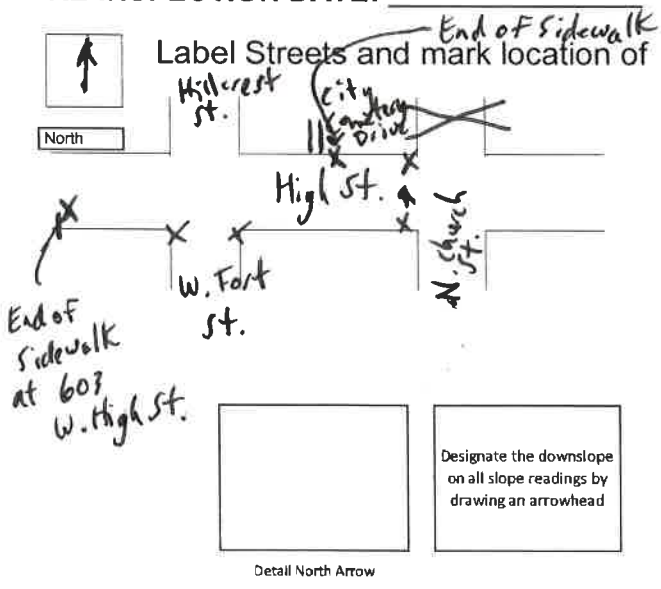
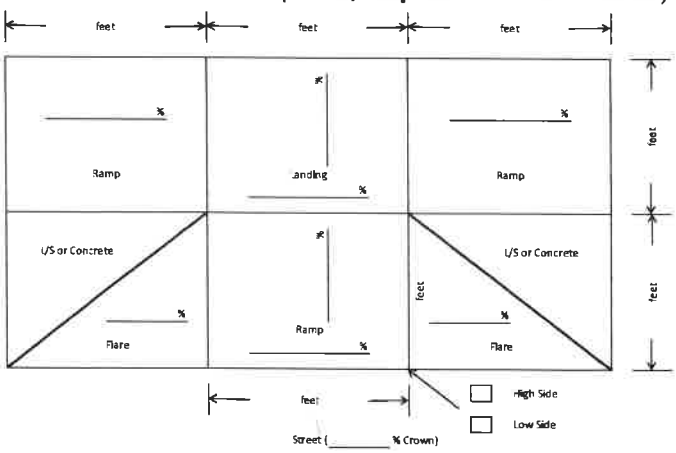
No curb ramps along High St. 6 total ramps needed

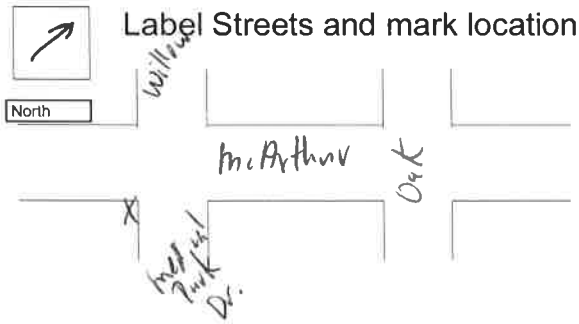
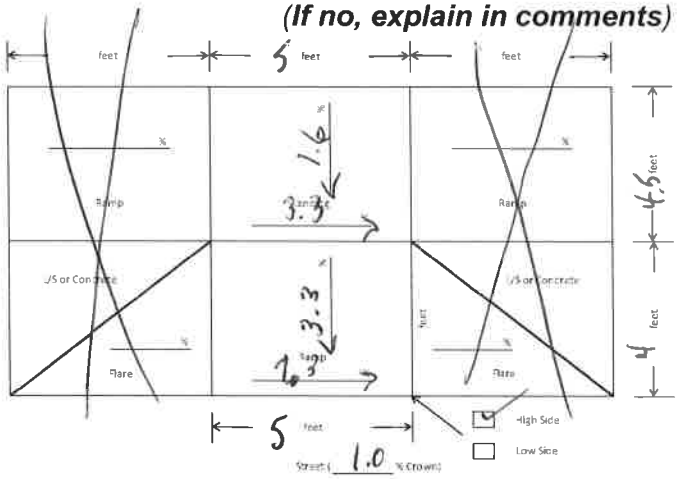
No crosswalk

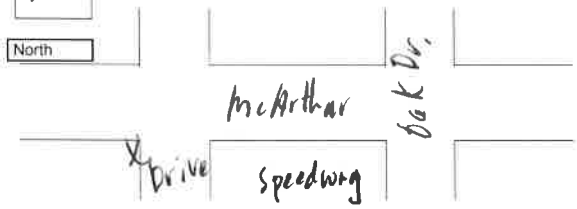
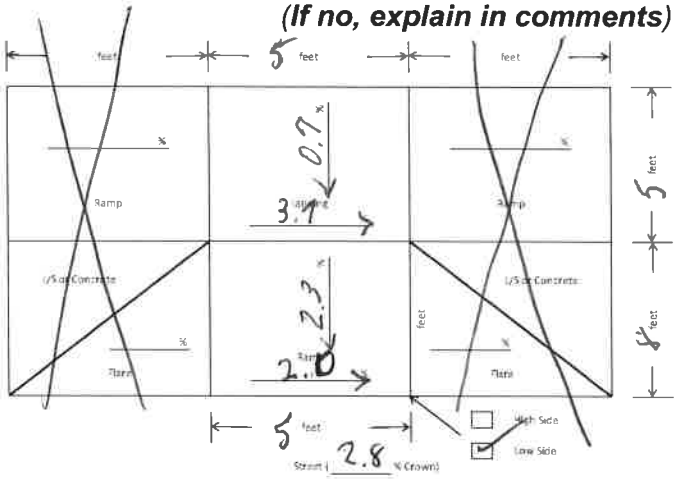
No crosswalk Can be fixed - cross slope

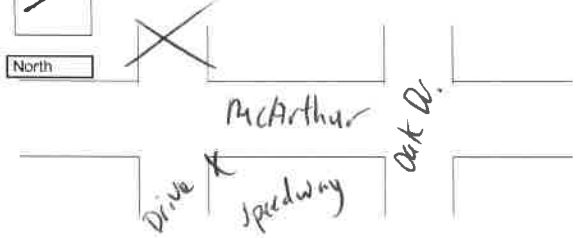
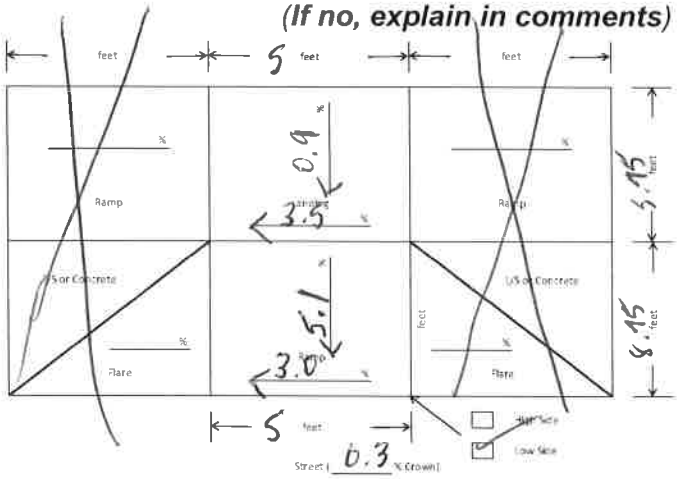
No crosswalk

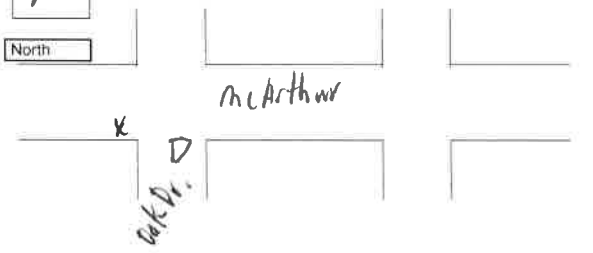
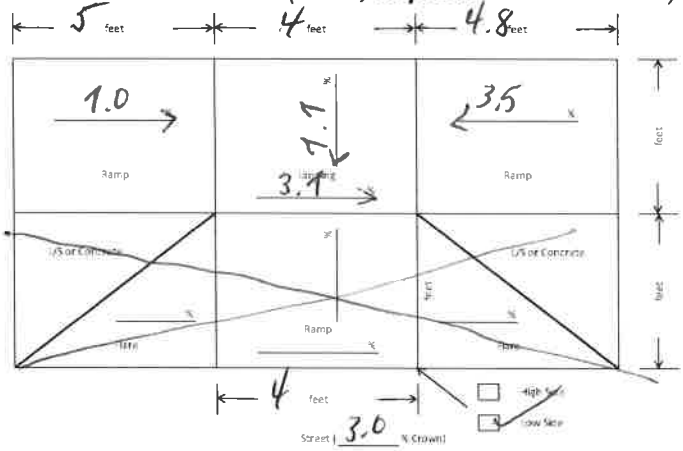
Curbing at back of landing

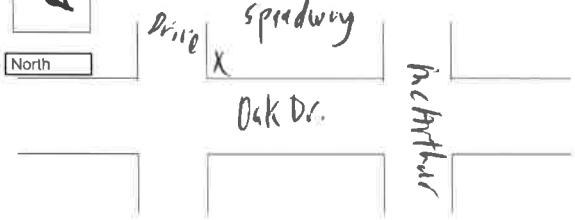
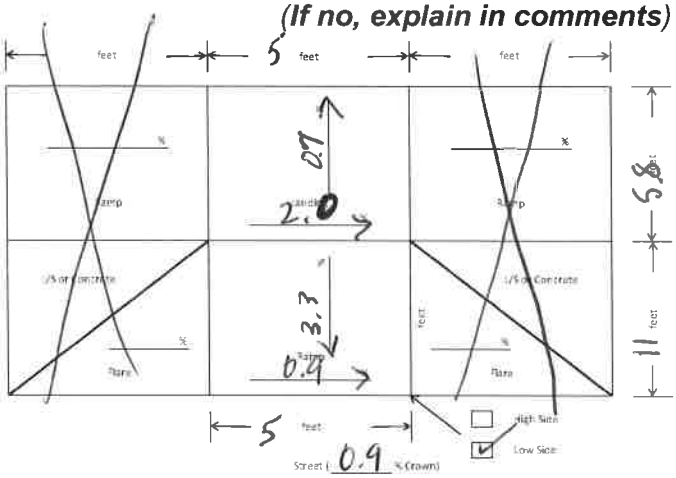
No crosswalk

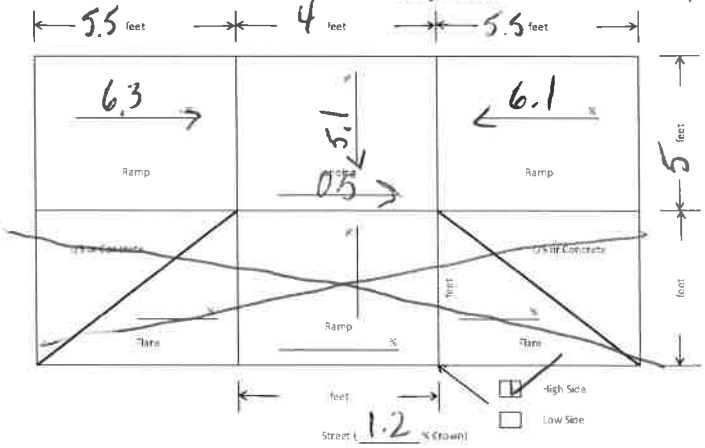
Curbing behind landing

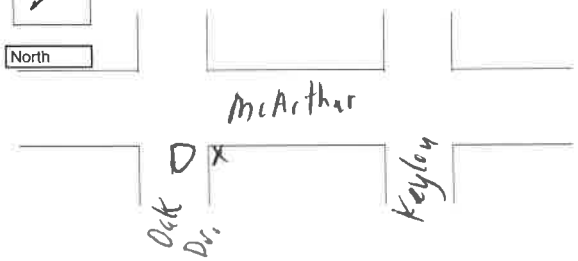
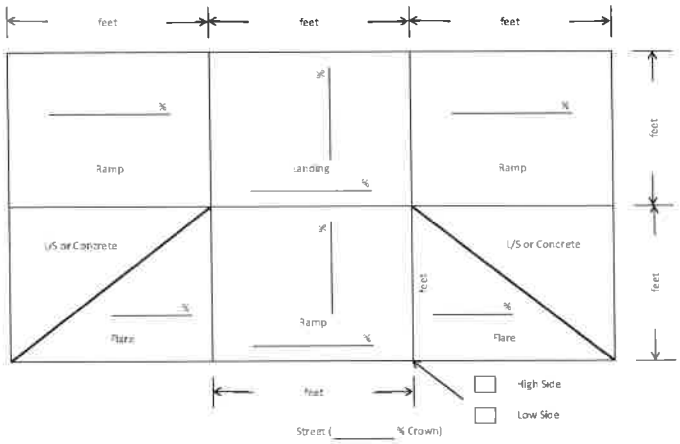
Needs a curb ramp to island

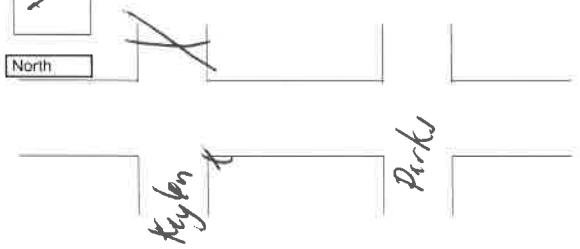
COMMENTS: Cracking
Spalling in ramp

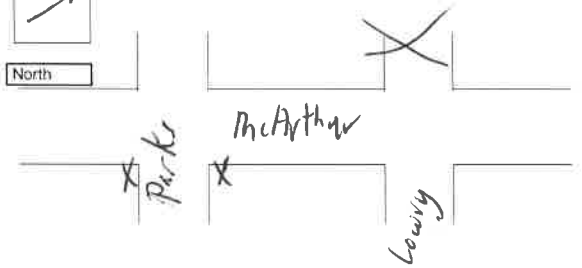
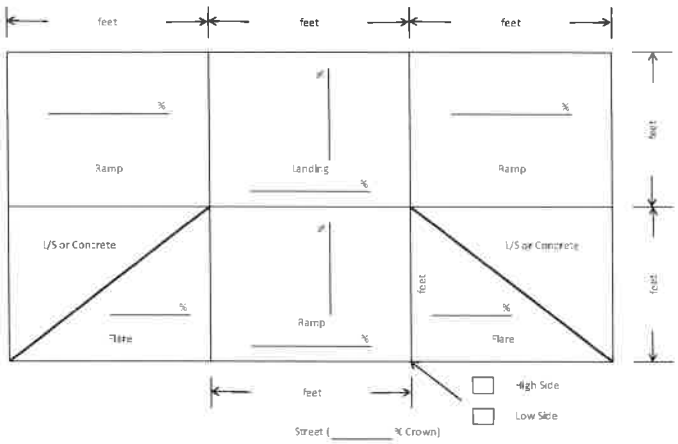
No curb ramps

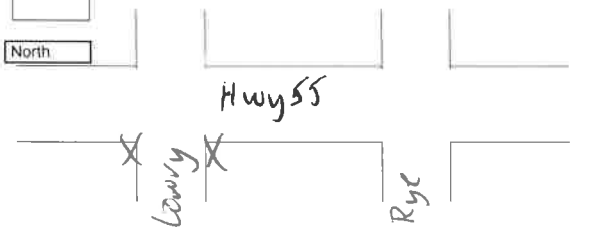
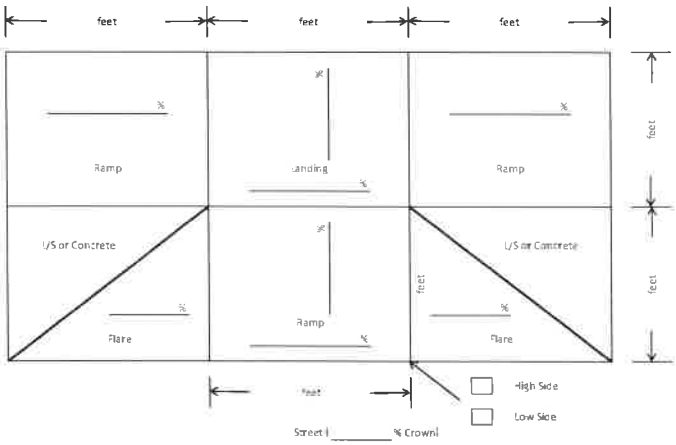
No curb ramps

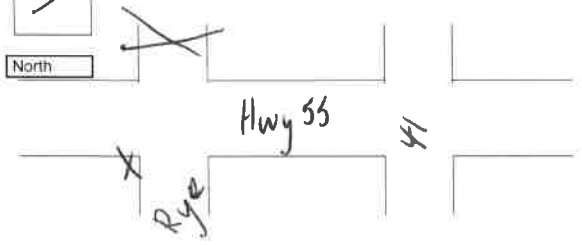
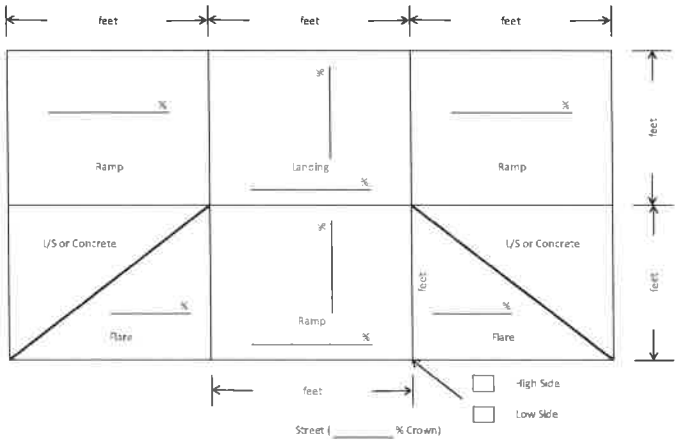
No curb ramp

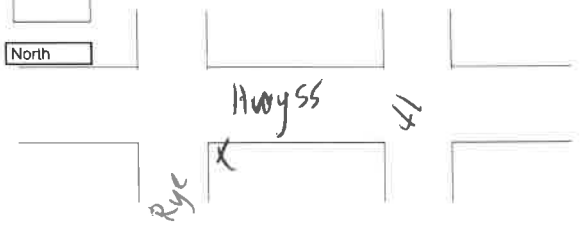
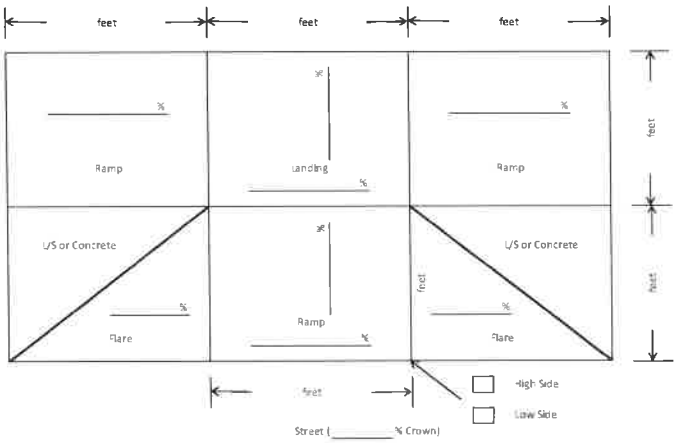
No curb ramp or crosswalk

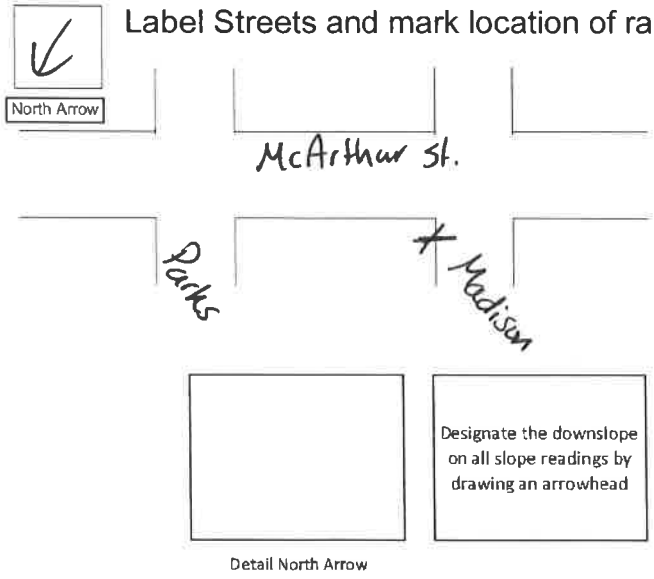
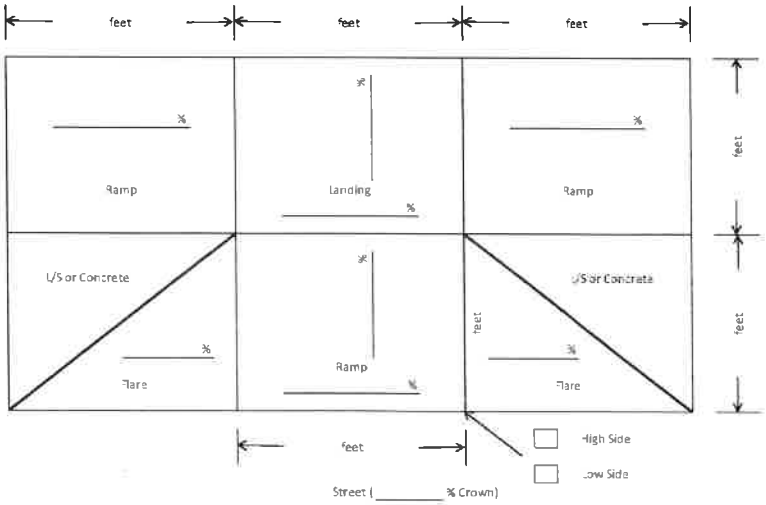
COMMENTS: No Curb ramp

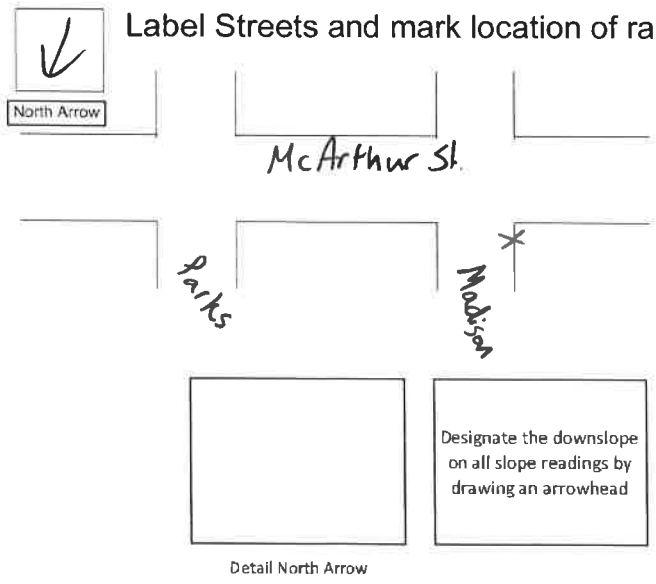
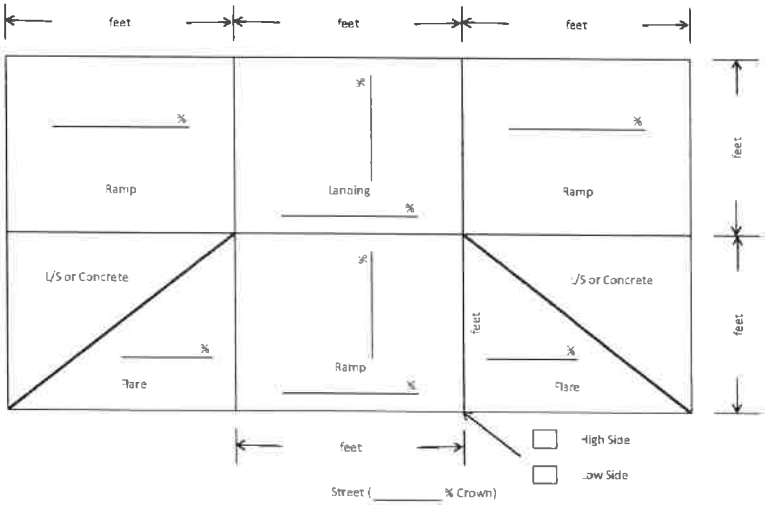
COMMENTS: No curb ramp

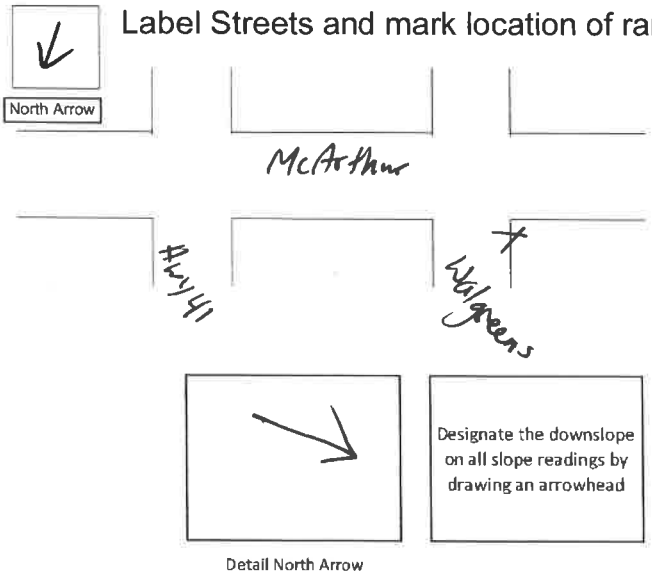
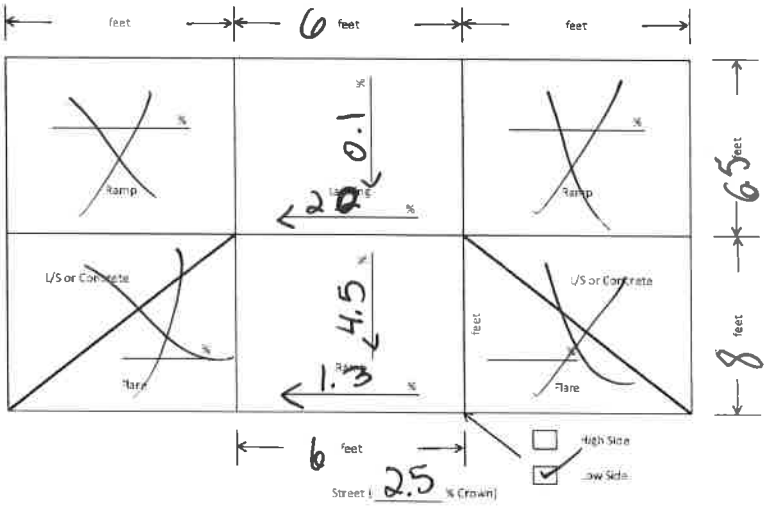
ramp tapers in length
