ADA Transition Plan and Self-Evaluation

City of
Manchester
Manchester, TN

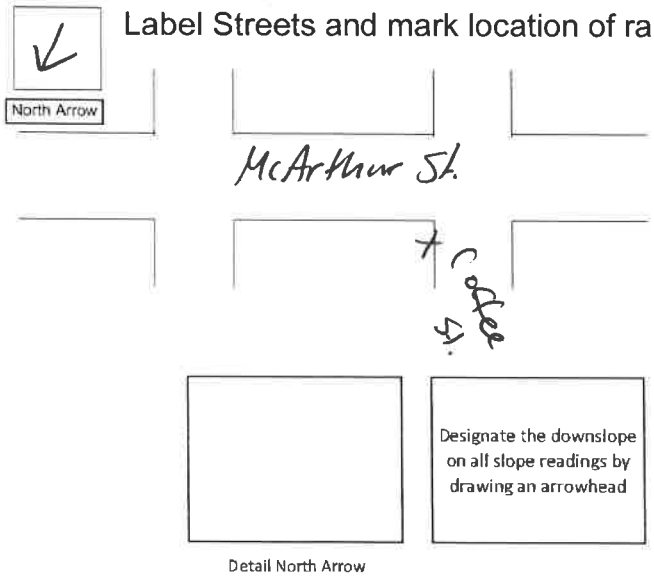
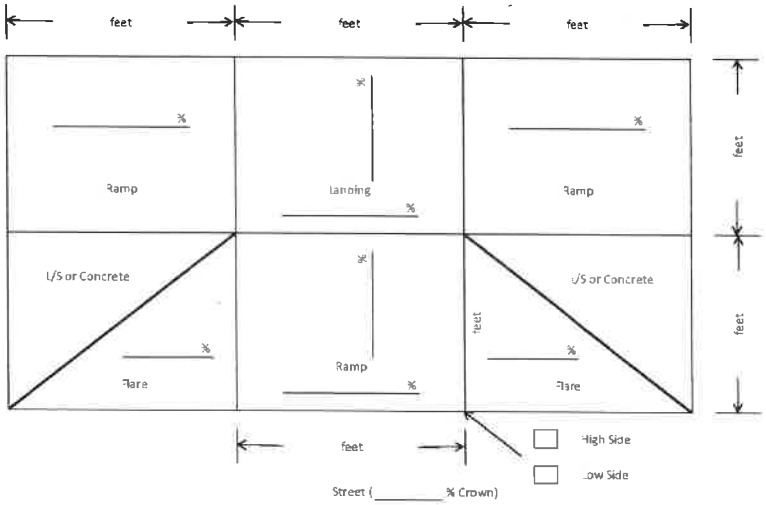
COMMENTS: No curb ramp

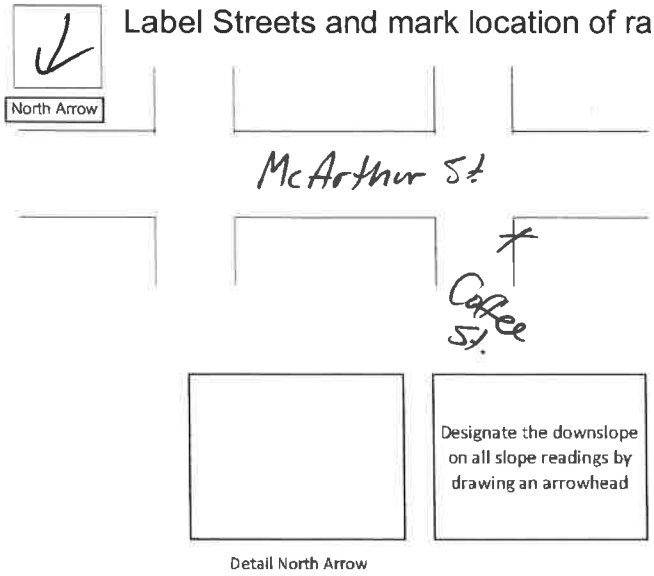
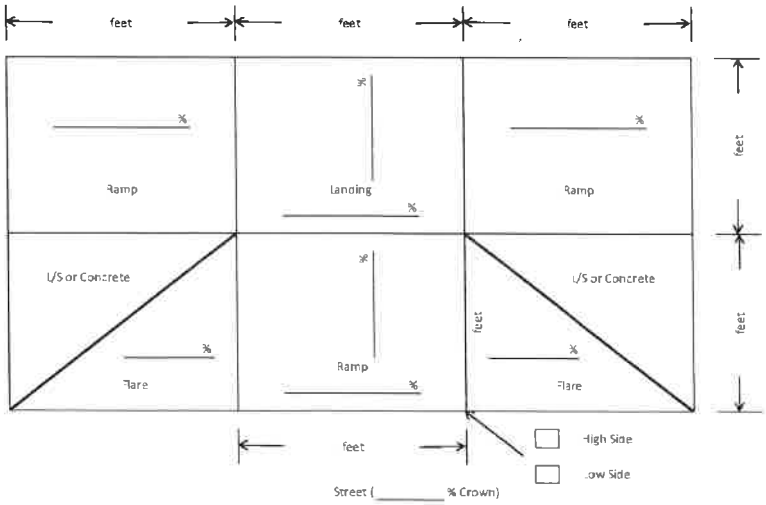
COMMENTS: No Curb ramp

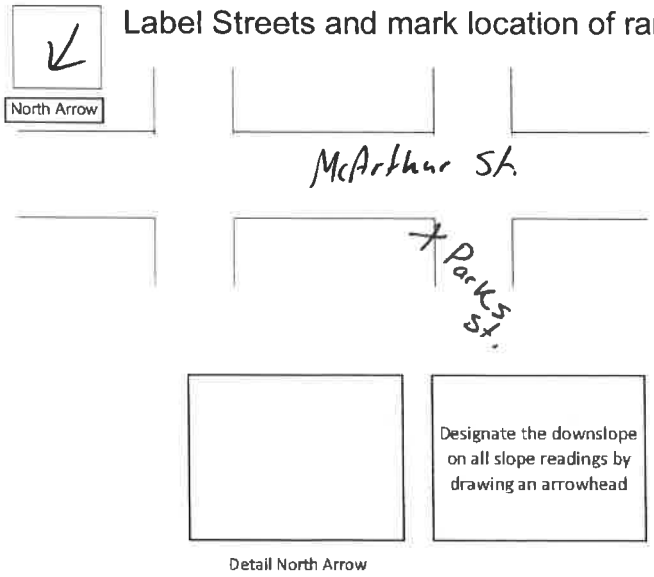
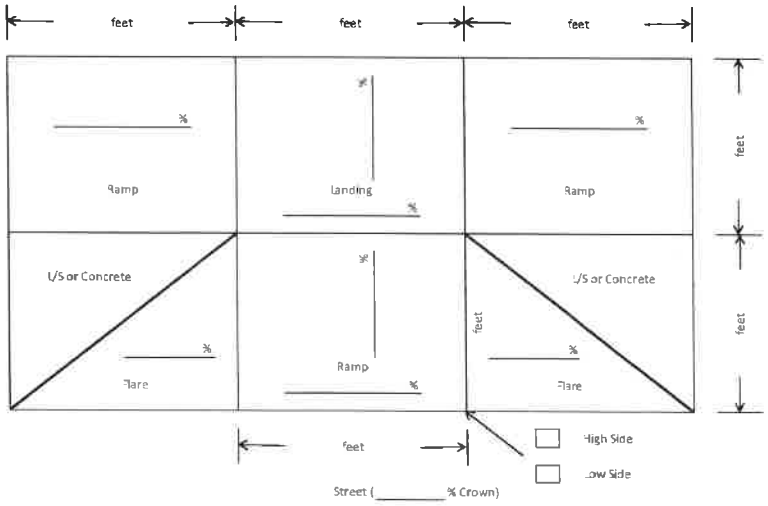
No Curb ramp

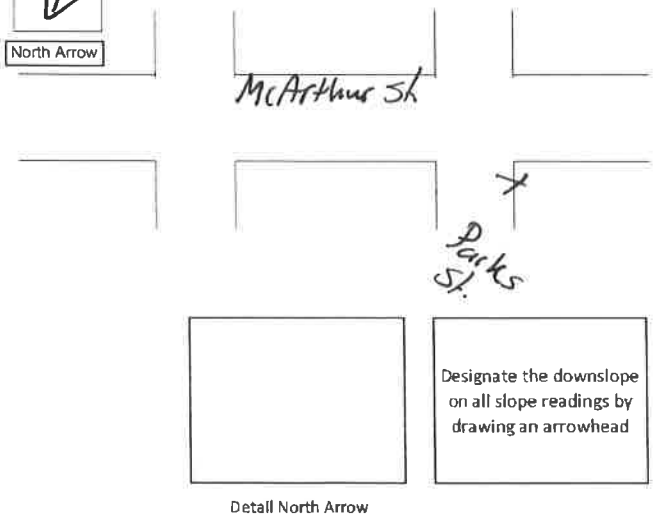
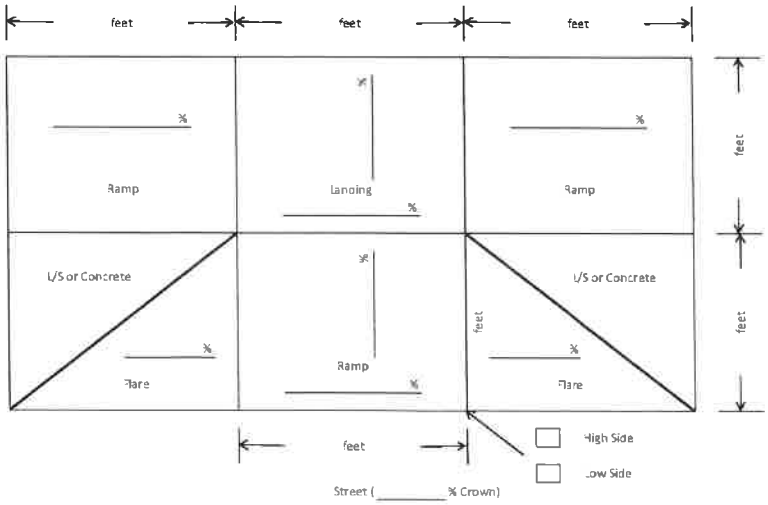
No Curb ramp

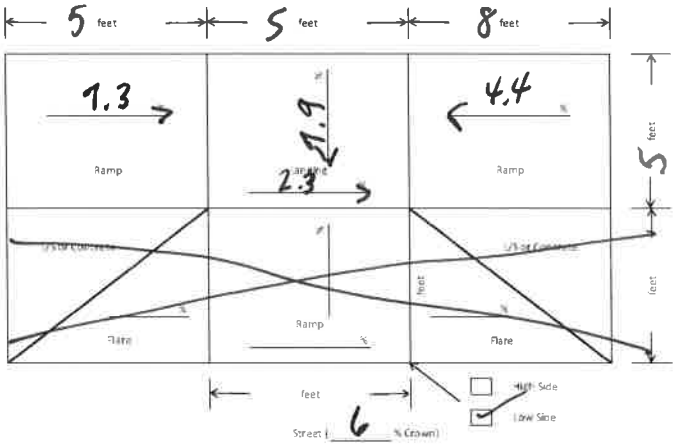
No curbing

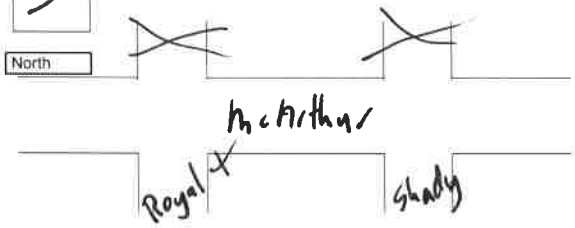
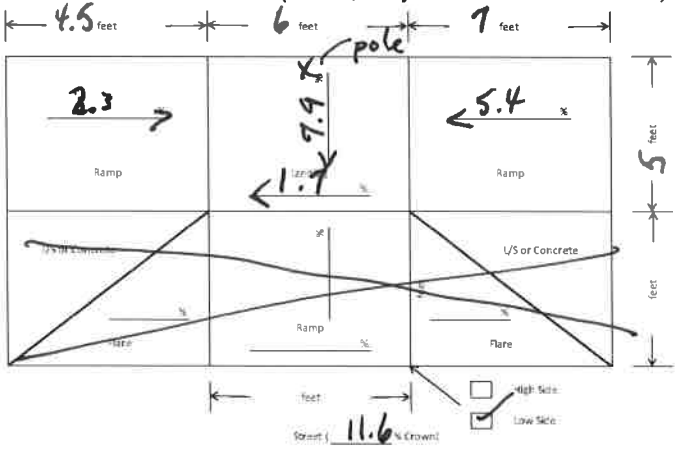
Electric pole is 1 ft. into ramp

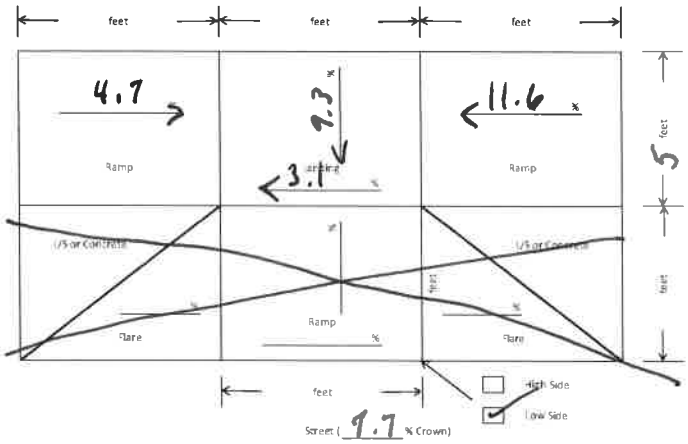
No curbs

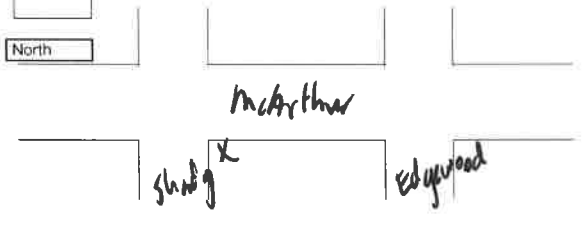
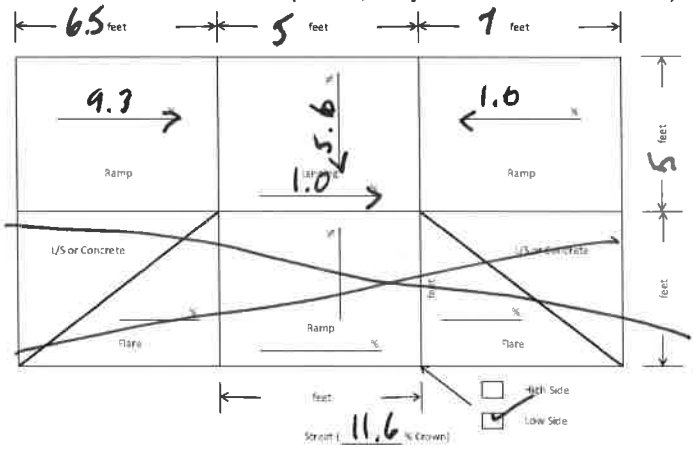
No curbs

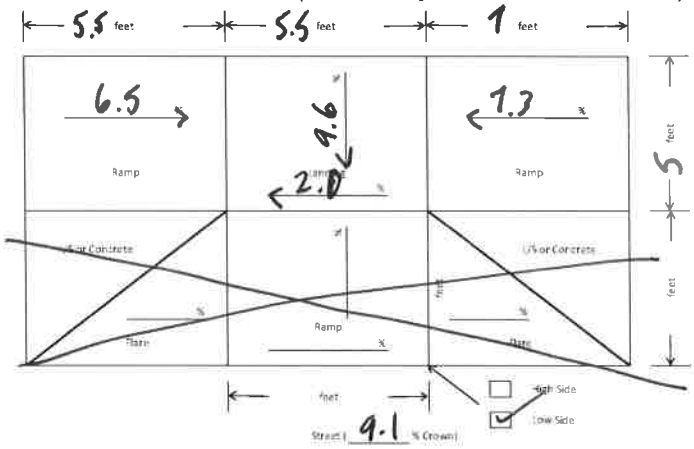
No curbing

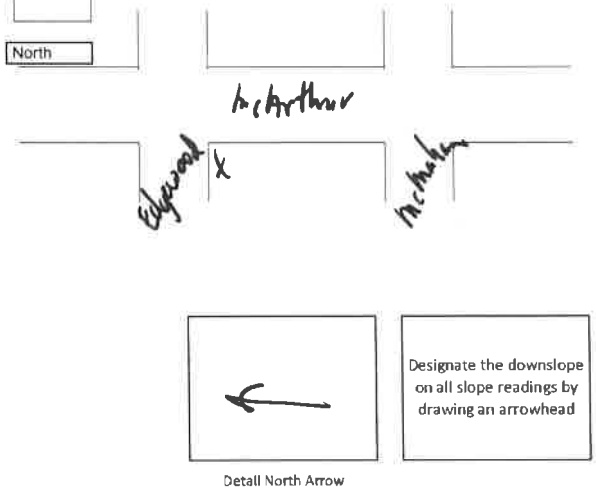
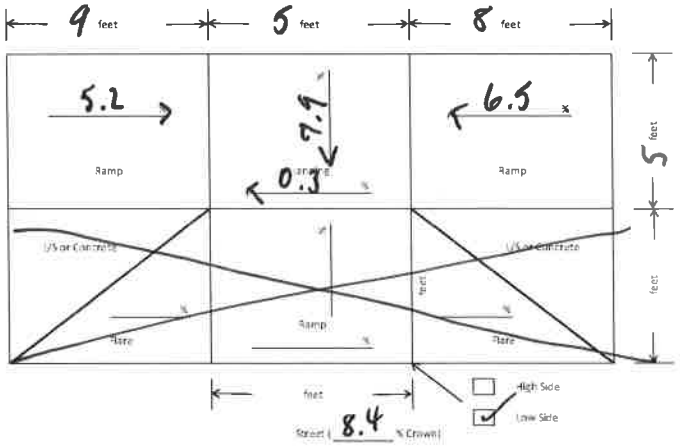
No curbing

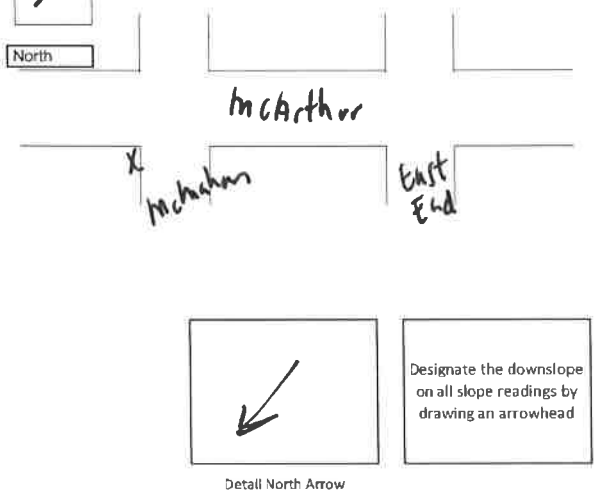
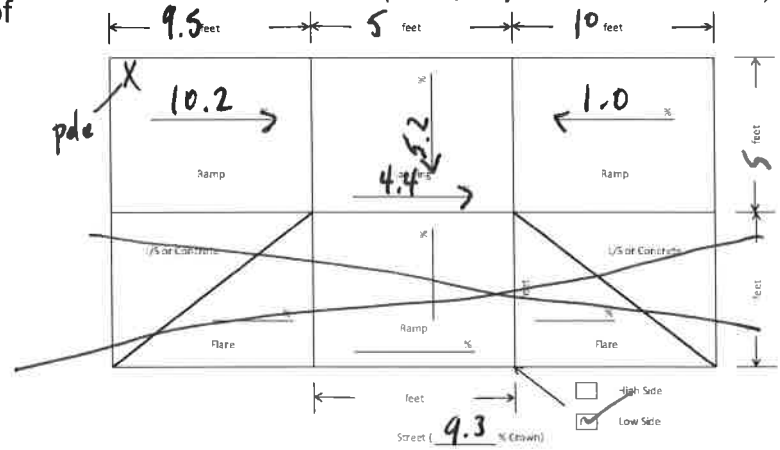
Electric pole protrudes into ramp 1 ft.

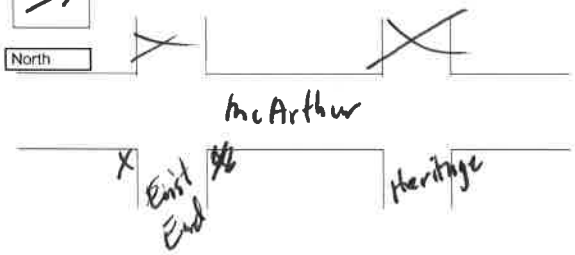
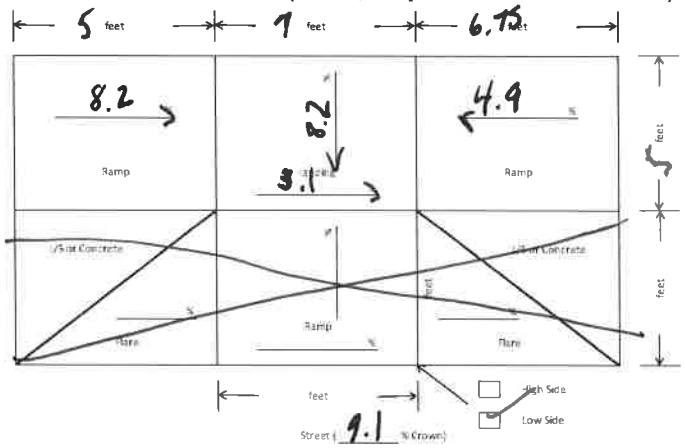
No curbs

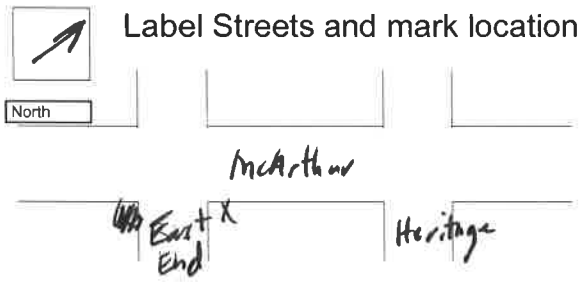
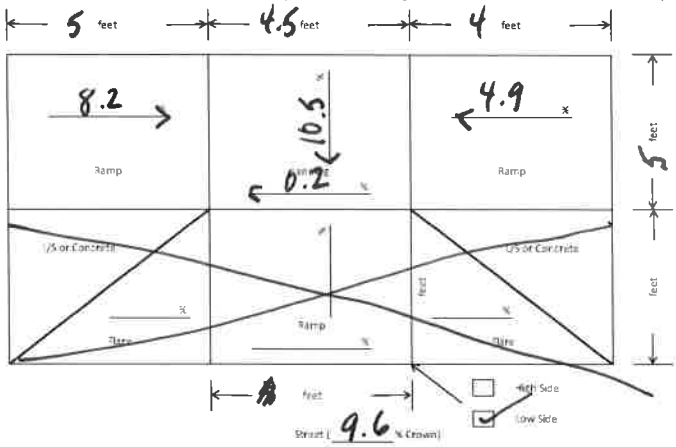
No curbs

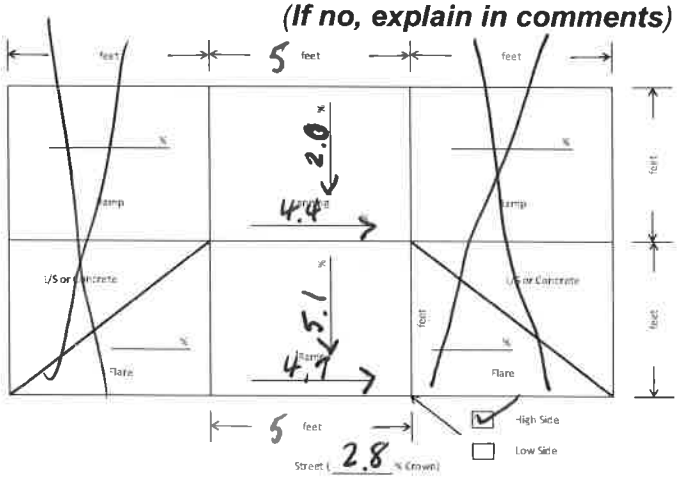
Max cross slope exceeded

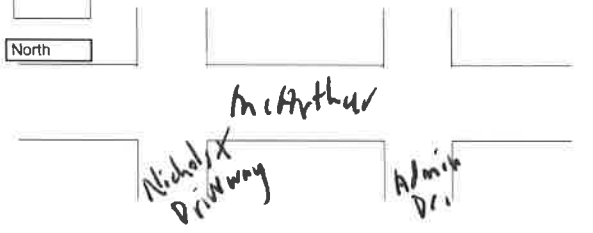
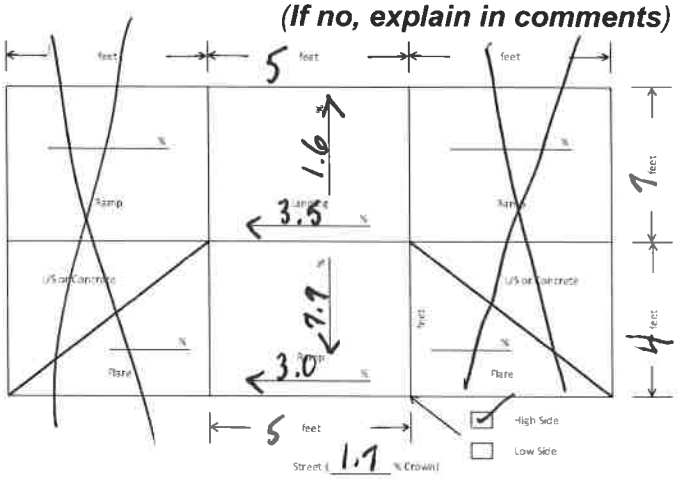
Max cross slope exceeded

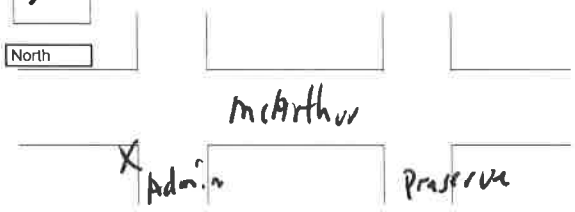
No crosswalk
Excessive cracking in ramp

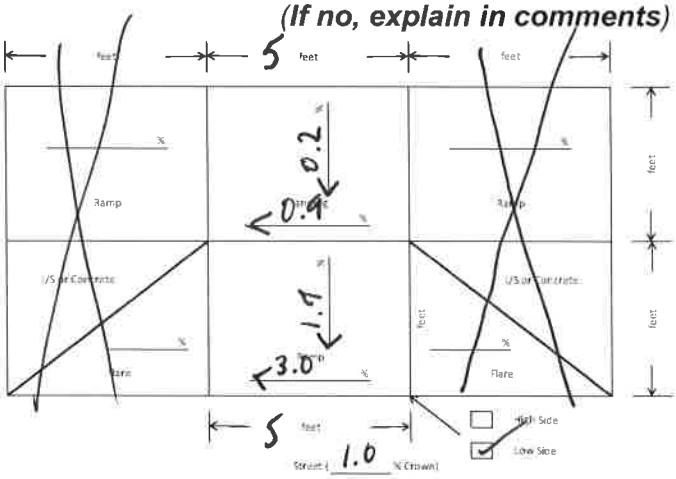
No crosswalk

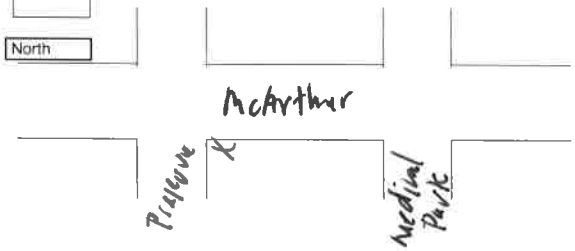
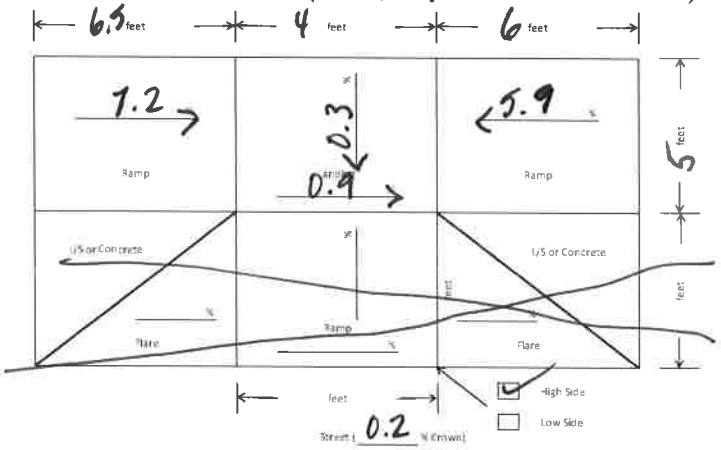
Curb behind landing

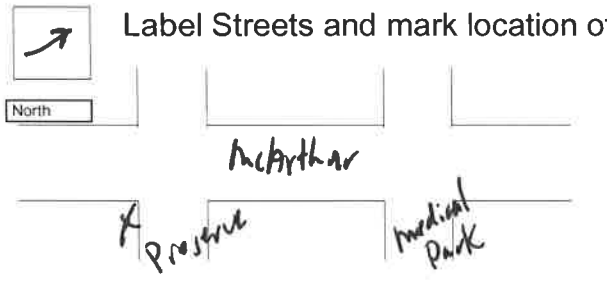
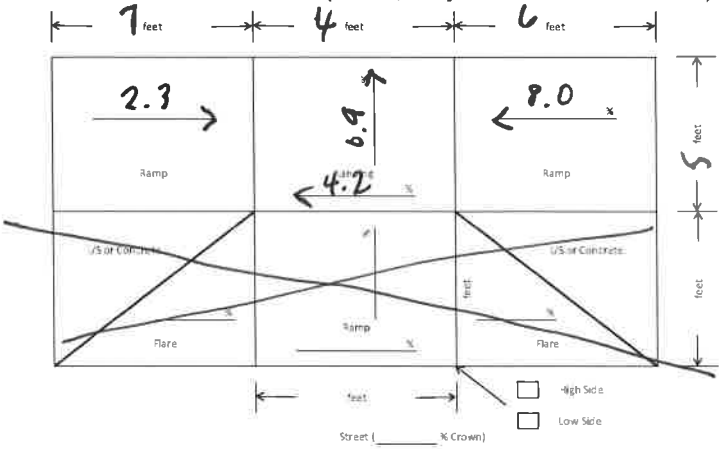
Curb behind landing

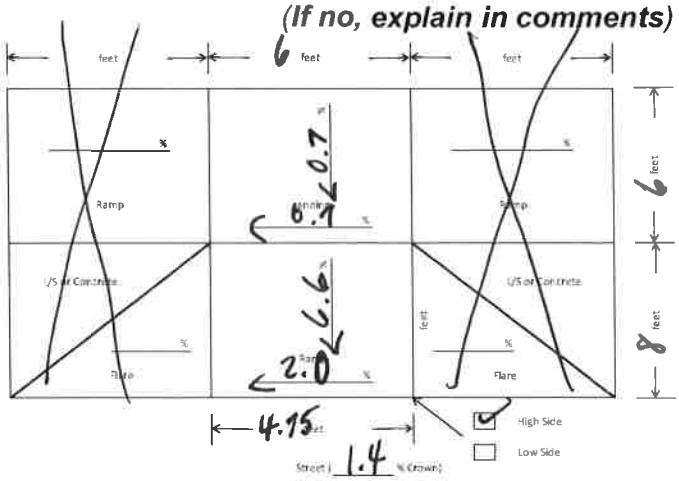
Detectable warning ramp cross slopes

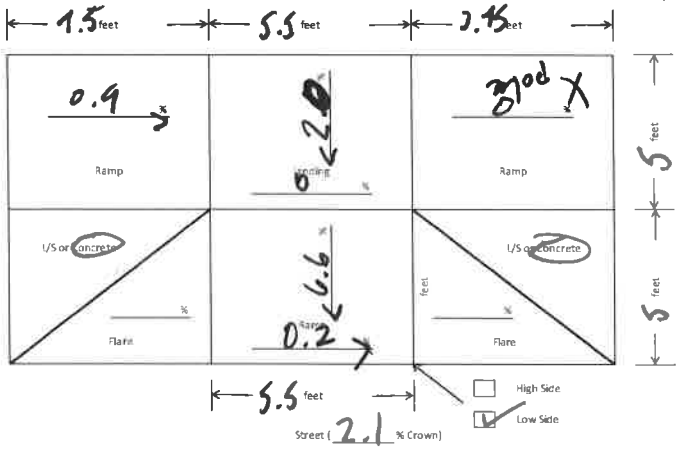
Signal pole in ramp leaving 2 ft to get around

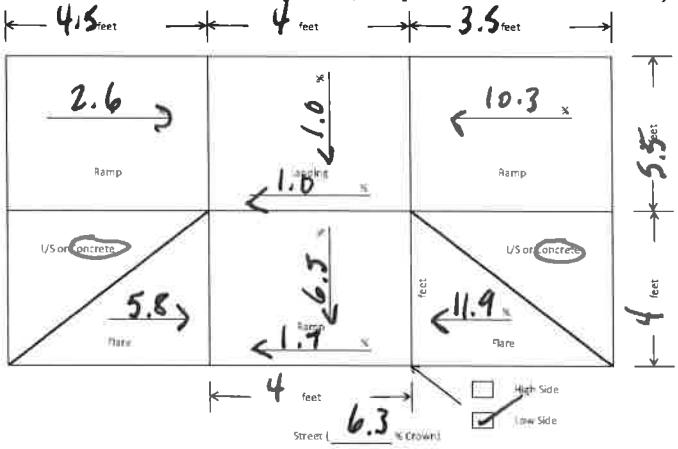
Signal box in ramp but have 4 ft. clearance

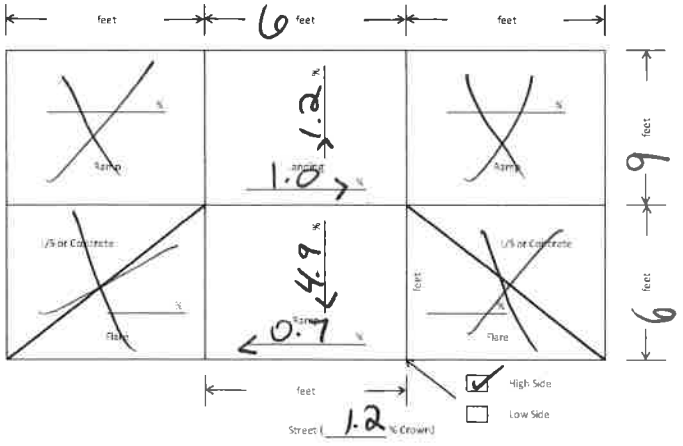
Island

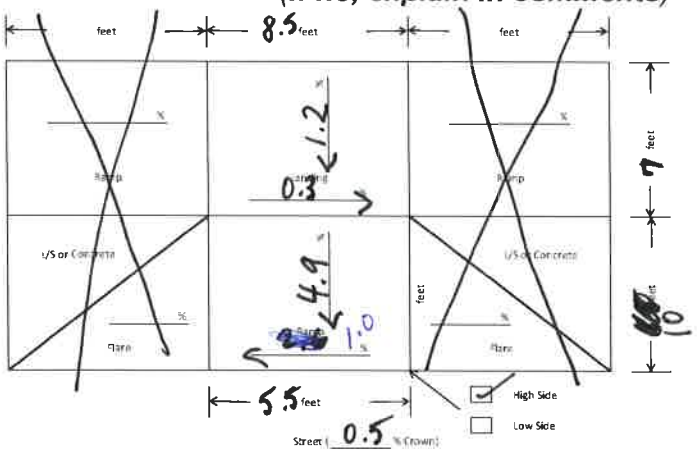
max Ramp cross-slope exceeded

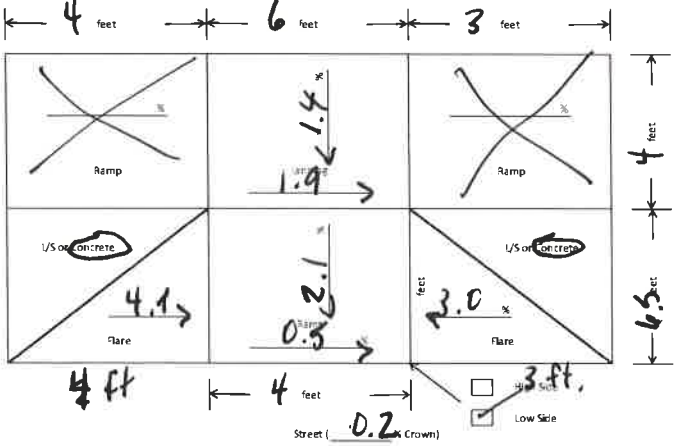
Detectable domes are red

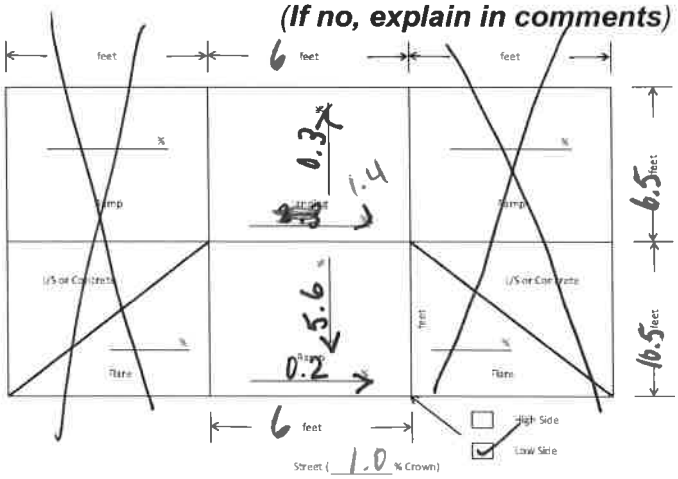
Exceeds max landing cross slope

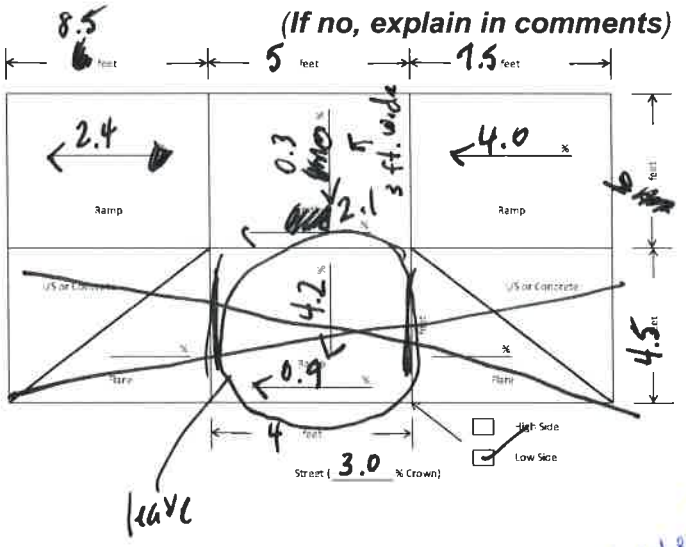
Detectable domes are red.

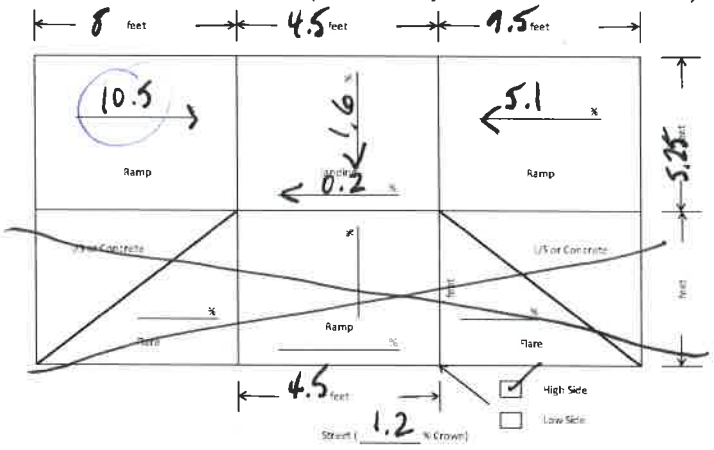
Curbing behind landing/ramp

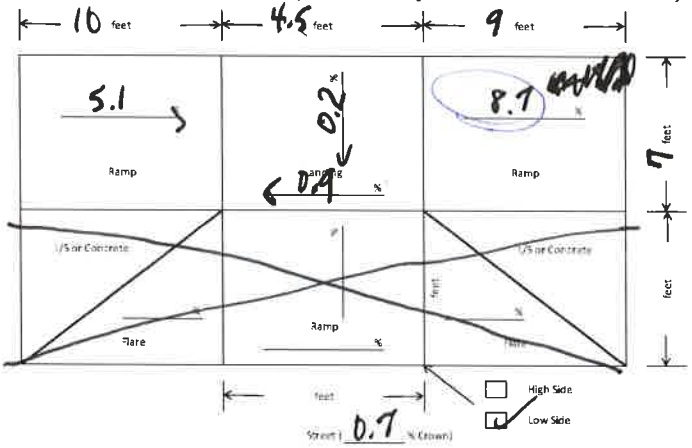
Curbing behind landing/ramp
max Ramp slope exceeded

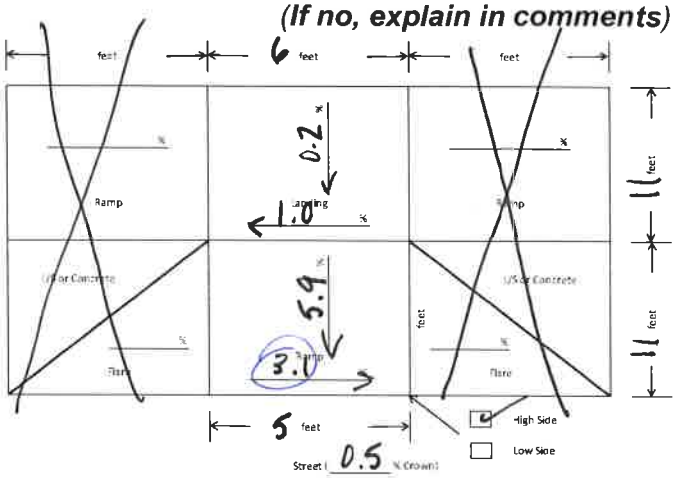
Max cross slope on ramp exceeded

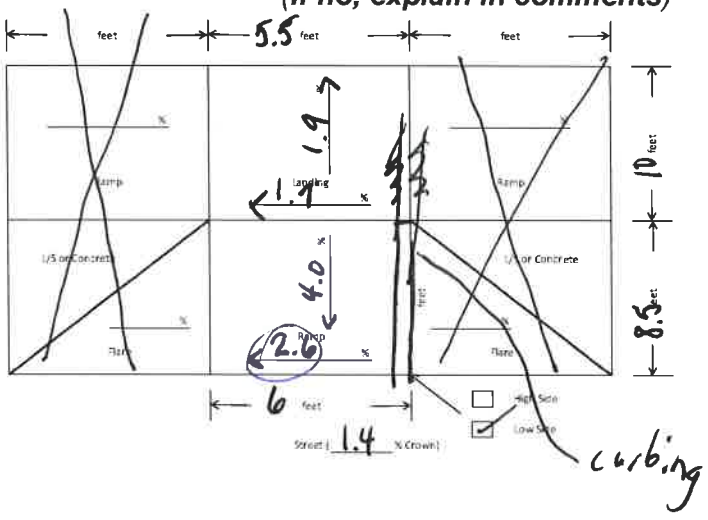
Ramp cross-slope exceeds max

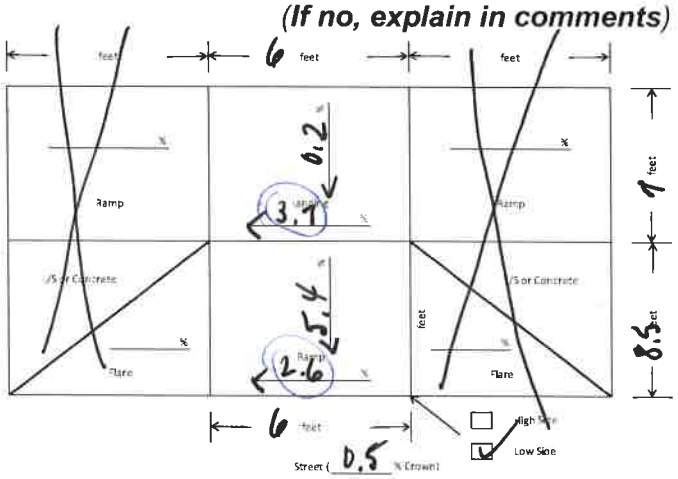
Max cross slopes exceeded

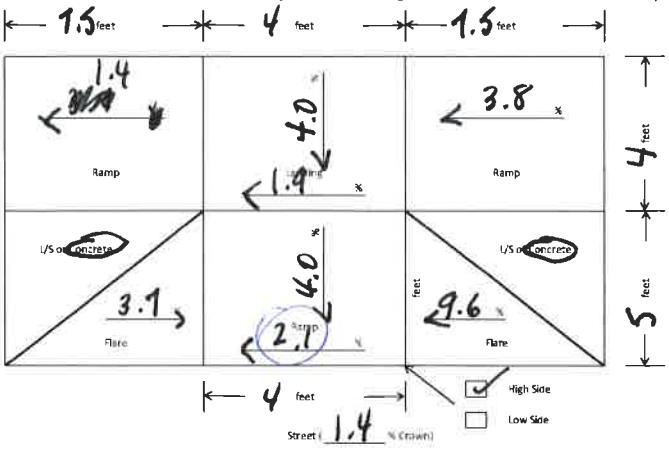
Detectable domes are red

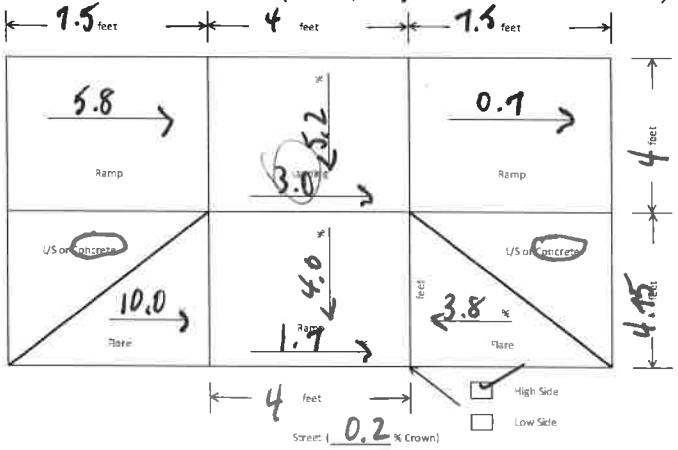
Detectable domes are red

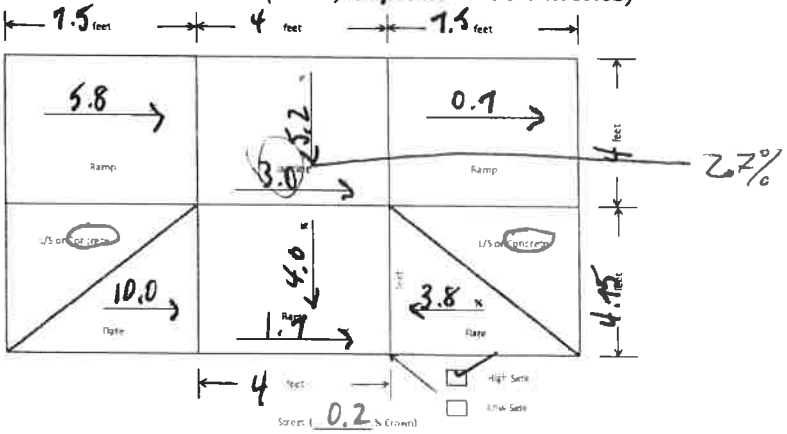
Detectable domes are red

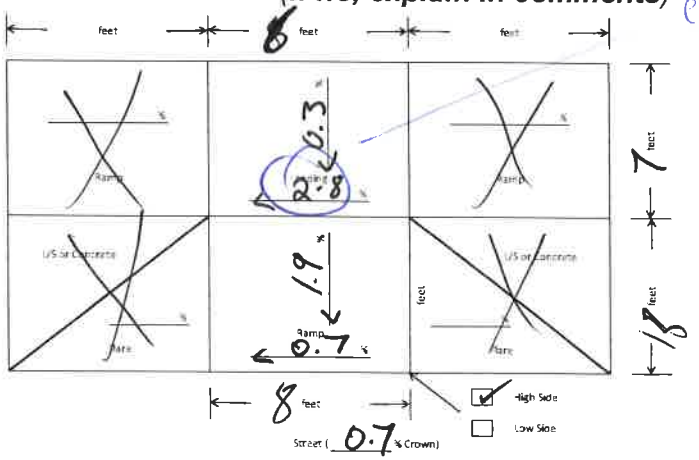
crushing landing

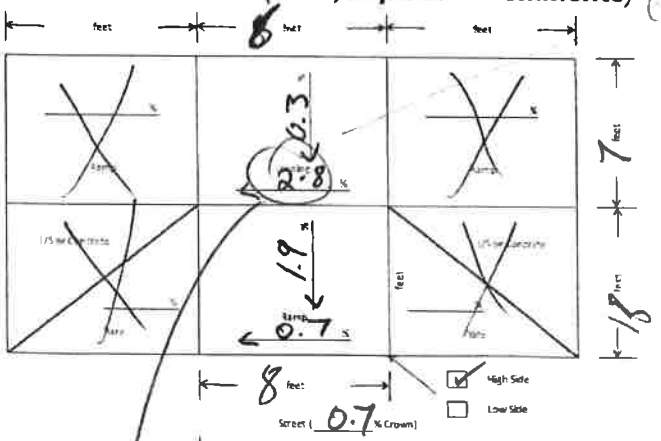
(crushing landing)

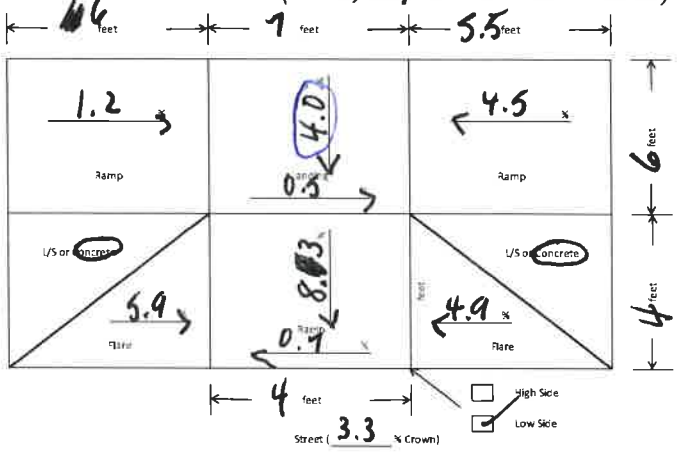
Detectable domes are red

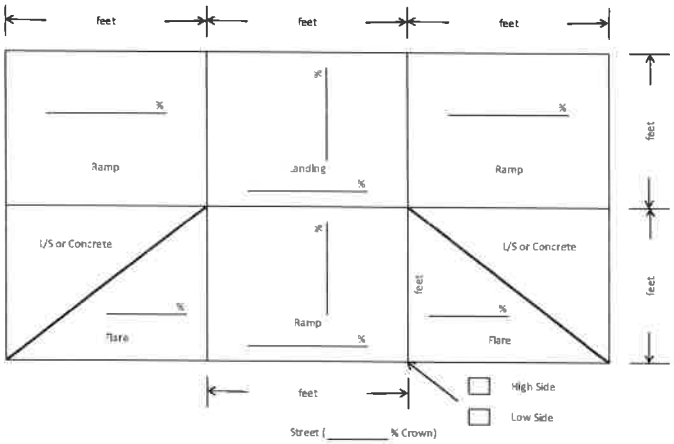
No curb ramp at end of sidewalk at ERPUD

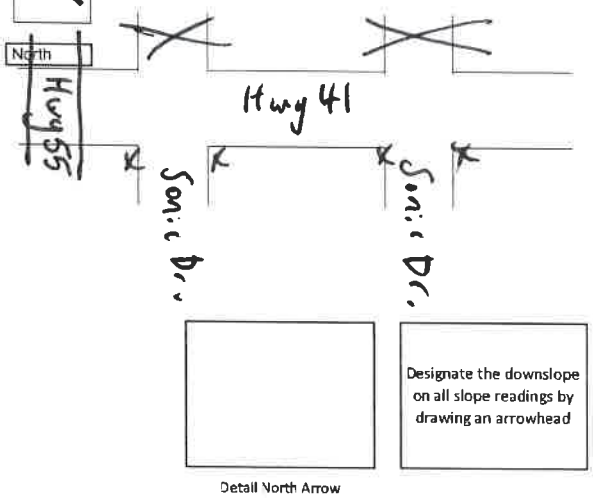
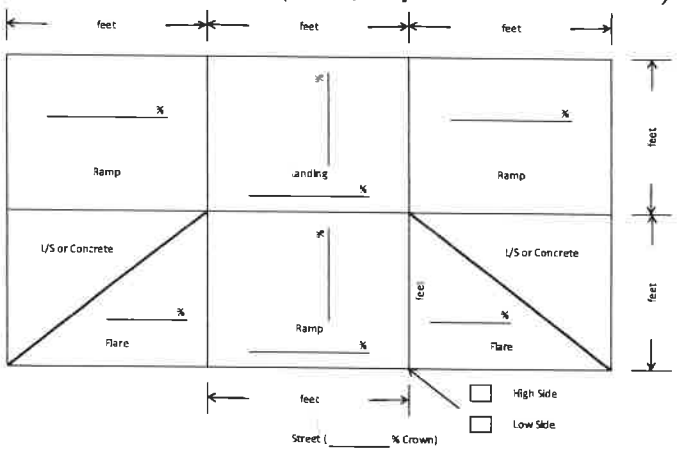
No curb ramps at Sonic entrances - 4 total ramps

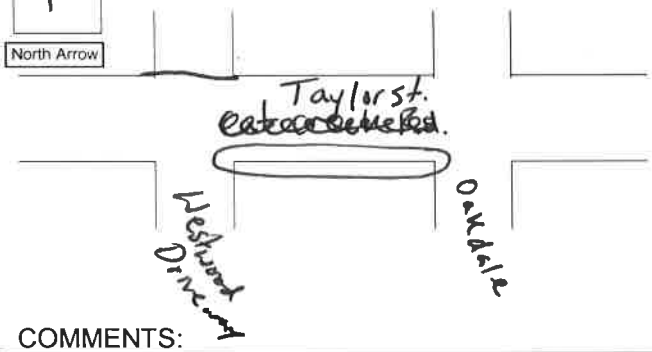
Excessive cracking in a particular section.

40' replacement

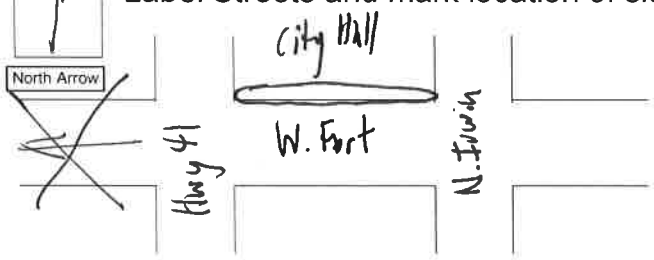
DEFICIENCY DESCRIPTION: cross-slope exceeds 2%.

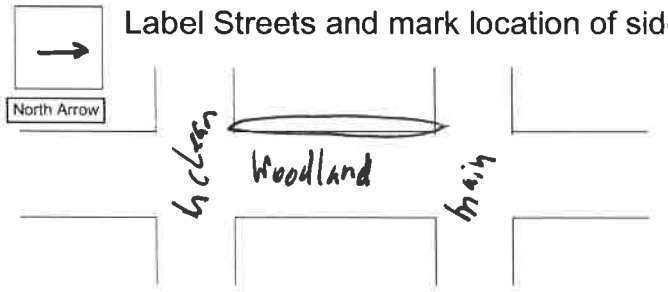
DEFICIENCY DESCRIPTION: No Curb ramps at drive of Main St. Church of Christ

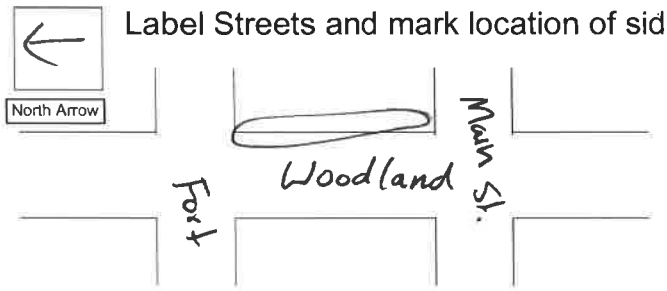
DEFICIENCY DESCRIPTION: sidewalk not connected fully

19' replacement

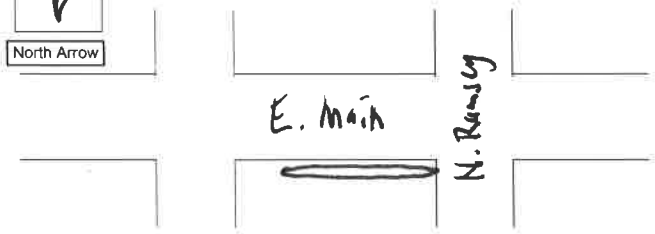
COMMENTS: Tree roots have busted sidewalk
153' Replacement

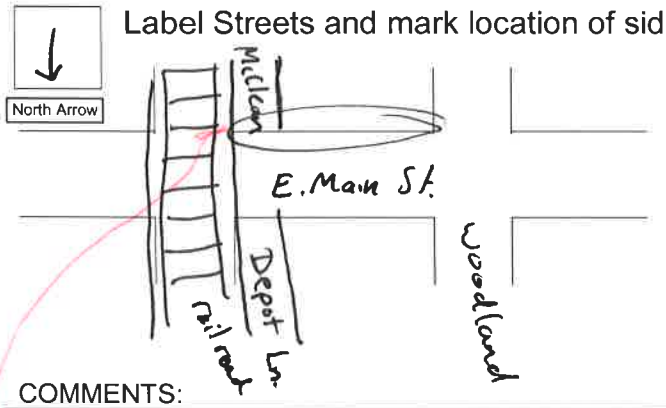
88' Missing

203' Replacement

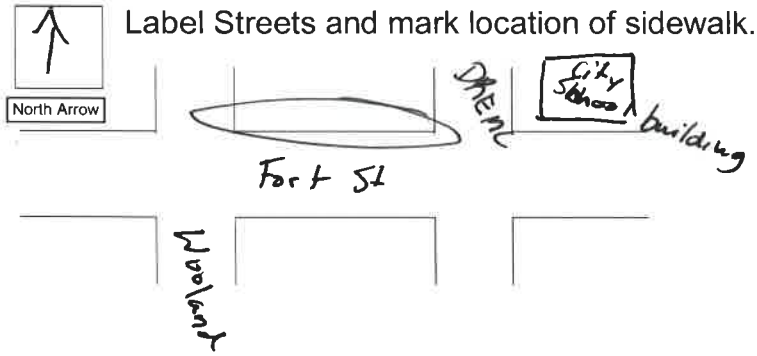
DEFICIENCY DESCRIPTION: ~~Asphalt Section~~ ½ asphalt

44' Replacement

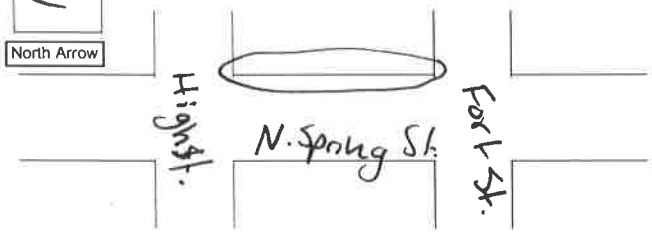
DEFICIENCY DESCRIPTION: guard railing needed 4ft drop to road from sidewalk. Steps at each ~~end~~ end with no railing

72' replacement

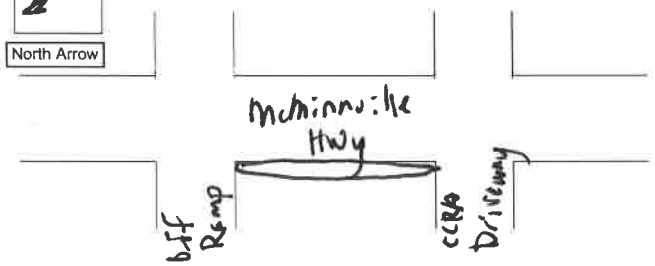
DEFICIENCY DESCRIPTION: Crossslopes at business drives exceed 2% max

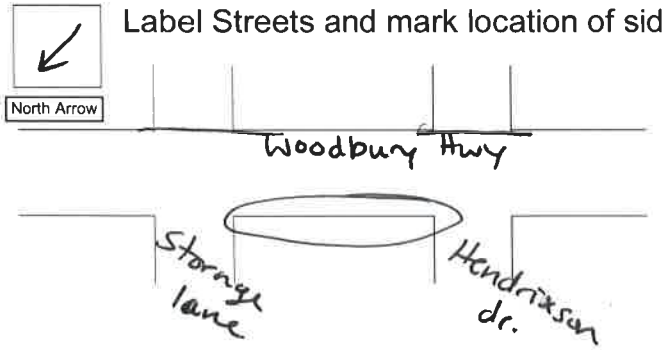
DEFICIENCY DESCRIPTION: cross-slopes at drives exceeds 2% max, no curb ramp at end of sidewalk

~60' replacement

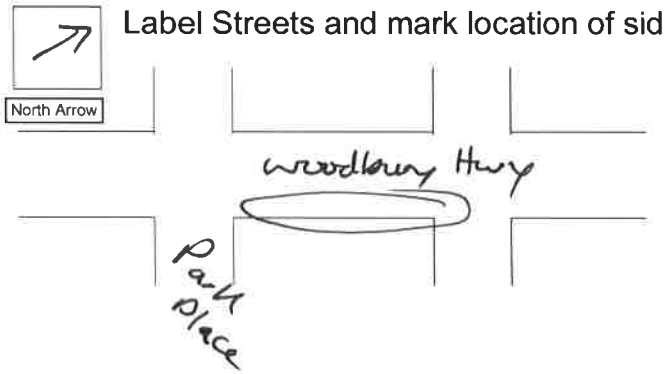
DEFICIENCY DESCRIPTION: ~~No curb ramp~~ cross-slopes at drives greatly exceeds 2% max, no passing space

386' replacement

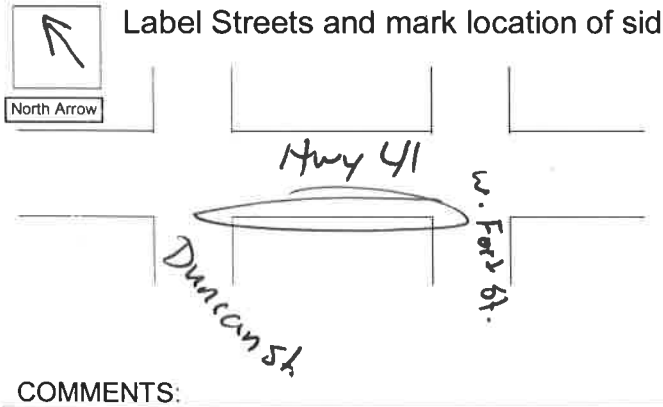
DEFICIENCY DESCRIPTION: No passing space, Mailbox protruding, manhole buckled up, excessive cross-slope at drives, spalling at one section

407' replacement

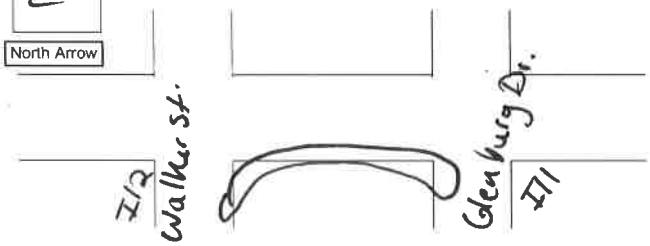
DEFICIENCY DESCRIPTION: No passing space, minor cracking, excessive cross-slope at driveways

157' replacement

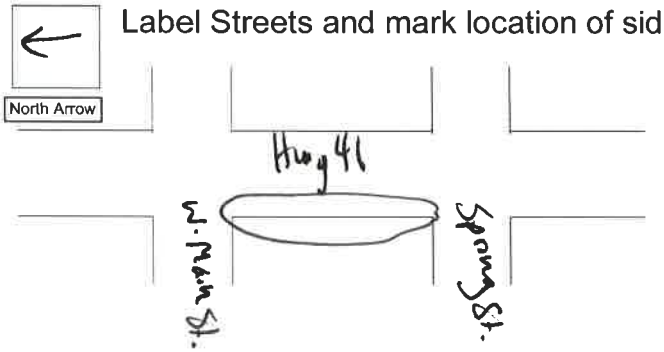
TYPE OF DEFECT	YES	NO
> 1/4" Lip	✓	
Buckled Up		✓
Depressed Down	✓	
Excessive Cracking	✓	
Excessive Spalling	✓	
Joint Separation (>1/2")		✓
Grates (>1/2")		✓
Drainage Problem		✓

DEFICIENCY DESCRIPTION: cross-slope exceeds 2% Max

350' replacement

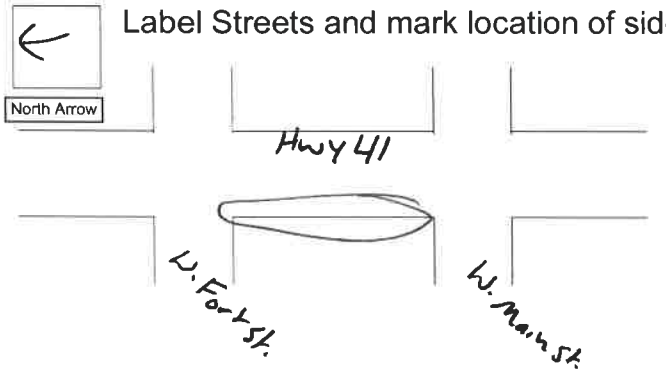
TYPE OF DEFECT	YES	NO
> 1/4" Lip	✓	
Buckled Up		✓
Depressed Down		✓
Excessive Cracking		✓
Excessive Spalling		✓
Joint Separation (>1/2")	✓	
Grates (>1/2")		✓
Drainage Problem		✓

26' replacement

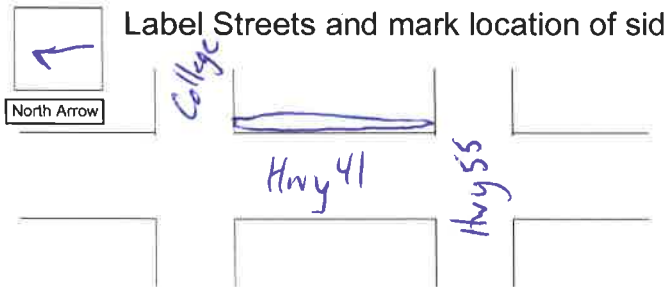
TYPE OF DEFECT	YES	NO
> 1/4" Lip	✓	
Buckled Up		✓
Depressed Down		✓
Excessive Cracking	✓	
Excessive Spalling		✓
Joint Separation (>1/2")		✓
Grates (>1/2")		✓
Drainage Problem		✓

47' replacement

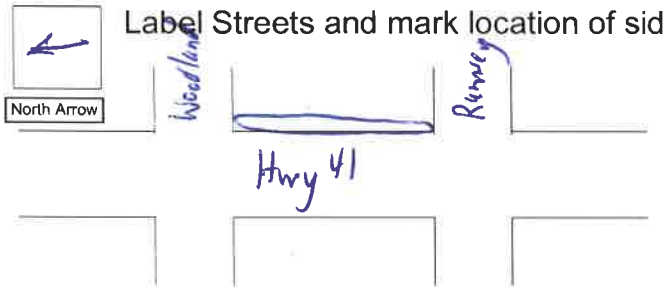
COMMENTS: @ Water meter is in sidewalk at strip mall - hole cut out and missing

TYPE OF DEFECT	YES	NO
> 1/4" Lip	✓	
Buckled Up	✓	
Depressed Down	✓	
Excessive Cracking	✓	
Excessive Spalling	✓	
Joint Separation (>1/2")	✓	
Grates (>1/2")		✓
Drainage Problem		✓

191' replacement + 160' bridge sidewalk replacement

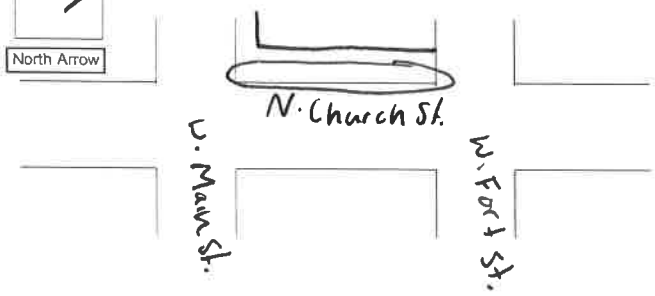
TYPE OF DEFECT	YES	NO
> 1/4" Lip		✓
Buckled Up		✓
Depressed Down		✓
Excessive Cracking		✓
Excessive Spalling		✓
Joint Separation (>1/2")		✓
Grates (>1/2")		✓
Drainage Problem		✓

DEFICIENCY DESCRIPTION: sidewalk end in grass, no curb ramp

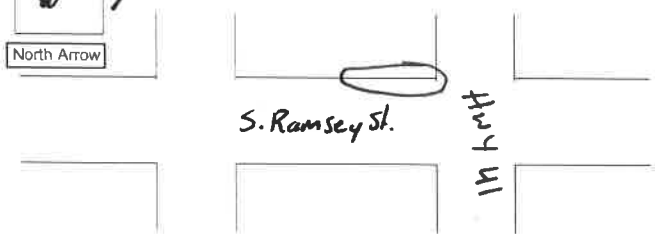
TYPE OF DEFECT	YES	NO
> 1/4" Lip		✓
Buckled Up		✓
Depressed Down		✓
Excessive Cracking		✓
Excessive Spalling		✓
Joint Separation (>1/2")		✓
Grates (>1/2")		✓
Drainage Problem		✓

DEFICIENCY DESCRIPTION: There is a 14% slope at old driveway section, minor cracking

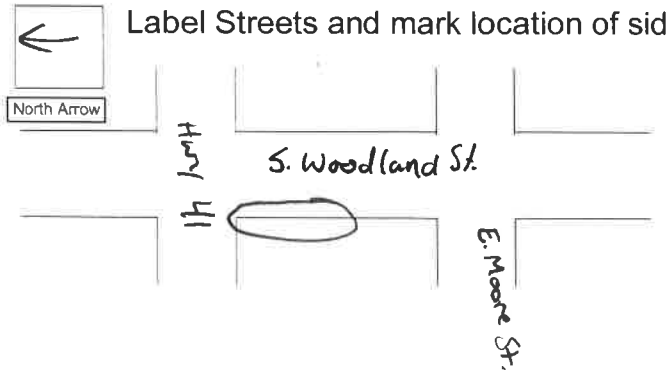
TYPE OF DEFECT	YES	NO
> 1/4" Lip		✓
Buckled Up		✓
Depressed Down		✓
Excessive Cracking		✓
Excessive Spalling		✓
Joint Separation (>1/2")		✓
Grates (>1/2")		✓
Drainage Problem		✓

DEFICIENCY DESCRIPTION: Sidewalk end at CCB drive through, no curb ramp at end. protruding shrubs ~ 1 foot into sidewalk

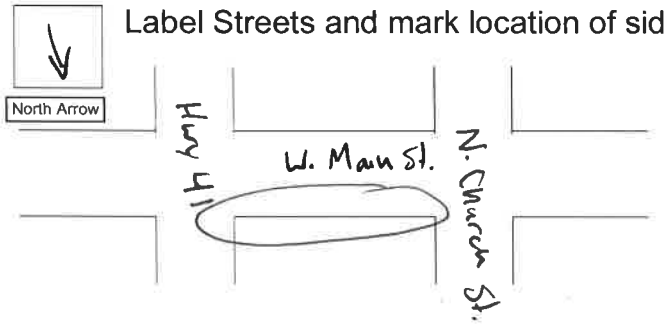
TYPE OF DEFECT	YES	NO
> 1/4" Lip		✓
Buckled Up		✓
Depressed Down		✓
Excessive Cracking		✓
Excessive Spalling		✓
Joint Separation (>1/2")		✓
Grates (>1/2")		✓
Drainage Problem		✓

DEFICIENCY DESCRIPTION: No passing spaces, slopes exceed maximums, sidewalk end at rear Church parking lot in grass, no curb ramp, depressed down in one small section, section of sidewalk missing at old backyard driveway leaving large lip.

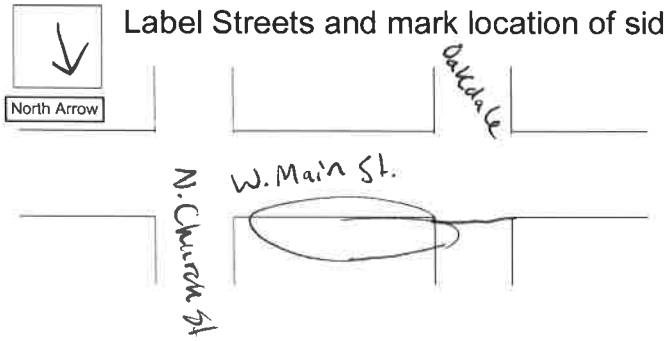
TYPE OF DEFECT	YES	NO
> 1/4" Lip	✓	
Buckled Up		✓
Depressed Down	✓	
Excessive Cracking		✓
Excessive Spalling		✓
Joint Separation (>1/2")		✓
Grates (>1/2")		✓
Drainage Problem		✓

DEFICIENCY DESCRIPTION: extreme buckling due to large trees/stumps, sidewalk end at N. Church St. in grass No curb ramp

20' replacement

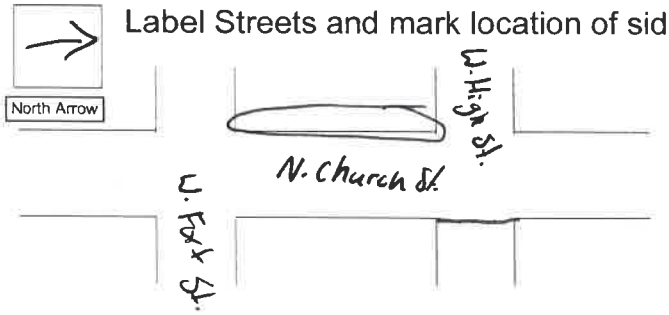
TYPE OF DEFECT	YES	NO
> 1/4" Lip	✓	
Buckled Up		✓
Depressed Down		✓
Excessive Cracking		✓
Excessive Spalling		✓
Joint Separation (>1/2")		✓
Grates (>1/2")		✓
Drainage Problem		✓

DEFICIENCY DESCRIPTION: 2 electric poles protruding ~ 1 foot into sidewalk, sidewalk covered with asphalt for drive of gas station leaving large lip

74' replacement

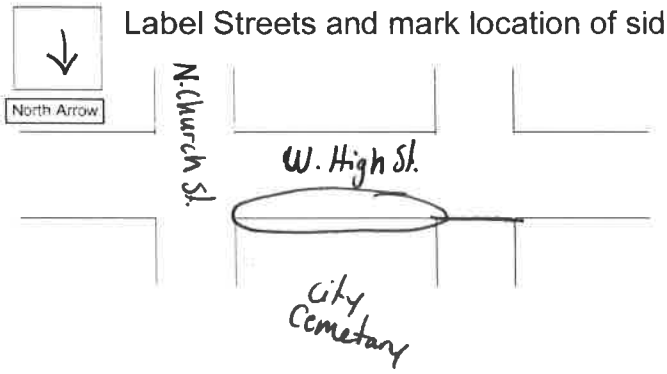
TYPE OF DEFECT	YES	NO
> 1/4" Lip	✓	
Buckled Up		✓
Depressed Down		✓
Excessive Cracking		✓
Excessive Spalling		✓
Joint Separation (>1/2")		✓
Grates (>1/2")		✓
Drainage Problem		✓

DEFICIENCY DESCRIPTION: No curb ramps at either end, sidewalk missing at driveways, overgrown shrubs protruding into sidewalk

78' replacement

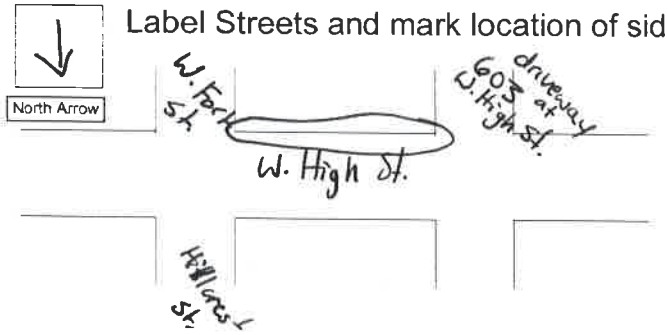
TYPE OF DEFECT	YES	NO
> 1/4" Lip	✓	
Buckled Up		✓
Depressed Down	✓	
Excessive Cracking	✓	
Excessive Spalling		✓
Joint Separation (>1/2")		✓
Grates (>1/2")		✓
Drainage Problem		✓

DEFICIENCY DESCRIPTION: No passing space, sidewalk missing/depressed at some driveways, no curb ramp at end (ends in grass), fire hydrant protruding ~1 ft into sidewalk at W. Fort end

110' replacement
