ADA Transition Plan and Self-Evaluation

City of
Manchester
Manchester, TN

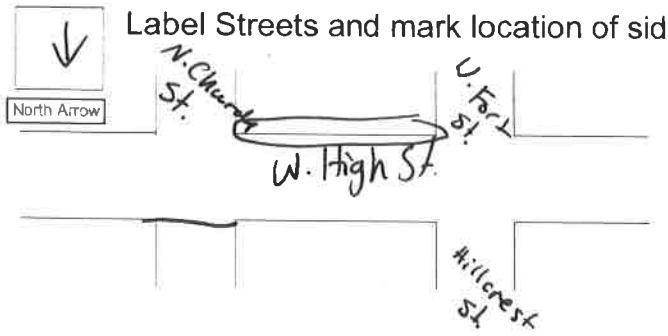
TYPE OF DEFECT	YES	NO
> 1/4" Lip	✓	
Buckled Up		✓
Depressed Down	✓	
Excessive Cracking	✓	
Excessive Spalling		✓
Joint Separation (>1/2")		✓
Grates (>1/2")		✓
Drainage Problem		✓

152' replacement

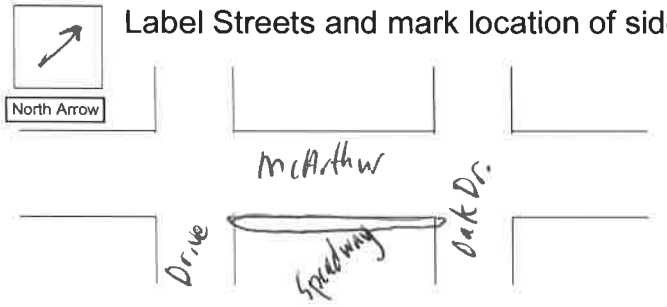
TYPE OF DEFECT	YES	NO
> 1/4" Lip		✓
Buckled Up		✓
Depressed Down		✓
Excessive Cracking		✓
Excessive Spalling		✓
Joint Separation (>1/2")		✓
Grates (>1/2")		✓
Drainage Problem		✓

DEFICIENCY DESCRIPTION: cross-slope exceeds 2% max, minor spalling

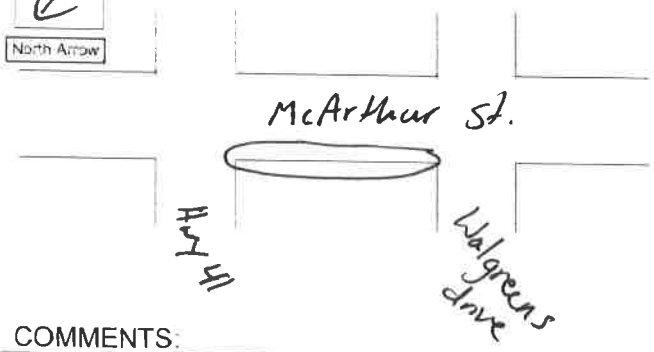
TYPE OF DEFECT	YES	NO
> 1/4" Lip		✓
Buckled Up		✓
Depressed Down		✓
Excessive Cracking		✓
Excessive Spalling		✓
Joint Separation (>1/2")		✓
Grates (>1/2")		✓
Drainage Problem		✓

DEFICIENCY DESCRIPTION: cross-slopes at drives exceed max.
Sidewalk covered with asphalt in some sections

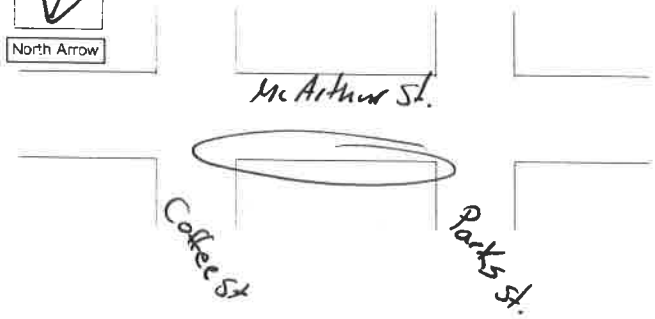
TYPE OF DEFECT	YES	NO
> 1/4" Lip	✓	
Buckled Up		✓
Depressed Down		✓
Excessive Cracking		✓
Excessive Spalling		✓
Joint Separation (>1/2")		✓
Grates (>1/2")		✓
Drainage Problem		✓

DEFICIENCY DESCRIPTION: minor cracking, cross-slopes at driveways exceed Max.

310' replacement

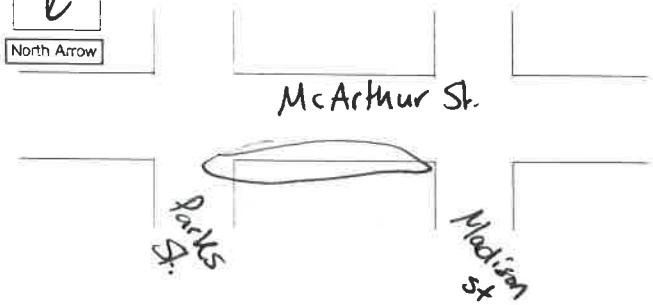
TYPE OF DEFECT	YES	NO
> 1/4" Lip	✓	
Buckled Up		✓
Depressed Down		✓
Excessive Cracking		✓
Excessive Spalling		✓
Joint Separation (>1/2")		✓
Grates (>1/2")		✓
Drainage Problem		✓

DEFICIENCY DESCRIPTION: buildup at section of sidewalk narrowing it to 3.5 ft.

227' replacement

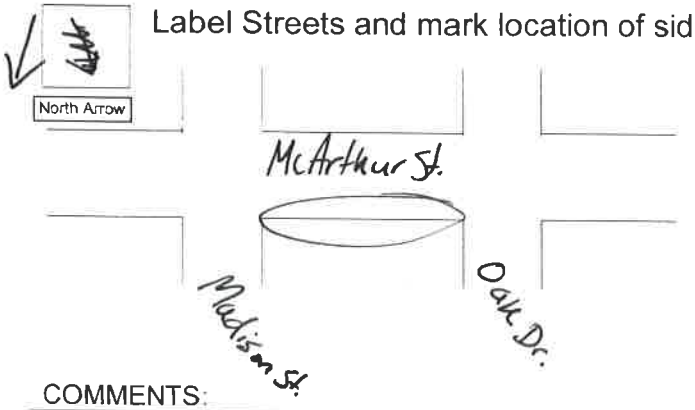
TYPE OF DEFECT	YES	NO
> 1/4" Lip	✓	
Buckled Up		✓
Depressed Down	✓	
Excessive Cracking	✓	
Excessive Spalling		✓
Joint Separation (>1/2")		✓
Grates (>1/2")		✓
Drainage Problem		✓

DEFICIENCY DESCRIPTION: cross-slope exceeds 2%

132' replacement

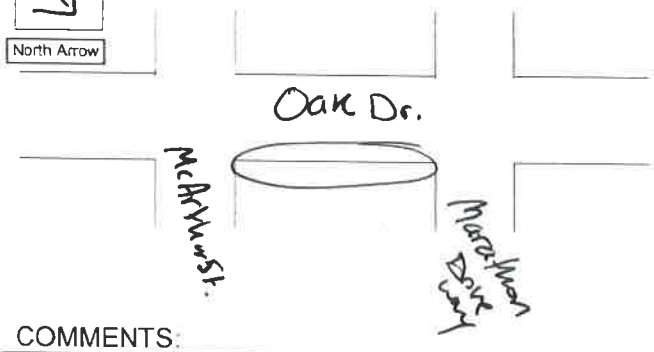
TYPE OF DEFECT	YES	NO
> 1/4" Lip	✓	
Buckled Up		✓
Depressed Down		✓
Excessive Cracking	✓	
Excessive Spalling	✓	
Joint Separation (>1/2")		✓
Grates (>1/2")		✓
Drainage Problem		✓

DEFICIENCY DESCRIPTION: cross-slope exceeds Max

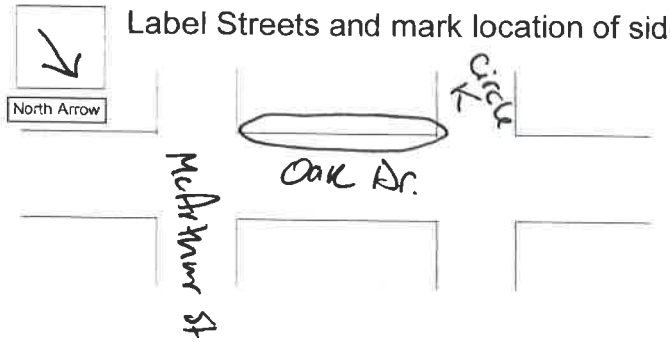
TYPE OF DEFECT	YES	NO
> 1/4" Lip	✓	
Buckled Up		✓
Depressed Down		✓
Excessive Cracking		✓
Excessive Spalling		✓
Joint Separation (>1/2")		✓
Grates (>1/2")		✓
Drainage Problem		✓

DEFICIENCY DESCRIPTION: buildup of sidewalk edge narrowing width to 4ft.

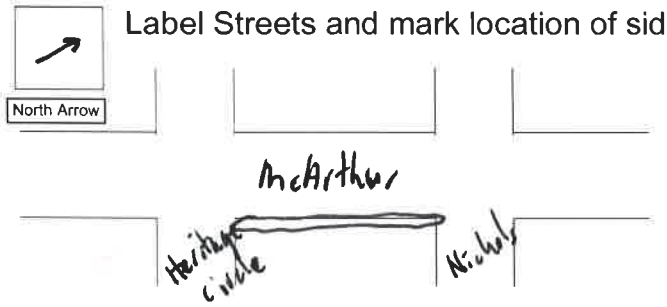
DEFICIENCY DESCRIPTION: MAX Cross-slope exceeded

307' Replacement

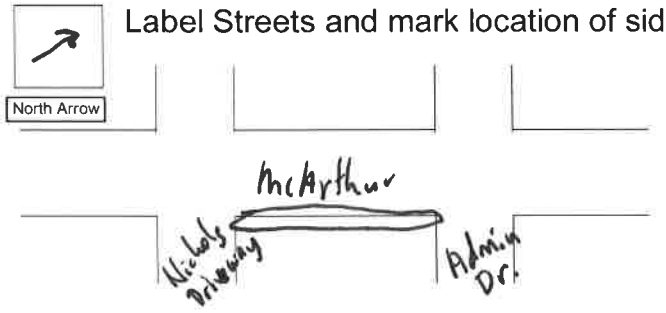
COMMENTS: Excellent work condition

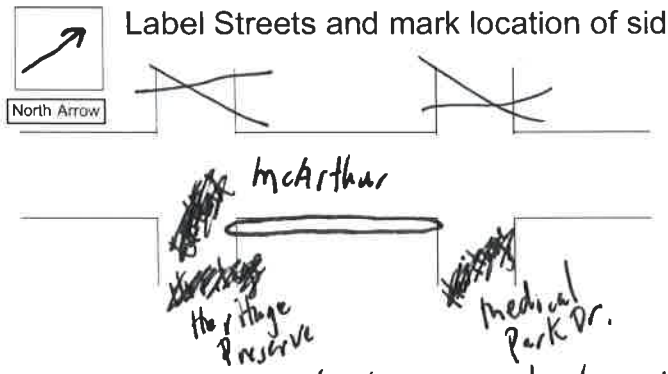
DEFICIENCY DESCRIPTION: Minor Spalling, Minor cracking, Cross-Slope exceeds max

335' Replacement

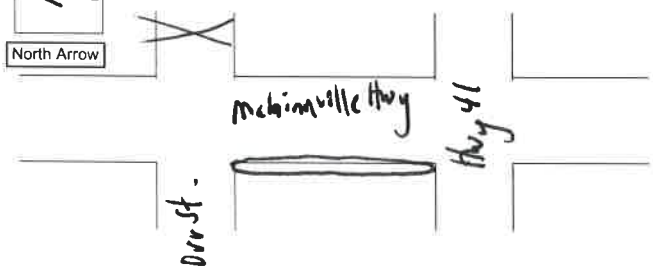
Excessive cracking in drive of Tadpoles building

DEFICIENCY DESCRIPTION: Sidewalk needs to be cleaned and edged

71' South Replacement 384' Bridge Sidewalk Replacement

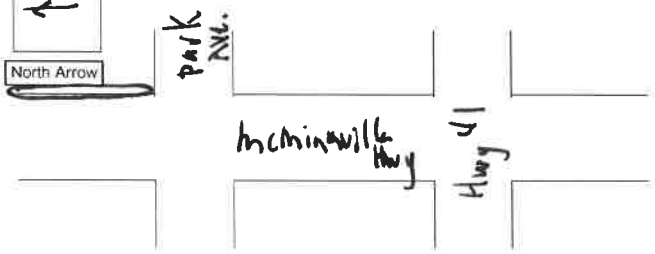
COMMENTS: Excessive cracking at south side of bridge

Excessive cracking and spalling on bridge

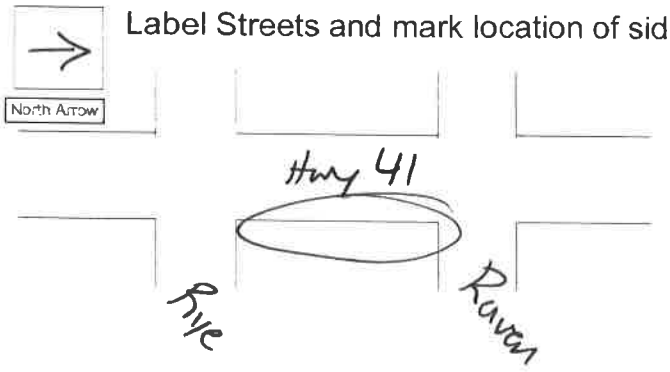
DEFICIENCY DESCRIPTION: Minor Cracking

50' Replacement

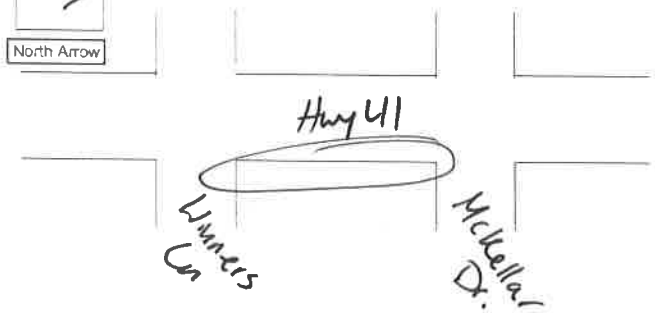
DEFICIENCY DESCRIPTION: excessive slopes at Rite Aid driveway
minor cracking

145' Replacement

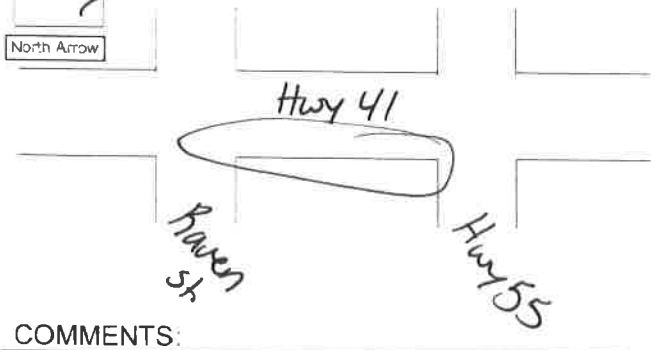
DEFICIENCY DESCRIPTION: 21.60% slopes at Fire Dept. driveway, water taps buckled up.

132' Replacement

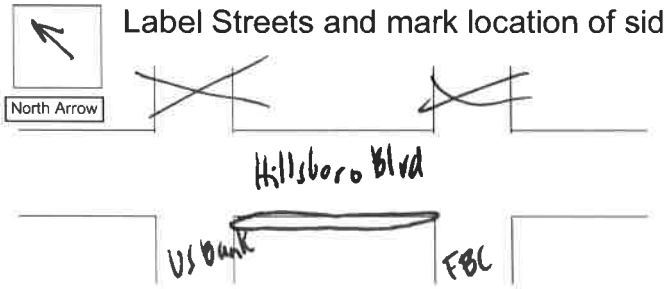
DEFICIENCY DESCRIPTION: protruding pole 2 ft.

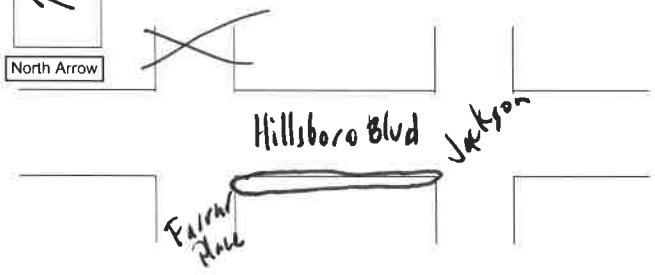
DEFICIENCY DESCRIPTION: Minor cracking

22' replacement

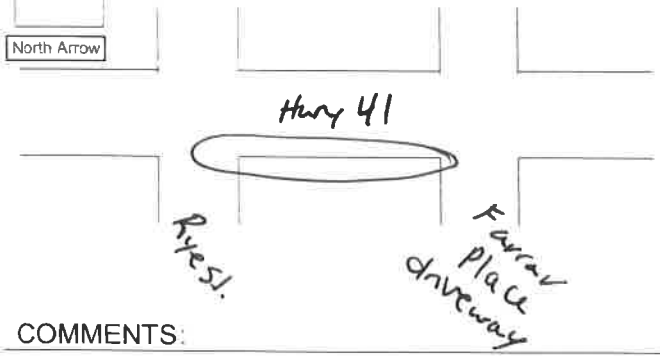
DEFICIENCY DESCRIPTION: electric pole at I3 protrudes 3.5 ft. into sidewalk
No crosswalk at Rye St.

78' replacement

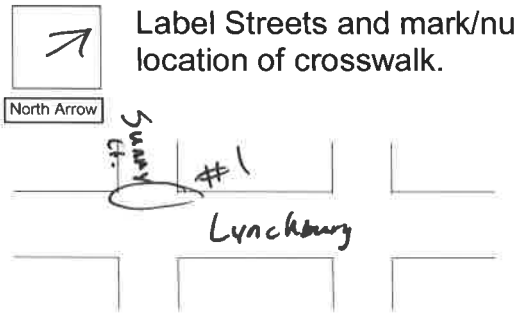
CROSSWALK #1

DEFICIENCY DESCRIPTION: No Crosswalk

Crosswalk Slope:	1.0	%
Cross-Slope:	1.7	%
Crosswalk Width:		FT
Crosswalk Length:	36	LF
Line Width		IN
Visibility:	Good / Poor

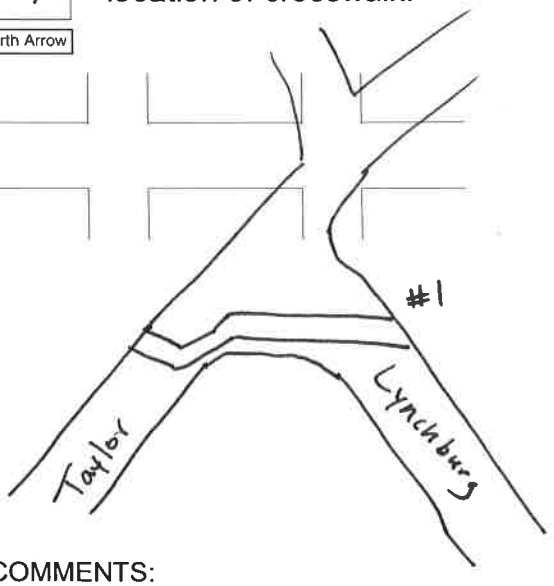
CROSSWALK #1

DEFICIENCY DESCRIPTION: Crosswalk width at Taylor St. 7ft.
width at Lynchburg 6.5 ft. at some point in middle width is 5.5f.

Crosswalk Slope:	5.2	%
Cross-Slope:	5.4	%
Crosswalk Width:	5-7	FT
Crosswalk Length:	107	LF
Line Width	4.5	IN
Visibility:	(Good) / Poor

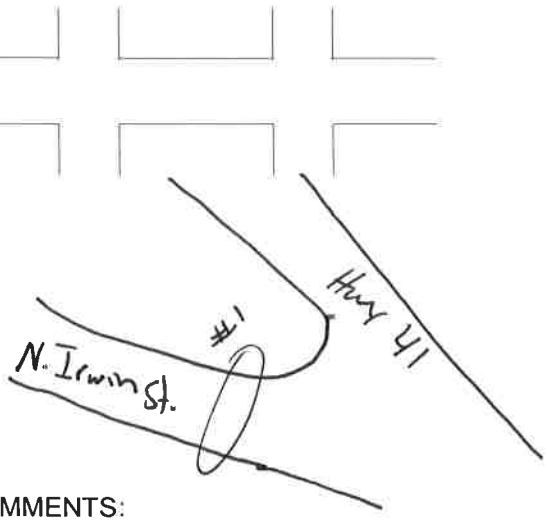
CROSSWALK #1

DEFICIENCY DESCRIPTION: Cross-slope exceeds 2% max @ yield control

Crosswalk Slope:	0.5	%
Cross-Slope:	5.9	%
Crosswalk Width:	10	FT
Crosswalk Length:	51	LF
Line Width	24	IN
Visibility:	(Good) / Poor

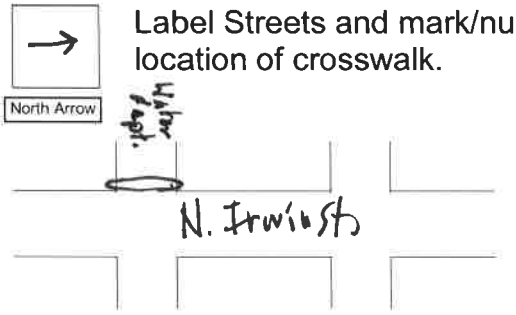
CROSSWALK #1

DEFICIENCY DESCRIPTION: No crosswalk

Crosswalk Slope:	0.2	%
Cross-Slope:	3.0	%
Crosswalk Width:	4	FT
Crosswalk Length:	16	LF
Line Width		IN
Visibility:	Good / Poor

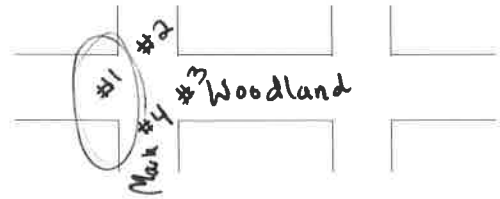
CROSSWALK #1 (2)

DEFICIENCY DESCRIPTION: #2, #3, #4 No Crosswalk

Crosswalk Slope:	%	2.6
Cross-Slope:	%	1.2
Crosswalk Width:	FT	
Crosswalk Length:	51 LF	
Line Width	IN	
Visibility:	Good / Poor

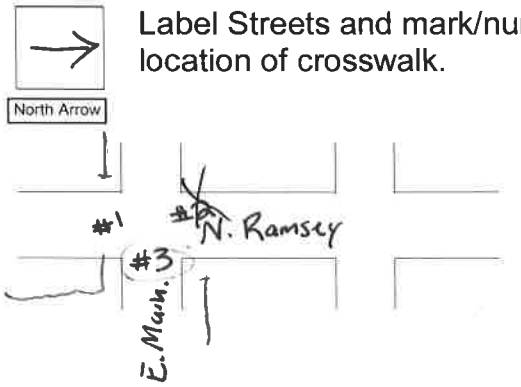
CROSSWALK #1

DEFICIENCY DESCRIPTION: No Crosswalks

Crosswalk Slope:	2.4	%
Cross-Slope:	3.8	%
Crosswalk Width:	✓	FT
Crosswalk Length:	31	LF
Line Width	✓	IN
Visibility:	Good / Poor

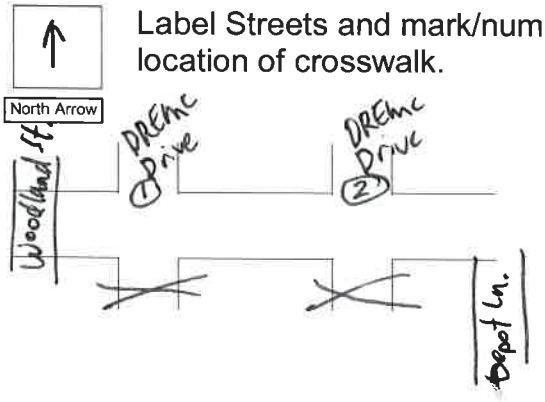
CROSSWALK #1

DEFICIENCY DESCRIPTION: No crosswalk at 2 DREMC Drives

Crosswalk Slope:	2.2	%
Cross-Slope:	1.3	%
Crosswalk Width:		FT
Crosswalk Length:	26	LF
Line Width		IN
Visibility:	Good / Poor

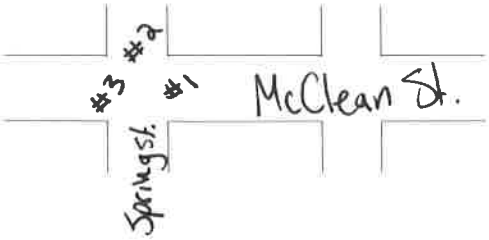
CROSSWALK #1

DEFICIENCY DESCRIPTION: #2 has drainage basin with > ½ holes

Crosswalk Slope:	4.4	%
Cross-Slope:	1.4	%
Crosswalk Width:	6	FT
Crosswalk Length:	71	LF
Line Width	8	IN
Visibility:	Good / ~~Poor~~

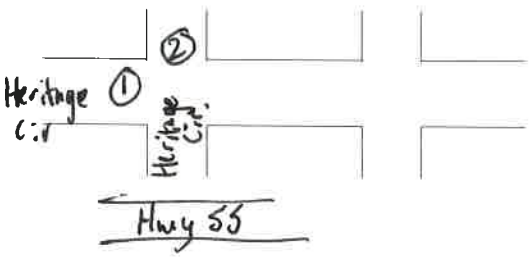
CROSSWALK #1

DEFICIENCY DESCRIPTION: No crosswalks between curb ramps
One curb ramp needs to be added

Crosswalk Slope:	_____	%
Cross-Slope:	_____	%
Crosswalk Width:	_____	FT
Crosswalk Length:	50	LF
Line Width	_____	IN
Visibility:	Good / Poor

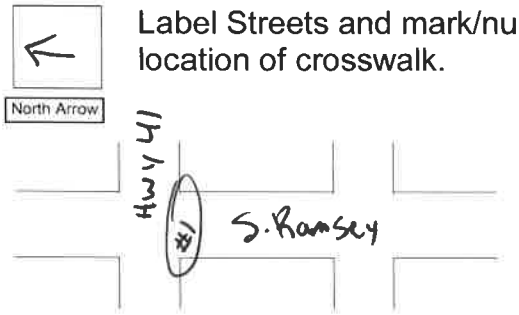
CROSSWALK #1

DEFICIENCY DESCRIPTION: No crosswalk

Crosswalk Slope:	2.4	%
Cross-Slope:	9.6	%
Crosswalk Width:		FT
Crosswalk Length:	79	LF
Line Width		IN
Visibility:	Good / Poor

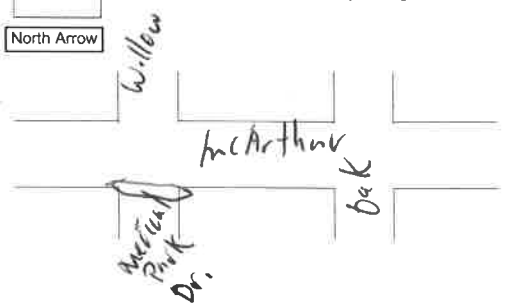
CROSSWALK #1

DEFICIENCY DESCRIPTION: No crosswalk

Crosswalk Slope:	1.4	%
Cross-Slope:	9.8	%
Crosswalk Width:		FT
Crosswalk Length:	40	LF
Line Width		IN
Visibility:	Good / Poor

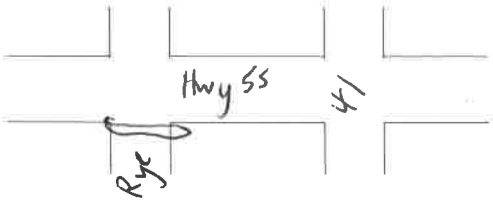
CROSSWALK #1

Crosswalk Slope:	1.0	%
Cross-Slope:	0.2	%
Crosswalk Width:	_____	FT
Crosswalk Length:	60	LF
Line Width	_____	IN
Visibility:	Good / Poor

DEFICIENCY DESCRIPTION: No crosswalks at two Speedway entrances

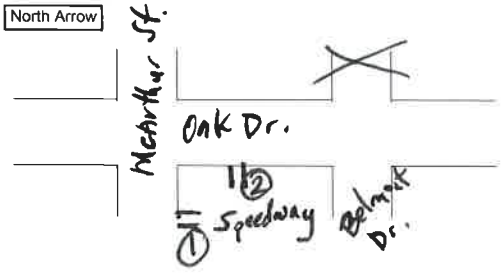
CROSSWALK #1

Crosswalk Slope:	_____	%
Cross-Slope:	_____	%
Crosswalk Width:	_____	FT
Crosswalk Length:	35	LF
Line Width	_____	IN
Visibility:	Good / Poor

DEFICIENCY DESCRIPTION: No crosswalk

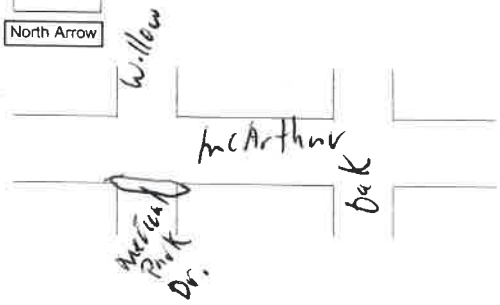
CROSSWALK #1

Crosswalk Slope:	1.4	%
Cross-Slope:	9.8	%
Crosswalk Width:		FT
Crosswalk Length:	40	LF
Line Width		IN
Visibility:	Good / Poor

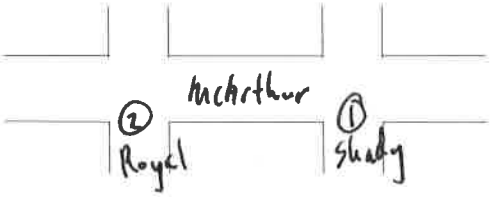
CROSSWALK #1

Crosswalk Slope:	1.6	%
Cross-Slope:	1.7	%
Crosswalk Width:		FT
Crosswalk Length:	66	LF
Line Width		IN
Visibility:	Good / Poor

DEFICIENCY DESCRIPTION: No crosswalks

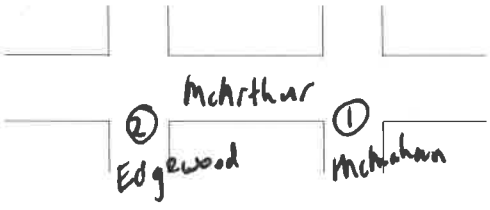
CROSSWALK #1

Crosswalk Slope:	0.5	%
Cross-Slope:	2.4	%
Crosswalk Width:		FT
Crosswalk Length:	65	LF
Line Width		IN
Visibility:	Good / Poor

DEFICIENCY DESCRIPTION: No crosswalks

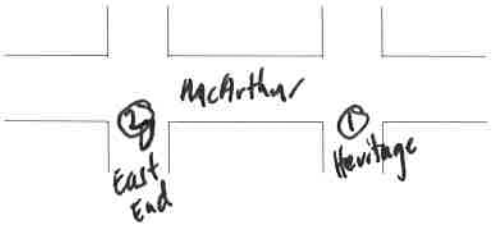
CROSSWALK #1

Crosswalk Slope:	1.2	%
Cross-Slope:	1.0	%
Crosswalk Width:		FT
Crosswalk Length:	63	LF
Line Width		IN
Visibility:	Good / Poor

DEFICIENCY DESCRIPTION: No crosswalk

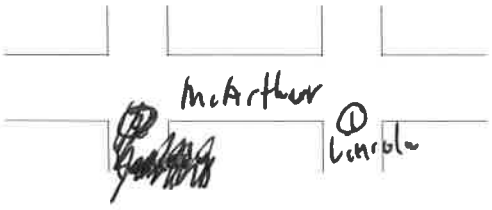
CROSSWALK #1

Crosswalk Slope:	1.0	%
Cross-Slope:	3.0	%
Crosswalk Width:	_____	FT
Crosswalk Length:	68	LF
Line Width	_____	IN
Visibility:	Good / Poor

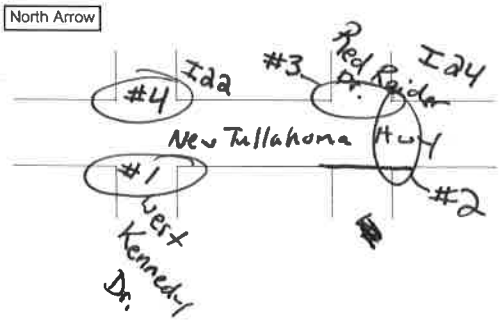
CROSSWALK #1

No Crosswalk

DEFICIENCY DESCRIPTION: No Crosswalk

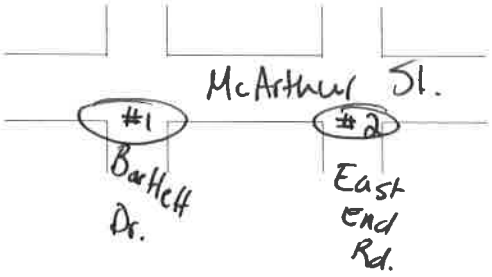
CROSSWALK #1

Crosswalk Slope:	0.9	%
Cross-Slope:	1.4	%
Crosswalk Width:		FT
Crosswalk Length:	60	LF
Line Width		IN
Visibility:	Good / (Poor)

DEFICIENCY DESCRIPTION: No crosswalk at either entrance of the Administrative Plaza

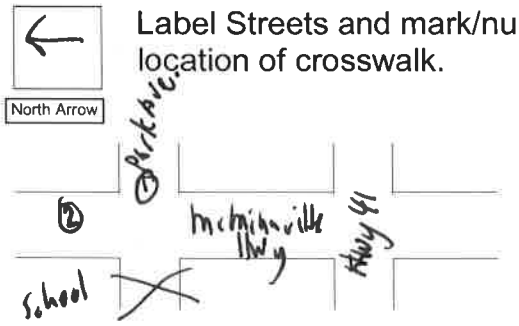
CROSSWALK #1

Crosswalk Slope:	0.6	%
Cross-Slope:	3.3	%
Crosswalk Width:		FT
Crosswalk Length:	30	LF
Line Width		IN
Visibility:	Good / Poor

Crosswalk #1 is missing

DEFICIENCY DESCRIPTION: No crosswalks
Stop bars may be too close; maybe for sight distance

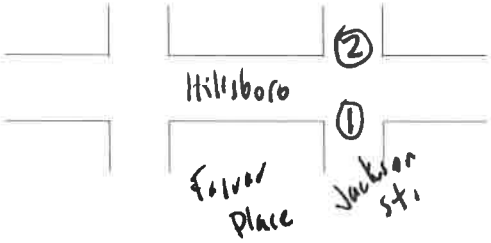
CROSSWALK #1

Crosswalk Slope:	0.2	%
Cross-Slope:	2.0	%
Crosswalk Width:		FT
Crosswalk Length:	54	LF
Line Width		IN
Visibility:	Good / Poor

DEFICIENCY DESCRIPTION: No Crosswalks

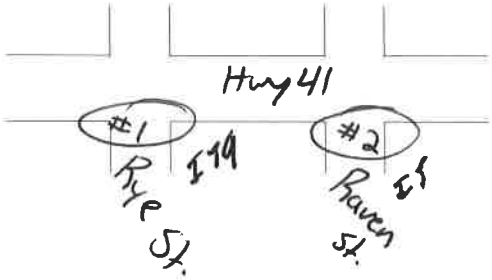
CROSSWALK #1

Crosswalk Slope:	1.7 %
Cross-Slope:	1.6 %
Crosswalk Width:	_____ FT
Crosswalk Length:	101 LF
Line Width	_____ IN
Visibility:	Good / Poor

DEFICIENCY DESCRIPTION: No Crosswalks

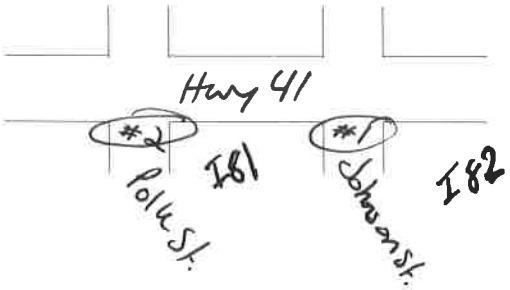
CROSSWALK #1

Crosswalk Slope:	0.5	%
Cross-Slope:	1.6	%
Crosswalk Width:		FT
Crosswalk Length:	46	LF
Line Width		IN
Visibility:	Good / ~~Poor~~

DEFICIENCY DESCRIPTION: No Crosswalk

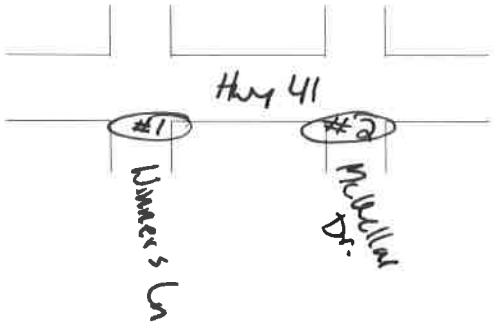
CROSSWALK #1

No Crosswalk

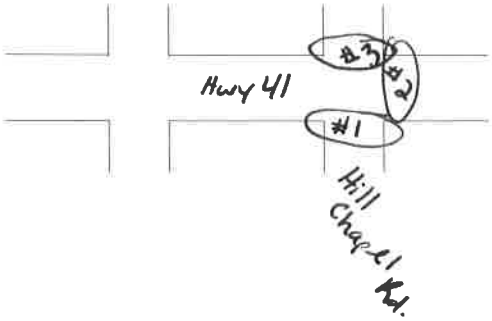
CROSSWALK #1

Crosswalk Slope:	1.4	%
Cross-Slope:	0.5	%
Crosswalk Width:	8	FT
Crosswalk Length:	117	LF
Line Width	8	IN
Visibility:	(Good) / Poor

DEFICIENCY DESCRIPTION: No Crosswalk

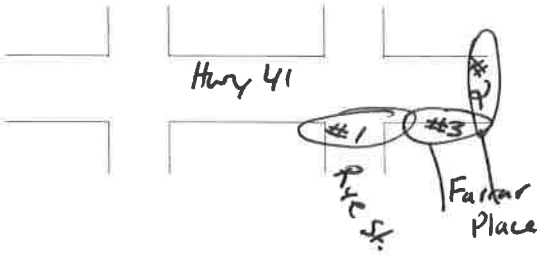
CROSSWALK #1

No Crosswalk

DEFICIENCY DESCRIPTION: No Crosswalk

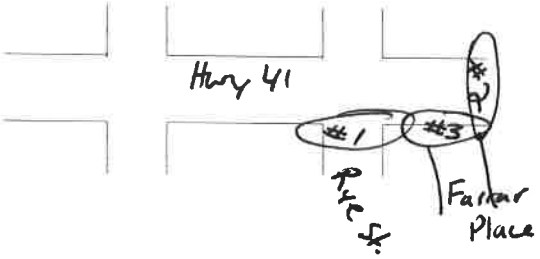
No Crosswalk
CROSSWALK #1

Crosswalk Slope:	0	%
Cross-Slope:	4.9	%
Crosswalk Width:	[illegible]	FT
Crosswalk Length:	43	LF
Line Width	_____	IN
Visibility:	Good / Poor
