ADA Transition Plan and Self-Evaluation

City of
Manchester
Manchester, TN

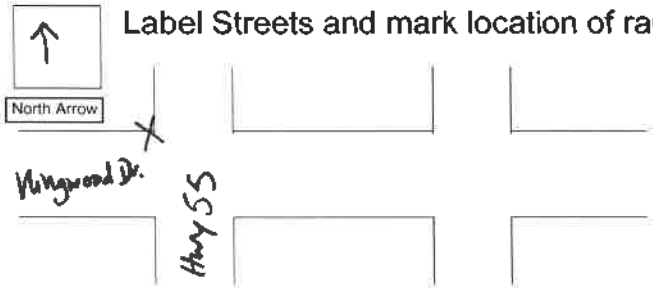
No Domes

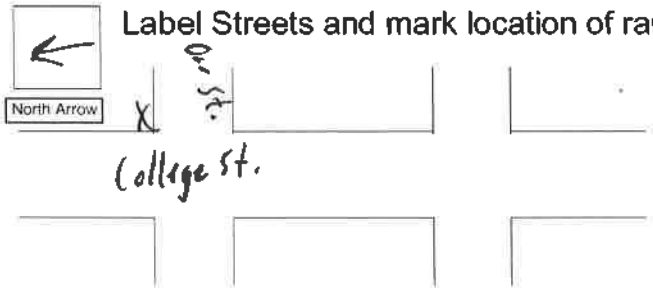
No curb ramp sidewalk dead ends

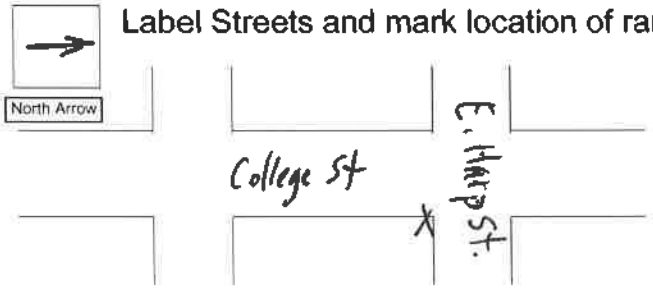
Sidewalk dead ends into pavement of College St. without a proper landing and no domes

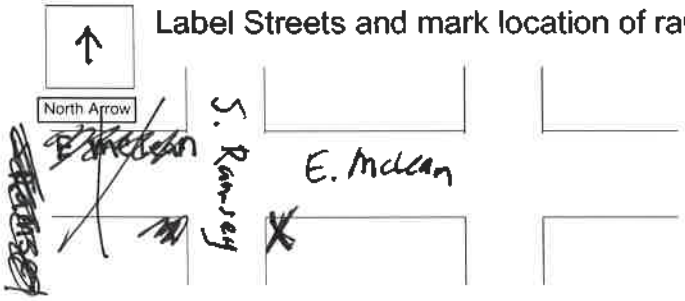
No detectable warnings

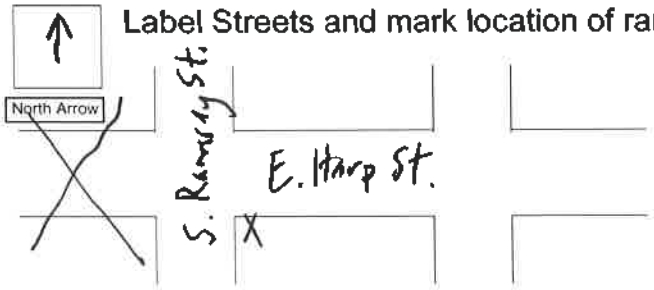
Chunk out of ramp for water valve box
only 3" into ramp
No domes

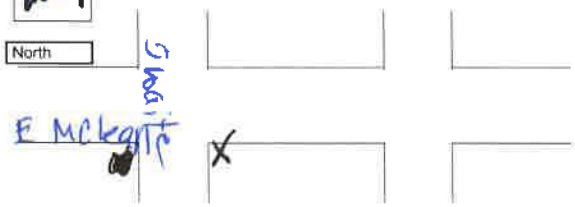
No curb Ramp

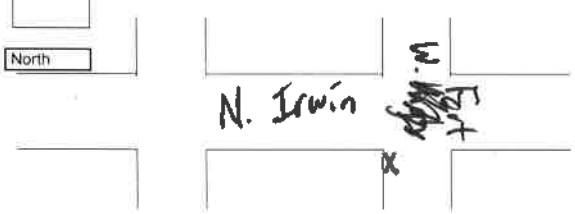
Detectable domes are red ; Not enough room between flare and edge of sidewalk coming in front of City Hall for accessibility

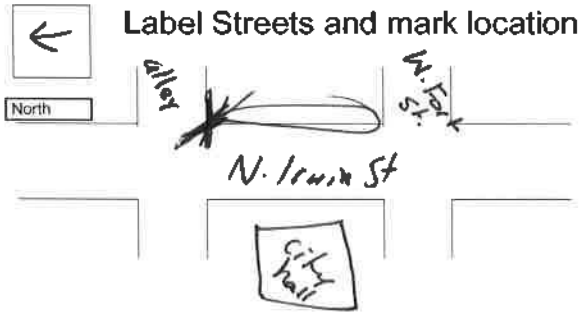
domes are red

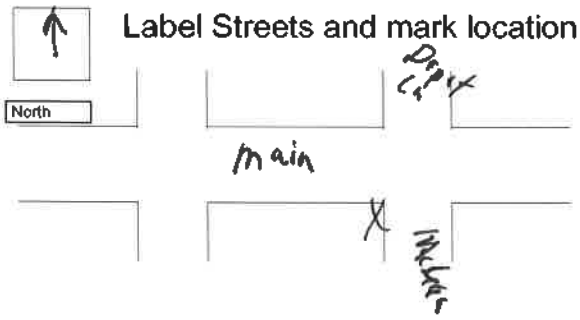
Excessive cracking in both landing and ramp

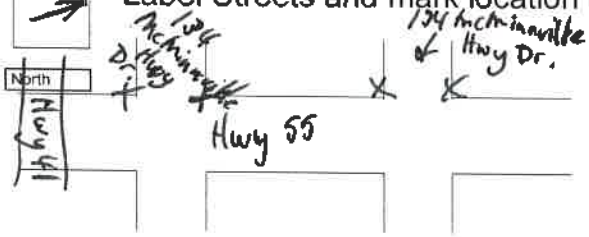
No curb ramps at old daycare facility - 8 in. steps
4 total ramps

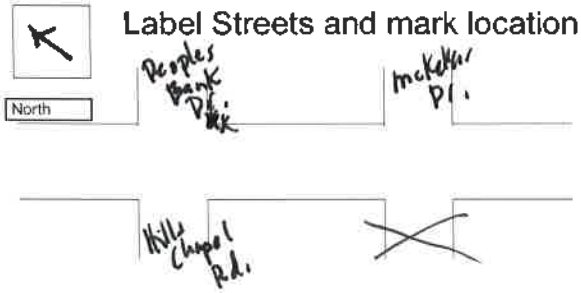
Need detectable domes for other side

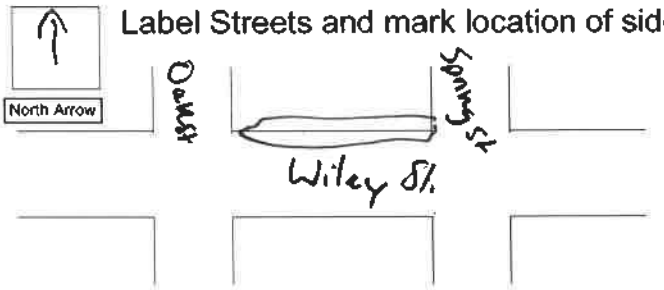
RE-INSPECTION DATE: _____ **CONFORMS TO STANDARD:** ☐ Yes ☑ No ***(If no, explain in comments)***

59' replacement

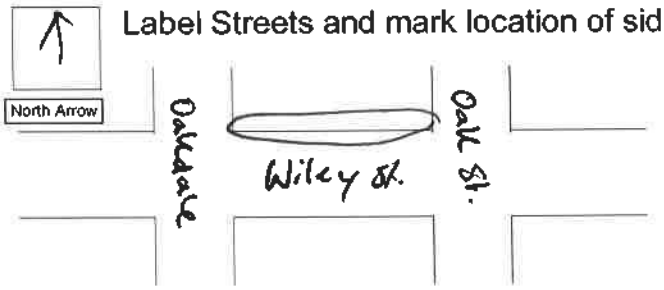
RE-INSPECTION DATE: _____ **CONFORMS TO STANDARD:** ☐ Yes ☑ No ***(If no, explain in comments)***

140' replacement

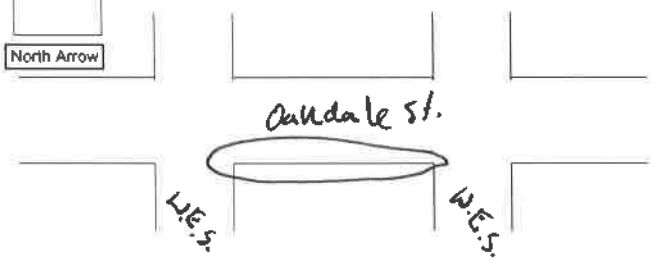
RE-INSPECTION DATE: _____ **CONFORMS TO STANDARD:** ☐ Yes ☑ No ***(If no, explain in comments)***

10' replacement

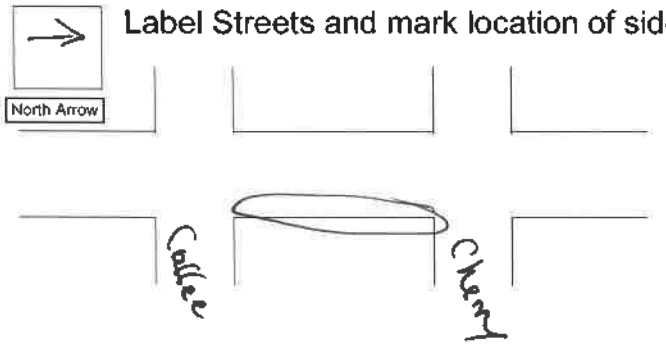
RE-INSPECTION DATE: _____ **CONFORMS TO STANDARD:** ☐ Yes ☑ No ***(If no, explain in comments)***

40' Replacement

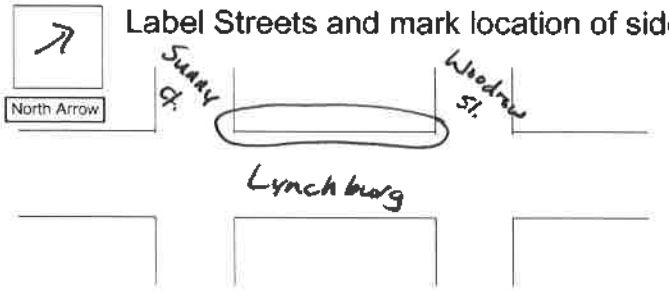
RE-INSPECTION DATE: _____ **CONFORMS TO STANDARD:** ☐ Yes ☑ No (***If no, explain in comments***)

92' replacement

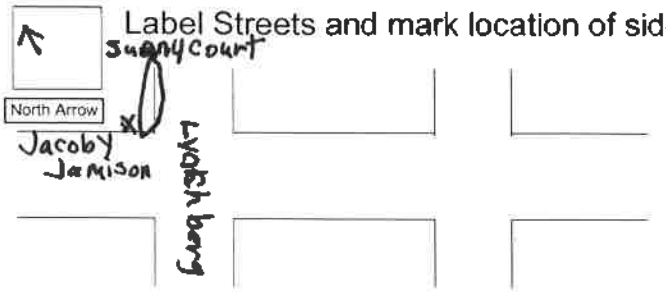
RE-INSPECTION DATE: _____ **CONFORMS TO STANDARD:** ☐ Yes ☑ No (***If no, explain in comments***)

10' replacement

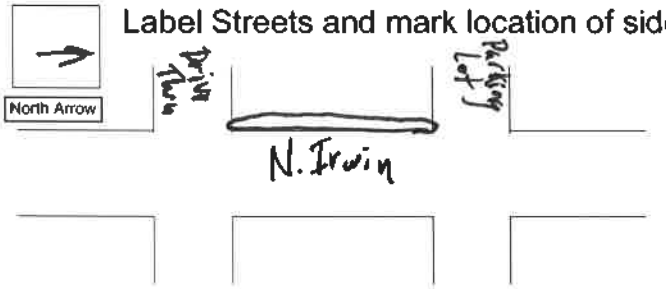
RE-INSPECTION DATE: _____ **CONFORMS TO STANDARD:** ☐ Yes ☑ No (***If no, explain in comments***)

100' replacement low priority

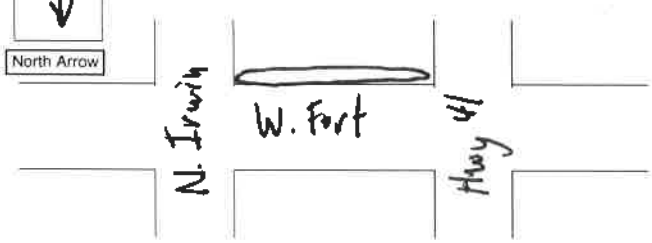
RE-INSPECTION DATE: _____ **CONFORMS TO STANDARD:** ☐ Yes ☑ No (***If no, explain in comments***)

20' replacement

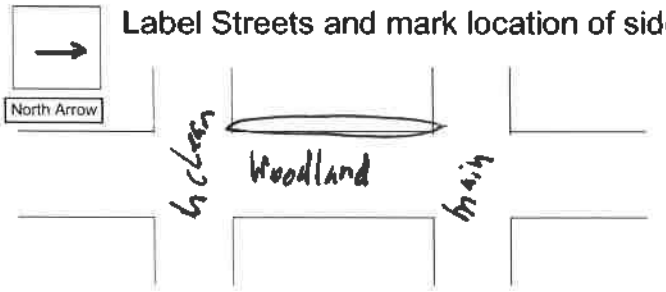
DEFICIENCY DESCRIPTION: No Curb ramps at drive of Main St. Church of Christ

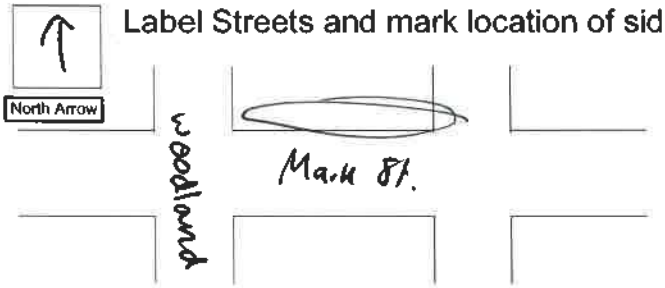
214' replacement

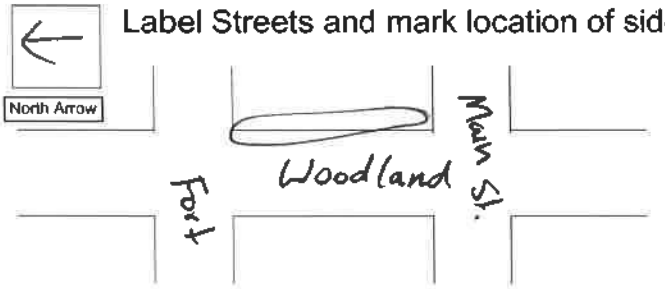
RE-INSPECTION DATE: _____ **CONFORMS TO STANDARD:** ☐ Yes ☑ No ***(If no, explain in comments)***

19' replacement

DEFICIENCY DESCRIPTION: sidewalk not connected fully

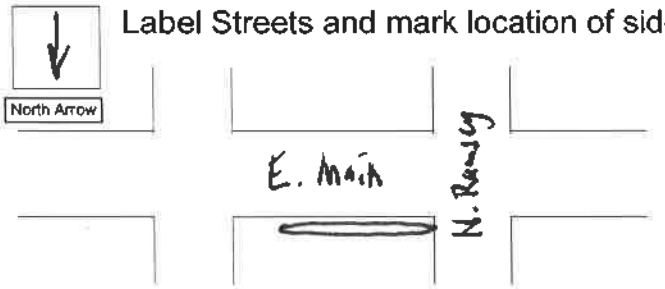
RE-INSPECTION DATE: _____ **CONFORMS TO STANDARD:** ☐ Yes ☑ No ***(If no, explain in comments)***

153' Replacement

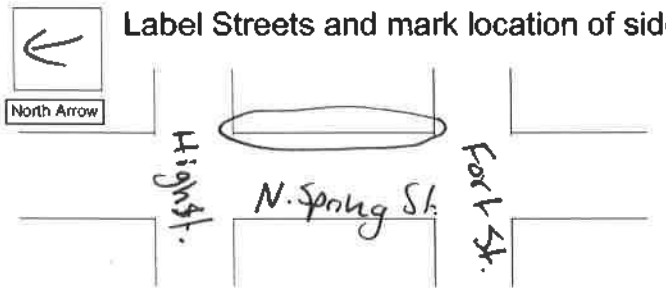
72' replacement

TYPE OF DEFECT	YES	NO
> 1/4" Lip	✓	
Buckled Up		✓
Depressed Down		✓
Excessive Cracking		✓
Excessive Spalling	✓	
Joint Separation (>1/2")		✓
Grates (>1/2")		✓
Drainage Problem		✓

DEFICIENCY DESCRIPTION: guard railing needed 4ft drop to road from sidewalk. Steps at each ~~end~~ end with no railing

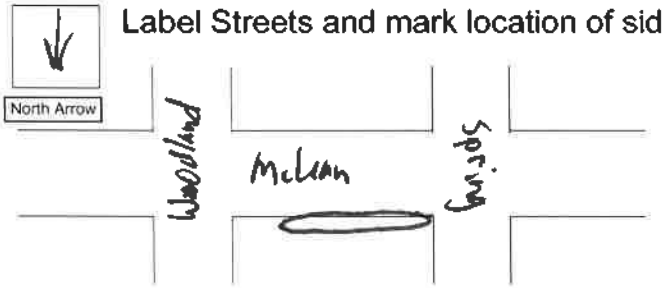
26' Replacement

TYPE OF DEFECT	YES	NO
> 1/4" Lip		✓
Buckled Up		✓
Depressed Down		✓
Excessive Cracking		✓
Excessive Spalling		✓
Joint Separation (>1/2")		✓
Grates (>1/2")		✓
Drainage Problem		✓

DEFICIENCY DESCRIPTION: Drain on South side of subdivision crosses sidewalk leaving extreme bump

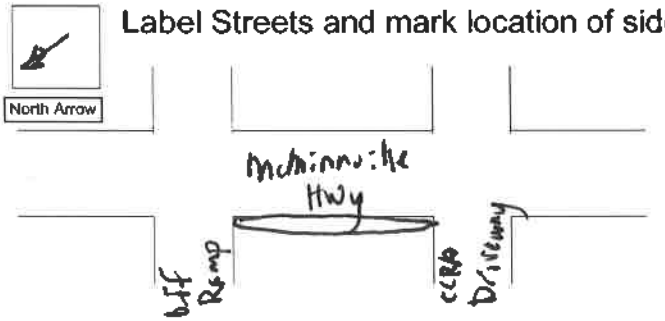
TYPE OF DEFECT	YES	NO
> 1/4" Lip		✓
Buckled Up		✓
Depressed Down		✓
Excessive Cracking		✓
Excessive Spalling		✓
Joint Separation (>1/2")		✓
Grates (>1/2")		✓
Drainage Problem		✓

DEFICIENCY DESCRIPTION: Crossslopes at business drives exceed 2% max

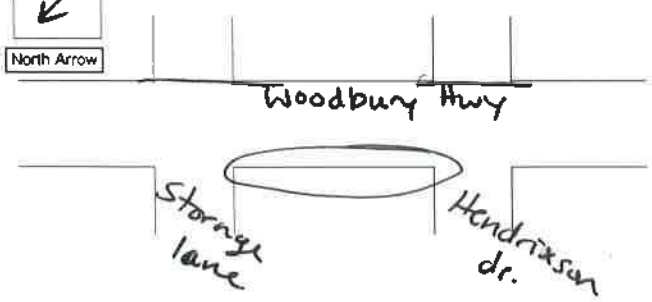
~60' replacement

TYPE OF DEFECT	YES	NO
> 1/4" Lip	✓	
Buckled Up	✓	
Depressed Down	✓	
Excessive Cracking	✓	
Excessive Spalling	✓	
Joint Separation (>1/2")	✓	
Grates (>1/2")		✓
Drainage Problem		✓

DEFICIENCY DESCRIPTION: cross-slopes at drives exceeds 2% max, no curb ramp at end of sidewalk

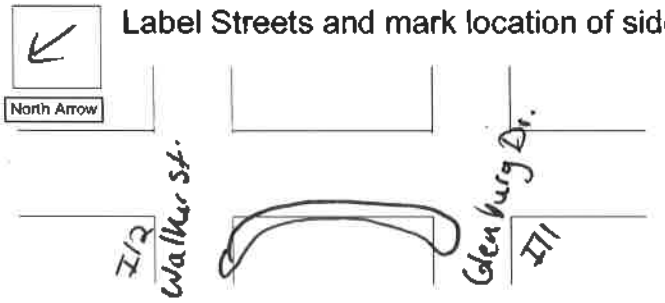
157' replacement

TYPE OF DEFECT	YES	NO
> 1/4" Lip	✓	
Buckled Up	✓	
Depressed Down		✓
Excessive Cracking		✓
Excessive Spalling	✓	
Joint Separation (>1/2")		✓
Grates (>1/2")		✓
Drainage Problem		✓

DEFICIENCY DESCRIPTION: No passing space, minor cracking, excessive cross-slope at driveways

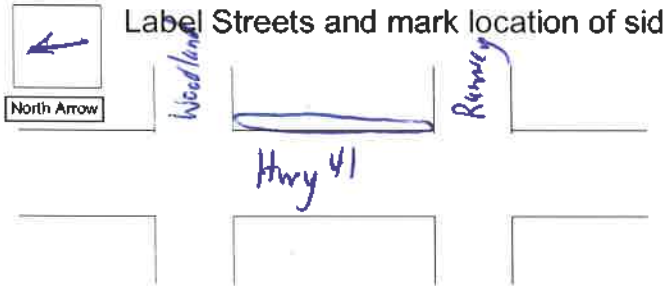
COMMENTS: Water meter is in sidewalk at strip mall - hole cut out and missing

191' replacement + 160' bridge sidewalk replacement

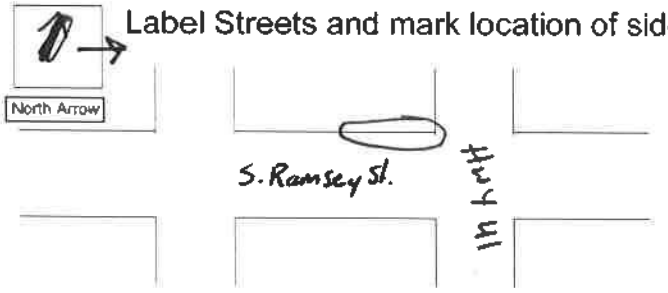
DEFICIENCY DESCRIPTION: There is a 14% slope at old driveway section, minor cracking

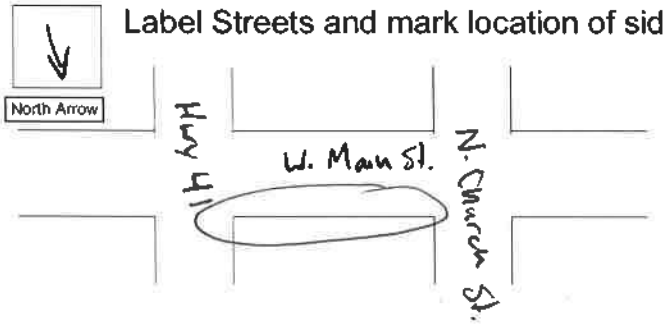
DEFICIENCY DESCRIPTION: No passing spaces, slopes exceed maximums, sidewalk end at rear church parking lot in grass, no curb ramp, depressed down in one small section, section of sidewalk missing at old backyard driveway leaving large lip.

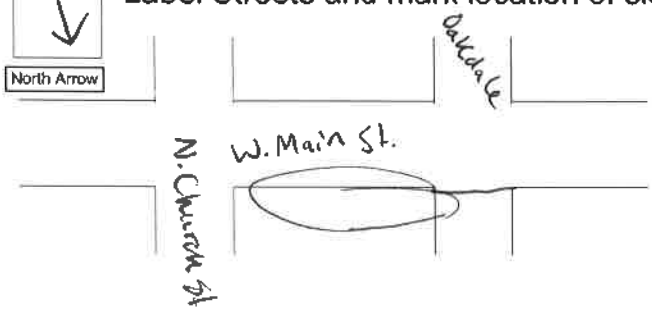
DEFICIENCY DESCRIPTION: extreme buckling due to large trees/stumps, sidewalk end at N. Curch St. in grass No curb ramp

20' replacement

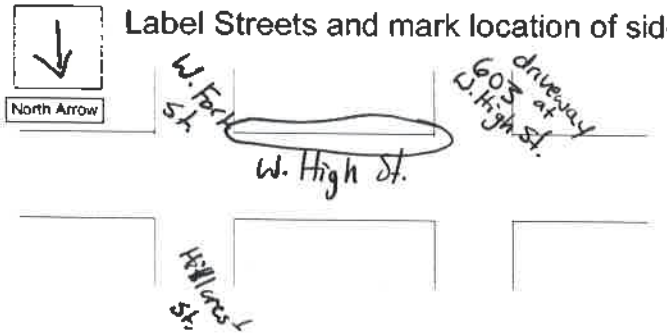
DEFICIENCY DESCRIPTION: No passing space, sidewalk missing/depressed at some driveways, no curb ramp at end (ends in grass), fire hydrant protruding ~1 ft into sidewalk at W. Fort end.

110' replacement

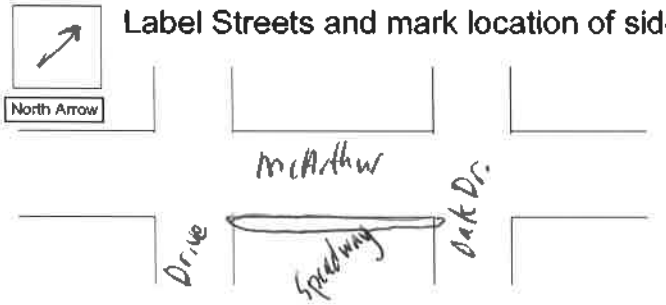
DEFICIENCY DESCRIPTION: cross-slope exceeds 2% max, minor spalling

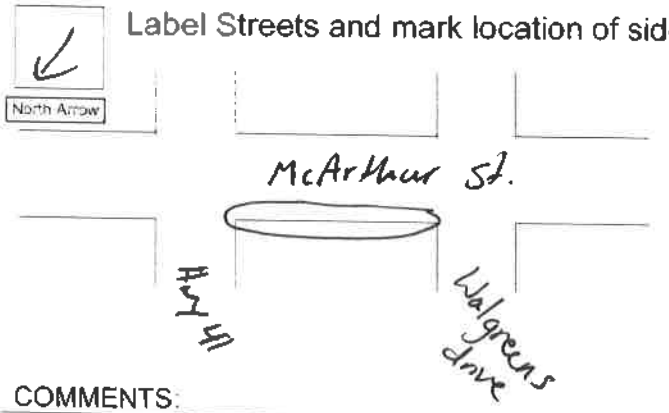
DEFICIENCY DESCRIPTION: cross-slopes at drives exceed max.
Sidewalk covered with asphalt in some sections

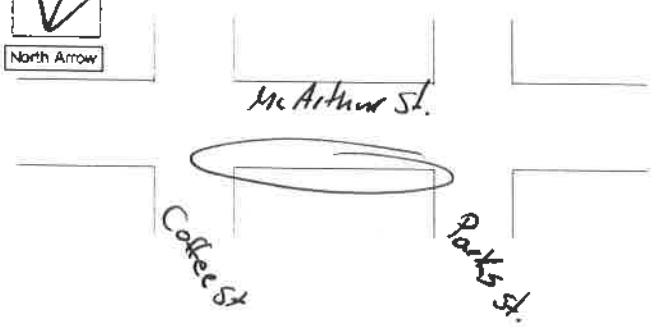
DEFICIENCY DESCRIPTION: minor cracking, cross-slopes at driveways exceed Max.

310' replacement

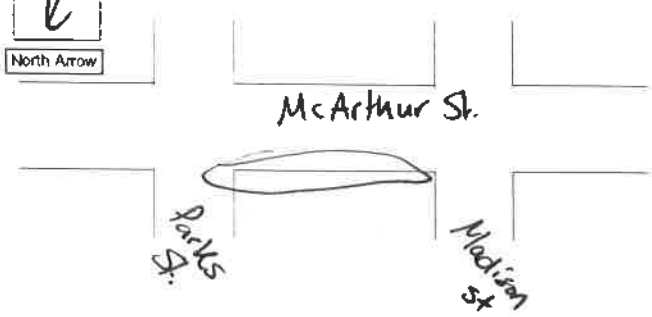
DEFICIENCY DESCRIPTION: buildup at section of sidewalk narrowing it to 3.5 ft.

227' replacement

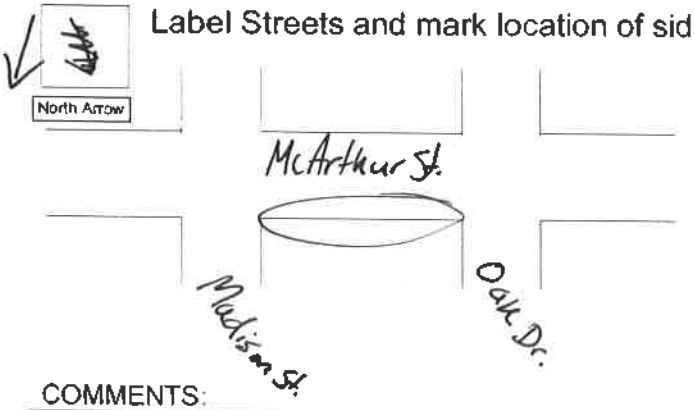
DEFICIENCY DESCRIPTION: cross-slope exceeds 2%

132' replacement

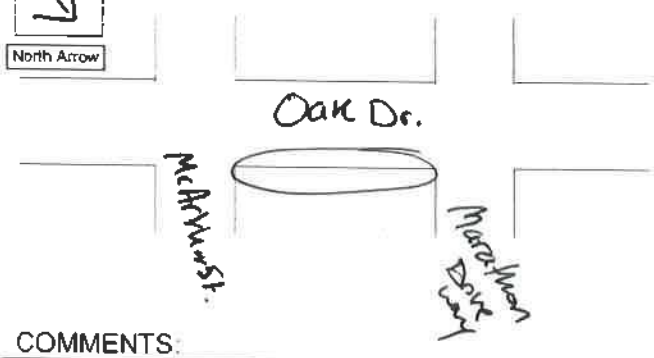
DEFICIENCY DESCRIPTION: cross-slope exceeds Max

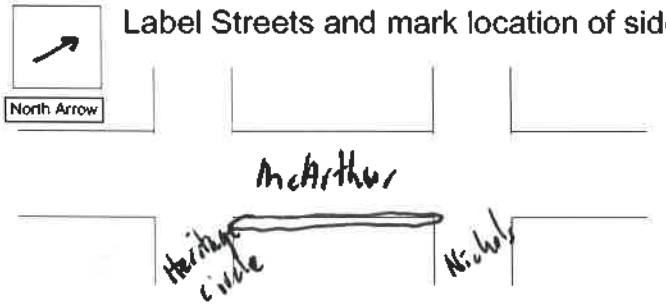
DEFICIENCY DESCRIPTION: Max Cross-slope exceeded

307' Replacement

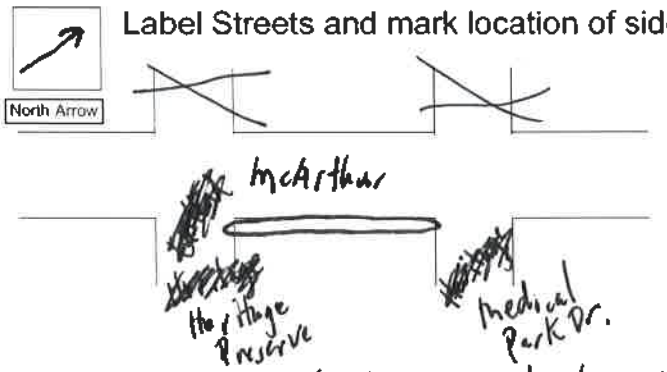
DEFICIENCY DESCRIPTION: Minor Spalling, Minor cracking, Cross-slope exceeds max

335' Replacement

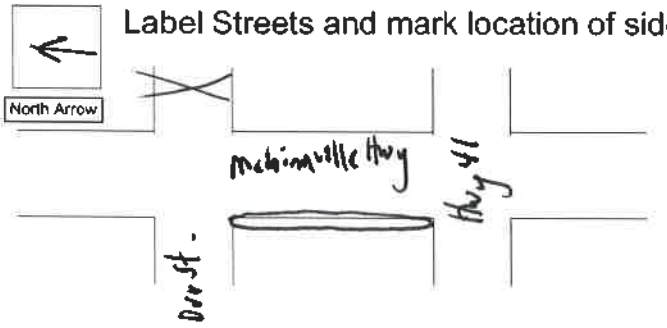
Excessive cracking in drive of Tadpoles building

DEFICIENCY DESCRIPTION: Sidewalk needs to be cleaned and edged

71' South Replacement 384' Bridge Sidewalk Replacement

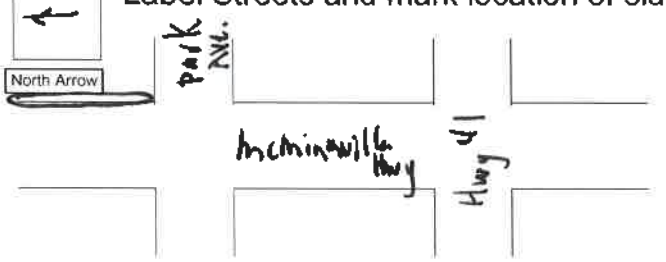
COMMENTS: Excessive cracking at south side of bridge

Excessive cracking and spalling on bridge

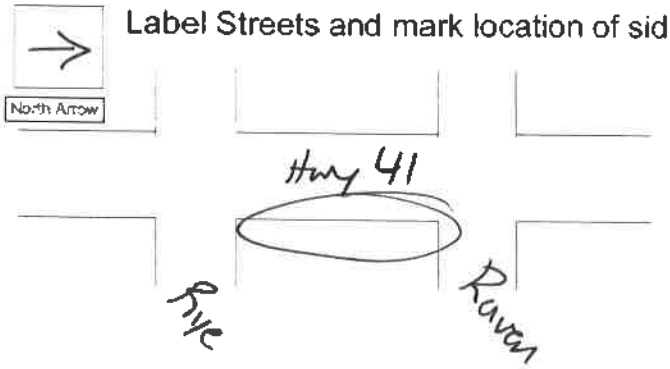
DEFICIENCY DESCRIPTION: Minor Cracking

50' Replacement

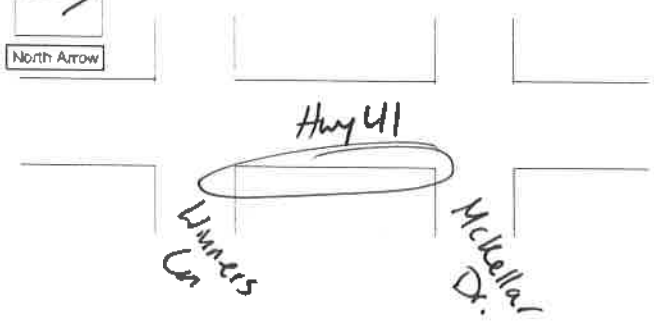
DEFICIENCY DESCRIPTION: excessive slopes at Rite Aid driveway
minor cracking

145' Replacement

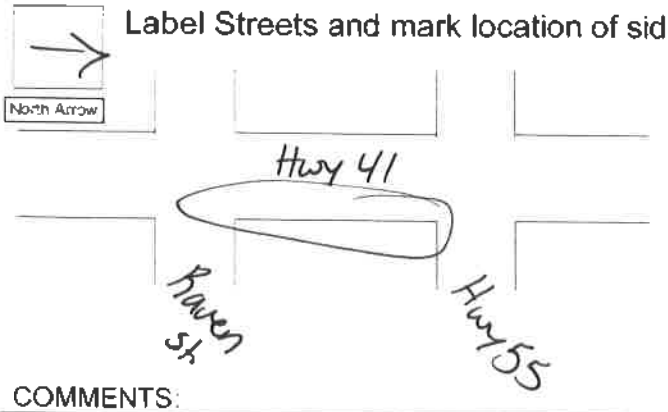
DEFICIENCY DESCRIPTION: 21.6% slopes at Fire Dept. driveway, water taps buckled up.

132' Replacement

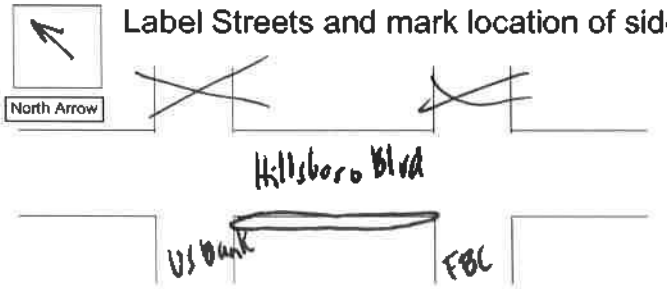
DEFICIENCY DESCRIPTION: protruding pole 2 ft.

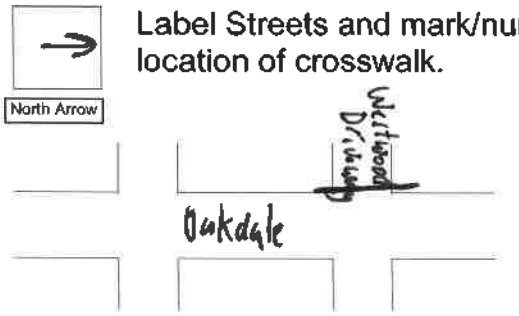
DEFICIENCY DESCRIPTION: No crosswalk

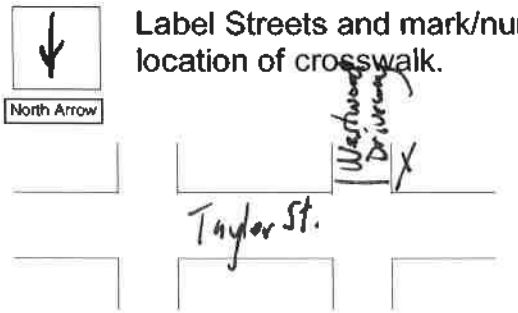
COMMENTS: Inadequate width

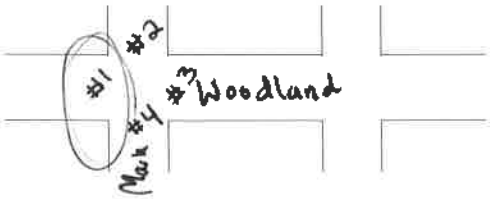
DEFICIENCY DESCRIPTION: #2, #3, #4 No Crosswalk

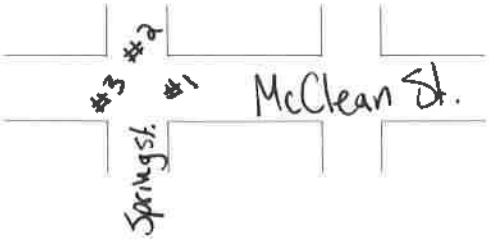
DEFICIENCY DESCRIPTION: #2 has drainage basin with > ½ holes

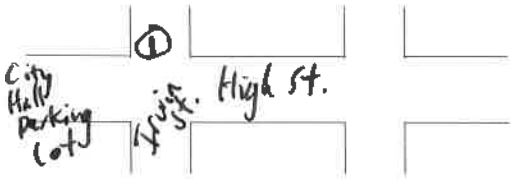
DEFICIENCY DESCRIPTION: No crosswalk
Curb ramp will need to be installed on
west side of Irwin St.

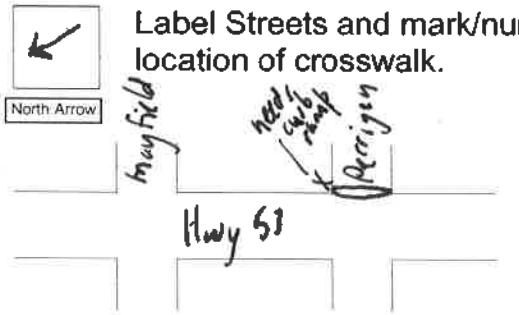
DEFICIENCY DESCRIPTION: No crosswalk

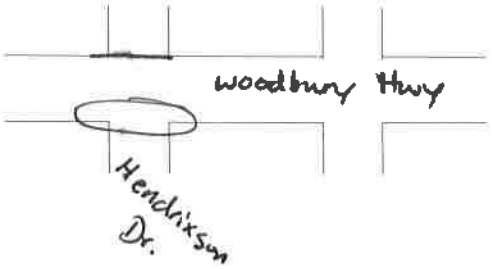
DEFICIENCY DESCRIPTION: No Crosswalk

CROSSWALK #1		CROSSWALK #2	
Crosswalk Slope:	1.9 %	Crosswalk Slope:	_____ %
Cross-Slope:	0.2 %	Cross-Slope:	_____ %
Crosswalk Width:	_____ FT	Crosswalk Width:	_____ FT
Crosswalk Length:	68 LF	Crosswalk Length:	_____ LF
Line Width	_____ IN	Line Width	_____ IN
Visibility:	Good / Poor	Visibility:	Good / Poor

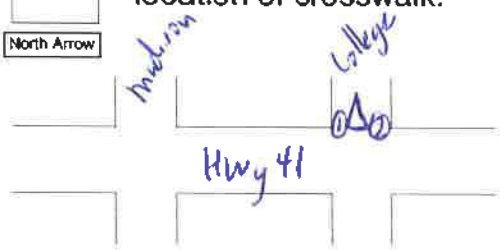
DEFICIENCY DESCRIPTION: No crosswalks

CROSSWALK #1		CROSSWALK #2	
Crosswalk Slope:	1.0 %	Crosswalk Slope:	0.4 %
Cross-Slope:	0.5 %	Cross-Slope:	0.3 %
Crosswalk Width:	_____ FT	Crosswalk Width:	_____ FT
Crosswalk Length:	24 LF	Crosswalk Length:	55 LF
Line Width	_____ IN	Line Width	_____ IN
Visibility:	Good / Poor	Visibility:	Good / Poor

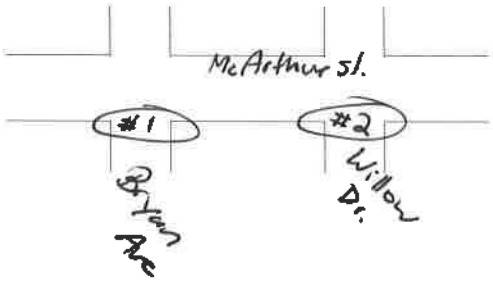
DEFICIENCY DESCRIPTION: No Crosswalk

CROSSWALK #1		CROSSWALK #2	
Crosswalk Slope:	2.8 %	Crosswalk Slope:	1.9 %
Cross-Slope:	3.3 %	Cross-Slope:	3.0 %
Crosswalk Width:	____ FT	Crosswalk Width:	____ FT
Crosswalk Length:	65 LF	Crosswalk Length:	67 LF
Line Width	____ IN	Line Width	____ IN
Visibility:	Good / Poor	Visibility:	Good / Poor

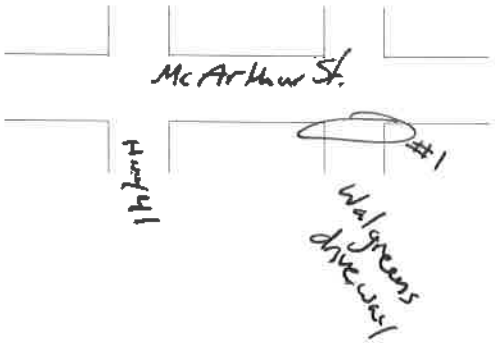
DEFICIENCY DESCRIPTION: No Crosswalk

CROSSWALK #1		CROSSWALK #2	
Crosswalk Slope:	0.2 %	Crosswalk Slope:	____ %
Cross-Slope:	4.2 %	Cross-Slope:	____ %
Crosswalk Width:	____ FT	Crosswalk Width:	____ FT
Crosswalk Length:	46 LF	Crosswalk Length:	____ LF
Line Width	____ IN	Line Width	____ IN
Visibility:	Good / Poor	Visibility:	Good / Poor

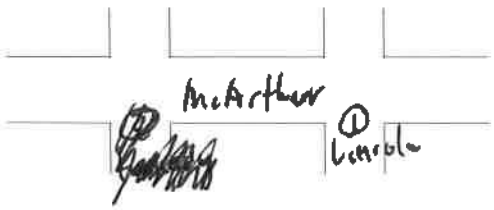
DEFICIENCY DESCRIPTION: No crosswalk

CROSSWALK #1		CROSSWALK #2	
Crosswalk Slope:	1.0 %	Crosswalk Slope:	_____ %
Cross-Slope:	3.0 %	Cross-Slope:	_____ %
Crosswalk Width:	_____ FT	Crosswalk Width:	_____ FT
Crosswalk Length:	68 LF	Crosswalk Length:	_____ LF
Line Width	_____ IN	Line Width	_____ IN
Visibility:	Good / Poor	Visibility:	Good / Poor
